NON-MODIFICATION SERVICE BULLETIN — ENGINE — INSPECTION OF THE NO. 5 BEARING COMPARTMENT (OIL JET) AND OIL TUBES FOR COKING

Turbojet Engine Service Bulletin No. V2500-ENG-72-0461 Revision No. 7 dated October 1, 2015.

NON-MODIFICATION SERVICE BULLETIN — ENGINE — INSPECTION OF THE NO. 5  
BEARING COMPARTMENT (OIL JET) AND OIL TUBES FOR COKING

# V2500-ENG-72-0461

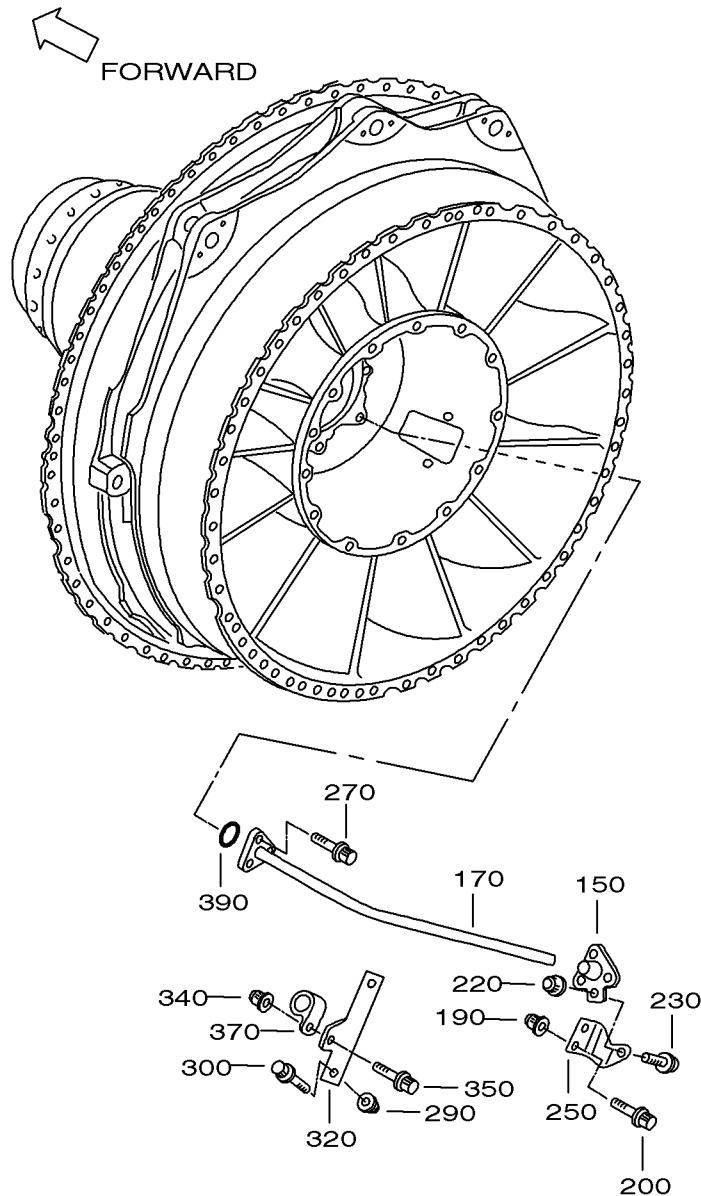
OIL FEED TUBE THROUGH THE TEC STRUT  
REFERENCE 5, PRE SERVICE BULLETIN V2500-ENG-72-0063 TEC (A1)  
FIGURE 1

- (11) Using borescope equipment, examine ID bore of the oil feed tube (Figure 1, item 170) for evidence of coking.
  - (12) If no coke is present, then do steps that follow:

- (1) Remove the exhaust cone in accordance with Reference 3, Task 78-11-12-000-010.
- (2) Remove 3 bolts and nuts (Figure 2, items 114 and 110).
- (3) Remove bolt , nut and clip (Figure 1, items 350, 340 and 370).
- (4) Remove bolt and nut (Figure 1, items 230 and 220).

- (5) Remove 3 bolts (Figure 1 item 270).
  - (6) Disengage the tube from the flange
  - (7) Remove and discard packing (Figure 1 item 390).
  - (8) Disconnect the feed tube (Figure 1 items 170 and 150) from the external tube (Figure 2 item 100).

- (9) Remove and discard packing (Figure 2 item 116).
  - (10) Clean in situ per Appendix 1 procedure Method 1, or remove the engine from the aircraft and perform Reference 2, Task 72-50-53-300-006, Repair 006, VRS5390.

- (a) Connect external tube (Figure 2, item 100) using new packing (Figure 2, item 116).
    - (b) Connect internal feed tube (Figure 1 item 170) using metallic seal (Figure 1 item 390).

- (c) Install 3 bolts (Figure 1 item 270). Torque bolts in increments of 25 lbf-in (2.82 Nm) to 101.784 lbf-in (11.5 Nm).
    - (d) Torque the 3 bolts and nuts (Figure 2, items 114 and 110) to 85 to 95 lbf-in (9 to 10 Nm).

- (e) Install the clamp to the oil feed tube (Figure 1 item 370). Attach the clamp to the bracket with the bolt (Figure 1 item 350) and locknut (Figure 1 item 340). Torque to 17.701 lbf-in (2.0 Nm).

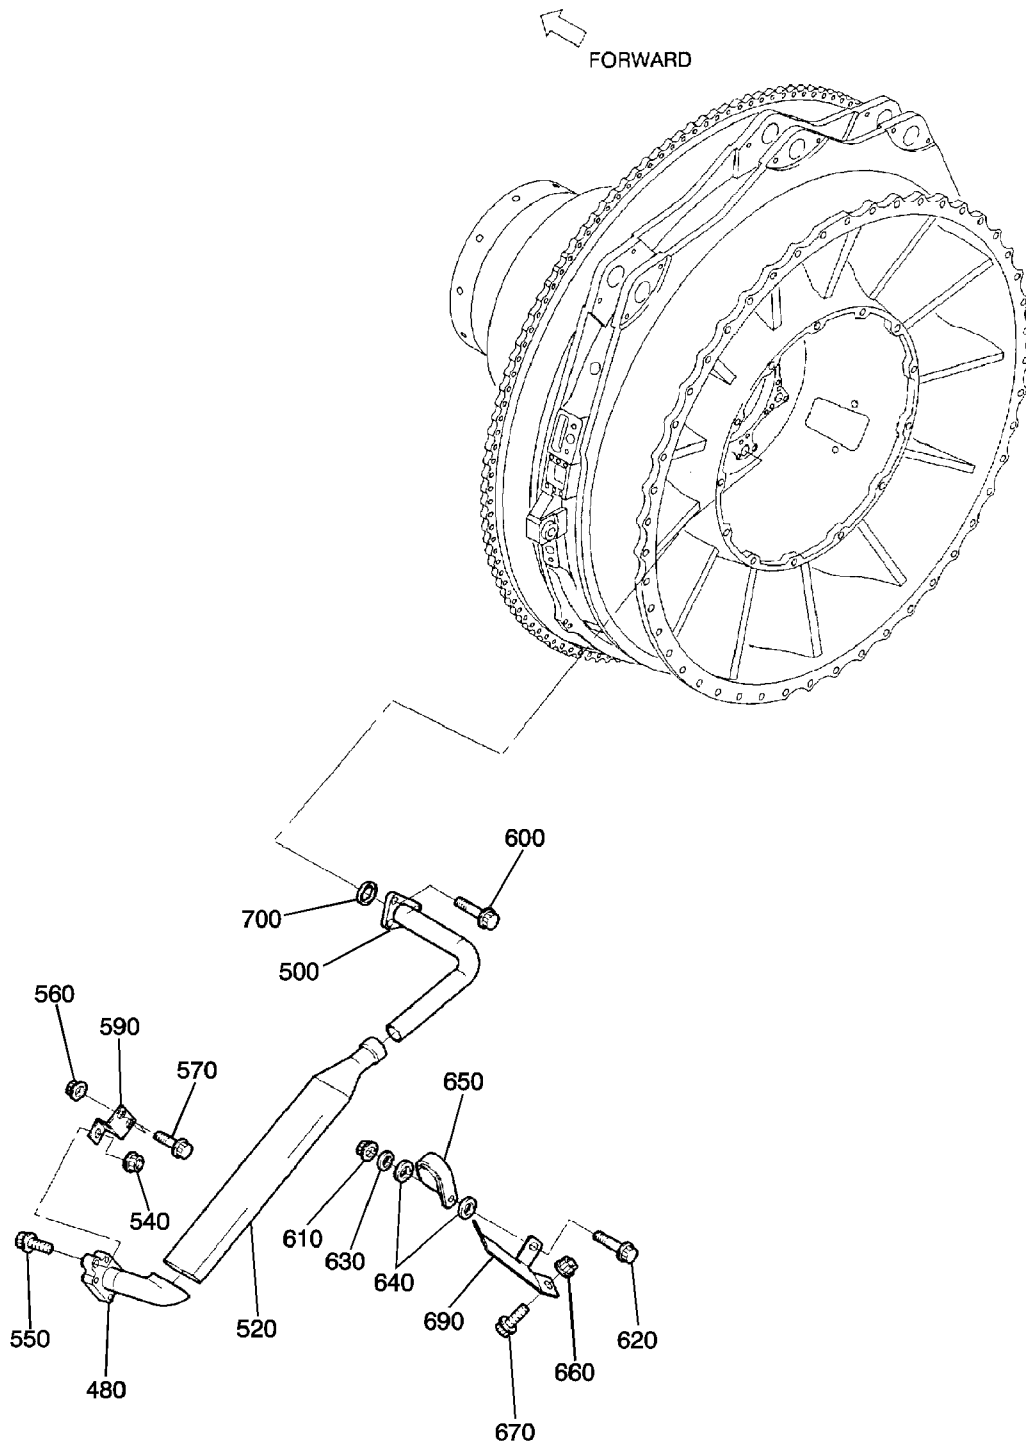
OIL SCAVENGE TUBE RUNNING THROUGH TEC STRUT  
REFERENCE 5, PRE SERVICE BULLETIN V2500-ENG-72-0063 TEC (A1)  
FIGURE 3

- (9) Using borescope equipment, examine the ID bore of the oil scavenge tube (Figure 3, item 520) for evidence of coking.
- (10) If no coke is present, then do the steps that follow:

- D. Inspection of the oil scavenge tube (Figure 3 and Figure 4) for all A1 engine models Pre Service Bulletin V2500-ENG-72-0063.
- (1) Remove the bolts and nuts (Figure 3, items 540, 550, 560, 570).

- (2) Remove the nut, the washer, the two spacers and the bolt from the bracket (Figure 3 items 610, 620, 630, 640).
  - (3) Remove the three bolts which attach the flange of the oil scavenge tube to the flange of the No. 5 bearing compartment (Figure 3 item 600).

- (4) Disengage the tube from the flange.
  - (5) Remove and discard metallic seal (Figure 3 item 700).
  - (6) Disconnect scavenge tube from external tube.

- (7) Remove and discard packing (Figure 4, item 117).
  - (8) Clean in situ per Appendix 1 procedure Method 1, or remove the engine from the aircraft and perform Reference 2, Engine Manual, Task 72-50-53-300-007, Repair 007, VRS5391.

- (a) Connect external tube (Figure 4, item 216) using new packing (Figure 4, item 117).
  - (b) Install metallic seal 1 off to the flange of the oil scavenge tube (Figure 3 item 700).

- (c) Install the three bolts which attach the oil scavenge tube to the No. 5 bearing compartment. Torque the bolts in increments of 25 lbf-in (2.82 Nm) to 101.784 lbf-in (11.5 Nm) (Figure 3 item 600).

- (d) Attach the clamp to the bracket with the bolt, washer, two spacers and Torque to 39.828 lbf-in (4.5 Nm) (Figure 3 items 610, 620, 630, 640).
  - (e) Install the bolts and locknuts which attach the oil scavenge tube to the bracket (Figure 3, items 540, 550, 560, 570). Torque to 101.784 lbf-in (11.5 Nm).

- (f) Torque the 4 bolts and nuts (Figure 3, items 540, 550, 560, 570) to 85 to 95 lbf-in (9 to 10 Nm).

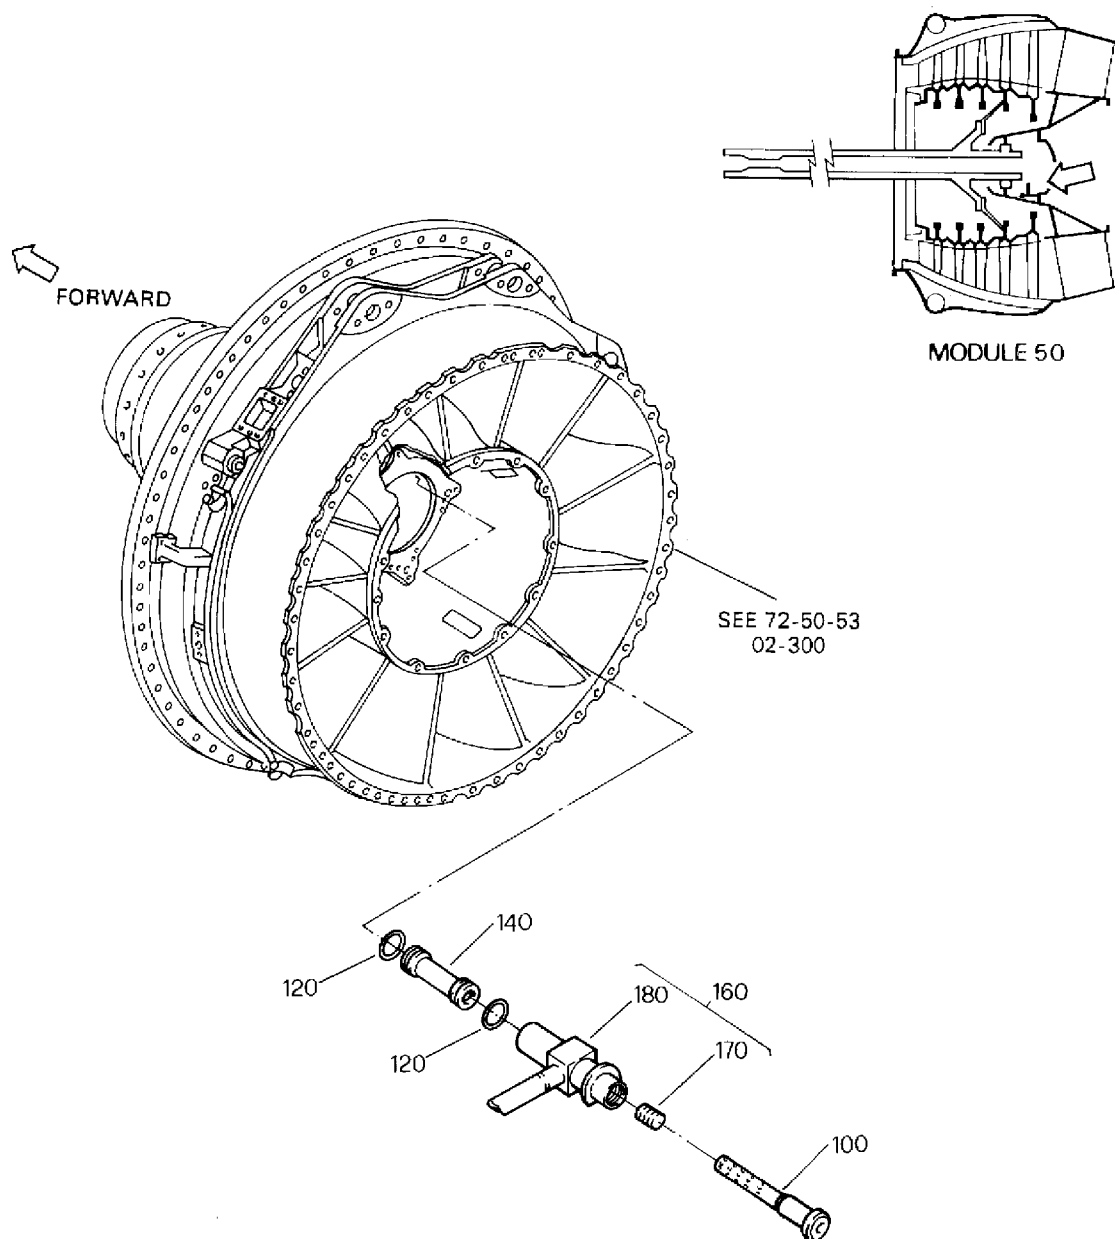
NO. 5 BEARING OIL JET AND TRANSFER TUBE  
FIGURE 6

- (2) Remove, clean and inspect the No. 5 bearing oil jet assembly for coke/blockage (Figure 6):

- (a) Release and remove the oil filter from the oil jet. Use IAE 1P16426 Remove/Installation Driver 1 off.
- (b) Move the oil transfer tube rearward into the oil jet until the removal of the oil jet is possible.
- (c) Move the oil jet forward and disengage from the front flange of the No. 5 bearing compartment. Remove the oil jet.
- (d) Remove the oil transfer tube from the oil jet and discard the 2 seal rings.
- (e) Replace or clean in accordance with Appendix 1 procedure.
- (f) Inspect the ID bores of oil nozzle and transfer tube for coke/blockage. (It is recommended to use a borescope of appropriate size or other optical equipment suitable as possible to inspect ID bores).

- (b) Torque the bolts between 85 to 105 lbf-in (10 to 12 Nm).
  - (2) Install the No. 5 bearing oil jet and transfer tube (Figure 6) as follows:
    - (a) Install toroidal sealing rings 2 off on both ends of the oil transfer tube.

- (b) Install one end of the oil transfer tube into the ID of the oil jet. Push the transfer tube into the oil jet in order to permit the subsequent installation.

- (c) Install the oil jet and align the eccentric diameter with the hole on the front flange of the No. 5 bearing compartment.
    - (d) Push the transfer tube from the rear with IAE 1F10153 installation Rod 1 off until it is fully installed into the flange of the No. 5 bearing housing.

- (e) Install the oil filter into the threaded hole of the oil jet. Torque the oil filter to 371.736 lbf-in (42.0 Nm). Use IAE 1F10182 Removal/Installation Driver 1 off.

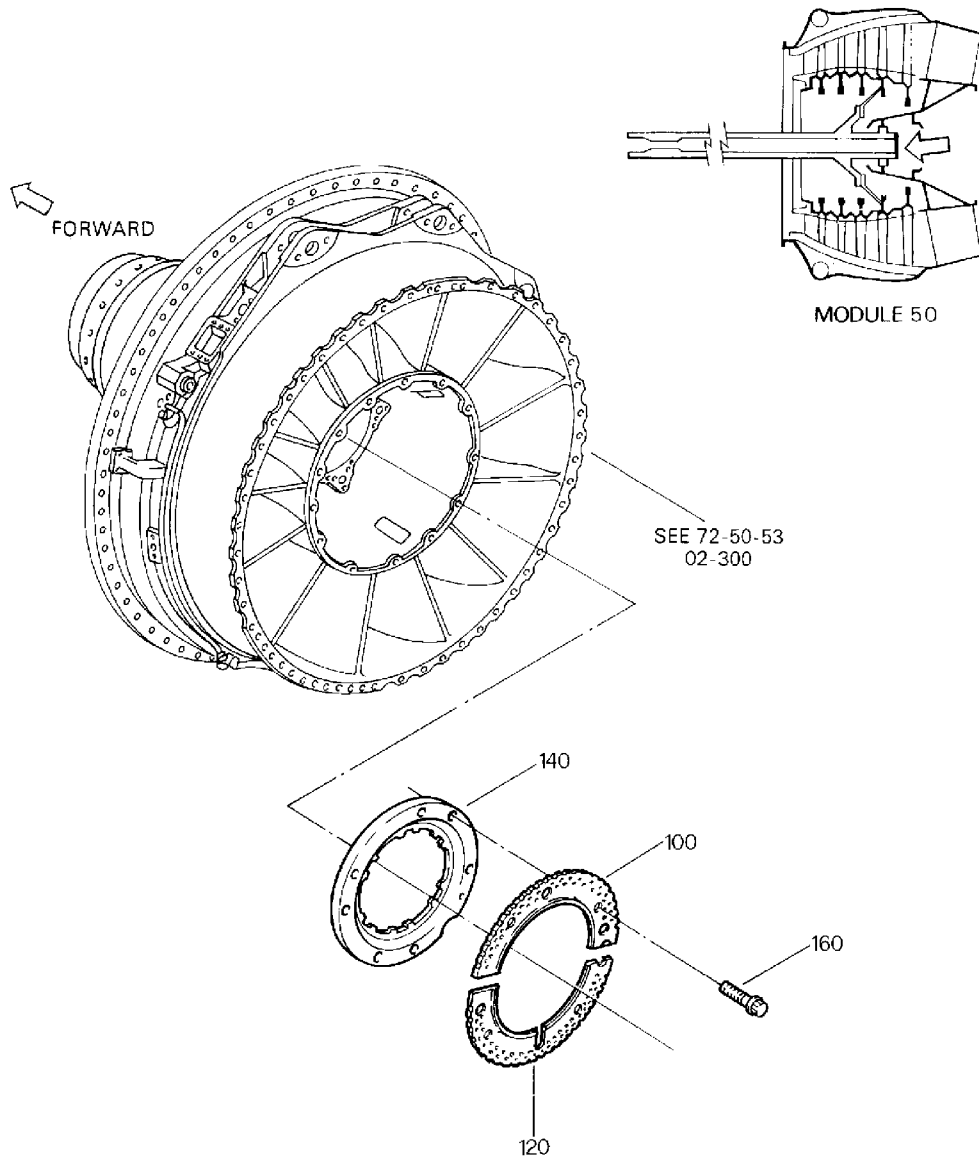
NO. 5 BEARING SUPPORT  
FIGURE 7, SHEET 2

- (a) Remove the bolts which attach the upper and lower deaerator on the retaining plate to the No. 5 bearing housing.
- (b) Remove the upper and lower deaerator.
- (c) Inspect the No. 5 bearing support for blockage of oil return holes.

- 1 If the total area of holes blockage is equivalent to the area of at least two fully-blocked holes cleaning is required.

**NOTE:** If total area of hole blockage is equivalent to the area of at least two fully-blocked holes, proper scavenging of oil from the No. 5 compartment will be affected. This can cause oil flooding of the compartment, and result in oil leakage past the carbon seal, and subsequent tailpipe smoke or fire event.

- 1 Carefully clean using pick to remove as much coke as possible to clear passages.

- 2 Using vacuum completely remove all loose particles from the compartment.

- a Reinspect compartment within 600 hours. Inspect No. 5 bearing support for blockage of oil return holes. Refer to Step E(3)(c). Proceed to Step F.

- a It is recommended the engine be removed from service within 600 flight hours for removal and thorough cleaning of the TEC. Proceed to Step F.
  - (e) If no hole blockage exist proceed as follows:

- (1) Install the upper and lower deaerator on the retaining ring. Align the holes with the cutout on the ends over the oil feed port.
    - (a) Install the bolts which attach the upper and lower deaerator on the retaining ring.
