V2500-A1/A5/D5 SERIES PROPULSION SYSTEMS SERVICE BULLETIN

This document transmits the Initial Issue of Service Bulletin EV2500-72-0462

ENGINE – LP COMPRESSOR – INTRODUCTION OF A REVISED HYDRAULIC SEAL AND A REVISED NO.2 BEARING OIL JET

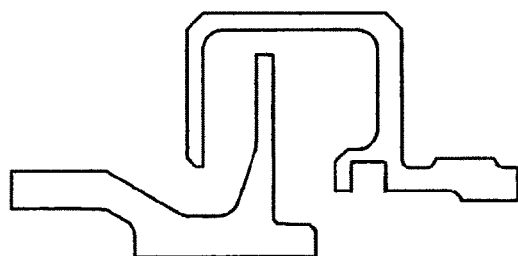
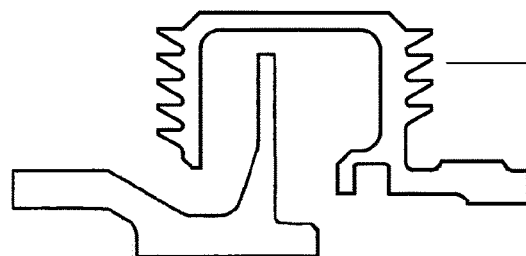
Before and after alteration of Hydraulic Seal
Figure 1

It was reported that cabin odour due to oil carbonization on the Hydraulic Seal Assembly.

Oil carbonisation occurs in the Hydraulic Seal Assembly due to high oil temperature in oil bath of the Hydraulic Seal. The oil carbonisation causes sticking of the Seal Ring on groove of the Hydraulic Seal and oil leaks to Front Bearing Compartment Weep Line through HPC Stub Shaft. When FBC Weep Line is clogged and the oil overflow from the weep line, the odour of the oil goes to the Cabin of the Aircraft.

- (a) The Hydraulic Seal Assembly is revised to add cooling fins to improve heat radiation. Refer to Figure 1 and 5.
- (b) The No.2 Bearing Oil Jet is revised to enlarge oil hole to increase oil flow to the Hydraulic Seal. Refer to Figure 2 and 6.

This Service Bulletin introduces cooling fins on the Hydraulic Seal Assembly to increase heat rejection, and enlarges diameter of the hole on the No.2 Bearing Oil Jet to increase oil flow. These redesigns prevent oil carbonization in the Hydraulic Seal.

- (3) Assemble the Hydraulic Ring and Seal Ring into the Hydraulic Seal Assembly. Refer to Figure 5 and EM (E-V2500-1IA) 72-32-10, Assembly, Config-01 or Config-02 or EM (E-V2500-3IA) Assembly, except:

- (a) Use the new 5A1900 Hydraulic Seal Assembly (72-32-19, 01-100).

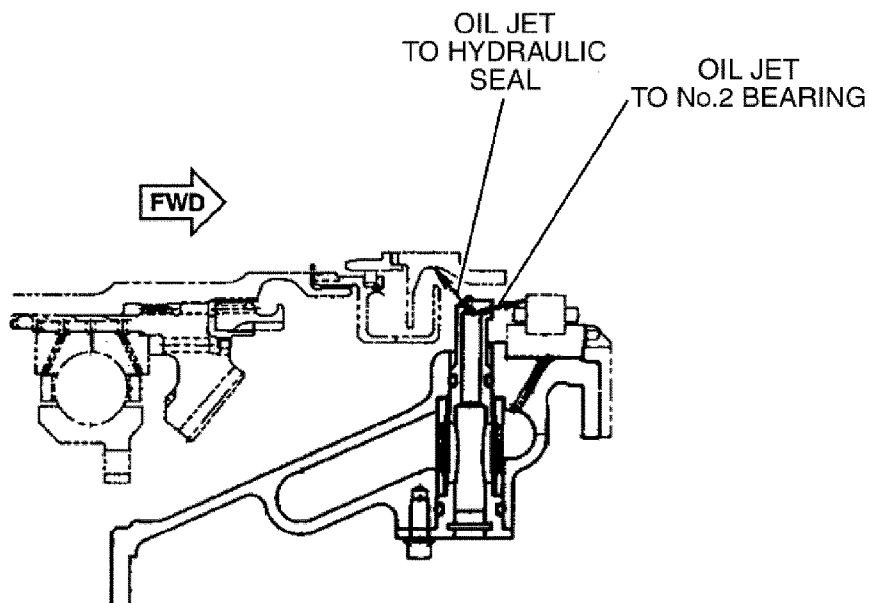
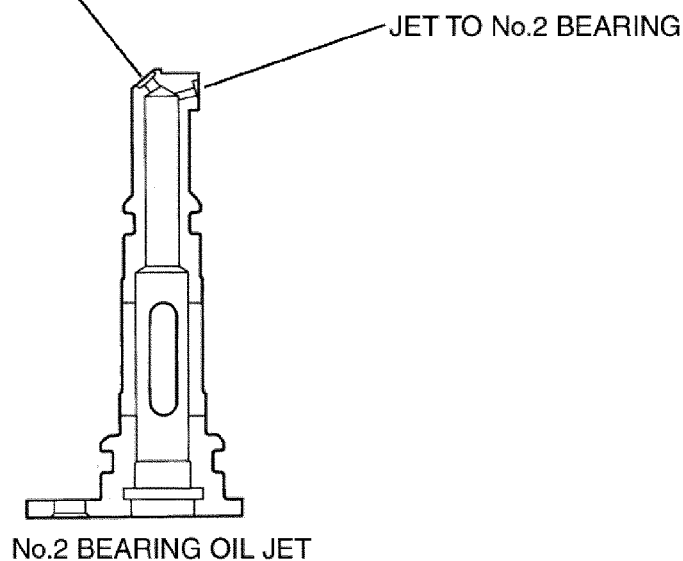
Before and after alteration of No.2 Bearing Oil Jet
Figure 2

JET TO HYDRAULIC SEAL
OIL FLOW
BEFORE ALTERATION: 2.7 TO 2.9 (PPM)
AFTER ALTERATION: 5.5 TO 5.7 (PPM)

- (2) Install the Oil Jet. Refer to Figure 6 and EM (E-V2500-1IA) 72-32-10, Assembly, Config-01 or Config-02 or EM (E-V2500-3IA) Assembly, except:

- (a) Use the new 5R0293 Oil Jet (72-32-17, 01-700).
