V2500-A5 SERIES PROPULSION SYSTEM NON-MODIFICATION SERVICE BULLETIN

This document transmits Revision 2 to Service Bulletin EV2500-72-0474

V2500-ENG-72-0474

NON - MODIFICATION SERVICE BULLETIN - HIGH PRESSURE TURBINE (HPT) STAGE 2 HUB
INSPECTION

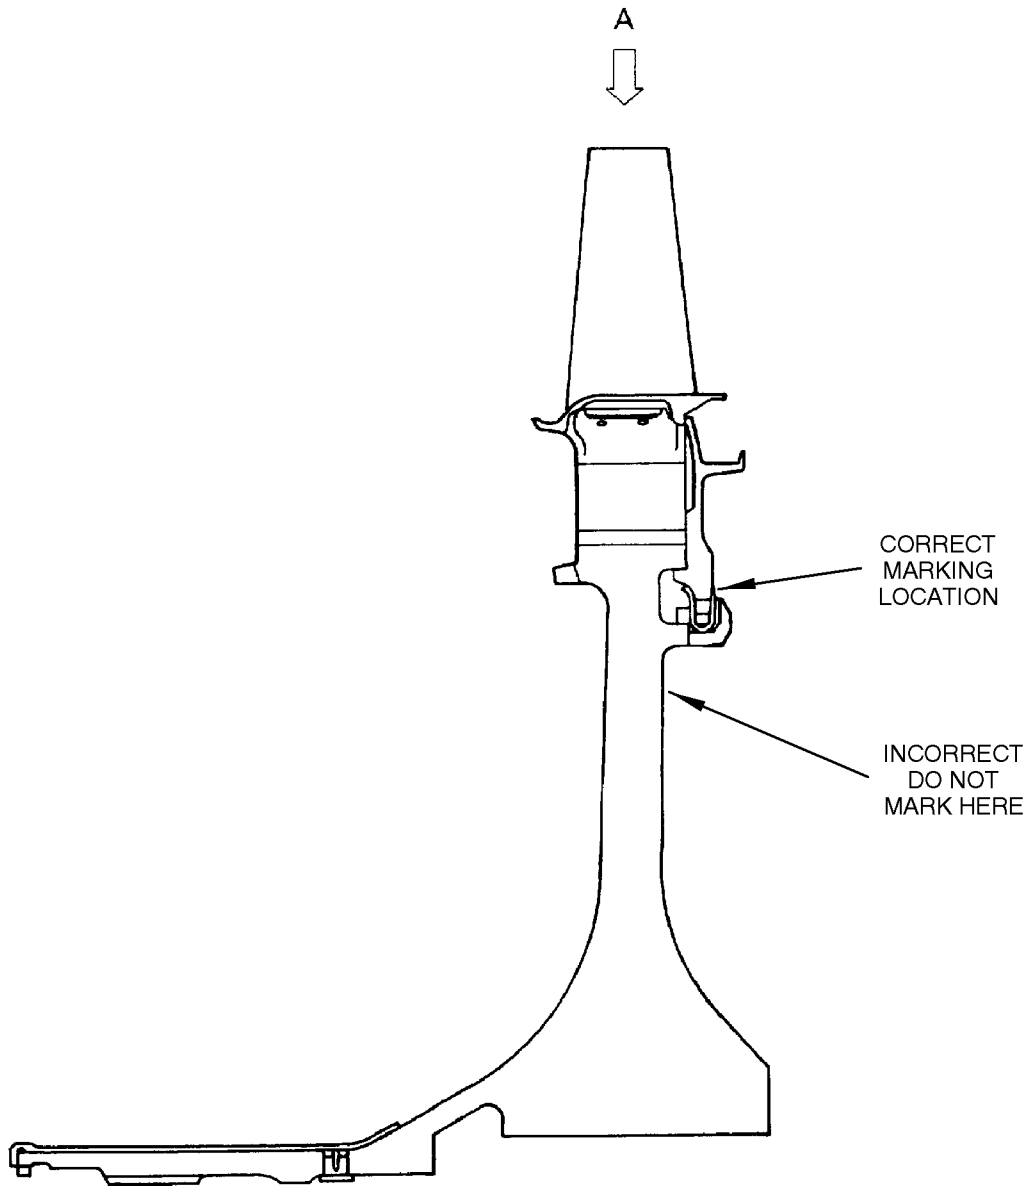
HPT STAGE 2 ROTOR MARKING LOCATION
Figure 1

- R (1) Problem: The HPT stage 2 Hub P/N 2A4802 Serial Number PKLBEU5303 in engine
serial number V11565 may have been incorrectly marked during assembly.
The HPT stage 2 rotor assembly should be identified on the stage 2 blade
retaining plate. The assembly number may have been improperly marked on
R the web of the HPT stage 2 hub.

- R (3) Objective: Revise the NMSB to no longer require that the hub be inspected
prior to achieving 5,100 cycles.
- R (4) Substantiation: Structural analysis and specimen testing has determined
R that the improperly marked hub can continue in service until the next shop
R visit where the rear of the HPT is assessable. The Engine Manual requires
R that at shop visits where the HPT stage 2 hub rear web is assessable, the
R interface inspection checks for improperly marked hub. And if an improper
R marking is found the hub to be repaired per VRS3704.
