ENGINE — HP TURBINE ROTOR ASSEMBLY — INTRODUCE NEW FIRST STAGE TURBINE BLADES AND STAGE 1 HPT COOLING DUCT ASSEMBLY WITH DECREASED FLOW

Turbojet Engine Service Bulletin No. V2500-ENG-72-0475 Revision No. 3 dated May 7, 2019.

V2500 Series 72-0475

The purpose of this Service Bulletin is to replace 1st stage Blades and Stage 1 HPT Cooling Duct.

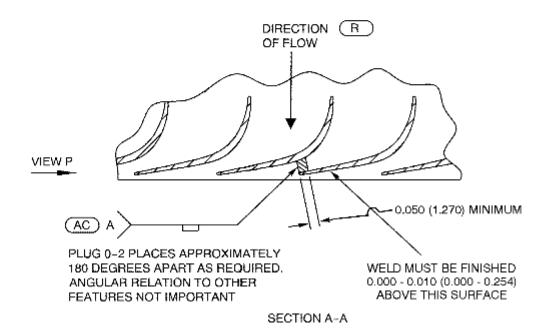
HPT DUCT REOPERATION PN 2A3487-01 TO PN 2A3914-01 (PART II) FIGURE 3, SHEET 3

(AC) WELD PER EM 72-44-50-300-010-REPAIR 010 (VRS3177)

To revise Figure 3, Sheet 3 and Figure 4, Sheet 4 to update the weld specification.

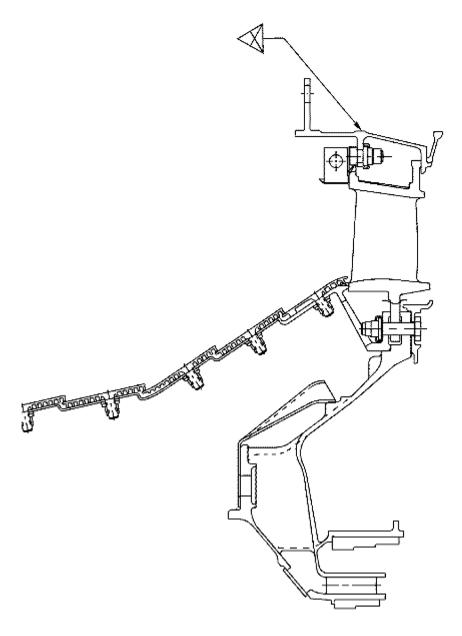
HPT DUCT REOPERATION PN 2A3487-01 TO PN 2A3914-01 (PART II) FIGURE 3, SHEET 5

MARK IDENT PER SPPM 70-09-00

- (6) Mark the new part number adjacent to the existing part number. Use the vibration peen method. Refer to Reference 1, Standard Practices/Processes Manual 70-09-00-400-501. See Reidentified Parts section for part numbers. See Figure 3 Sheet 1.

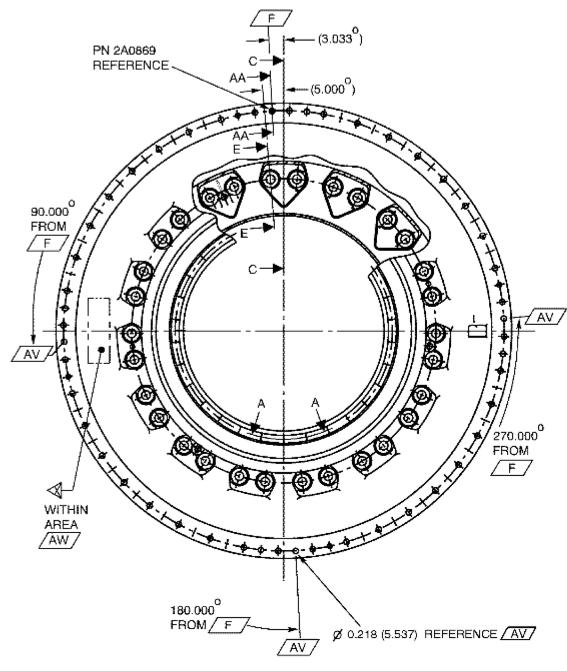
HPT DUCT REOPERATION PN 2A3914-01 TO PN 2A3487-01 (PART III) FIGURE 4, SHEET 1

PLUG WELD 3 HOLES AT LOC/AV/

- C. Plug weld three (3) holes at location AV per Reference 1, Standard Practices/Processes Manual 70-31-13. See Figure 4 (Sheets 1-5).
 - (1) Inspect and verify all dimensions in Figure 4 (Sheets 1-5).

- (5) Mark the new part number adjacent to the existing part number. Use the vibration peen method. Refer to Reference 1, Standard Practices/Processes Manual, 70-09-00-400-501. See Reidentified Parts section for part numbers. See Figure 4 Sheet 1.

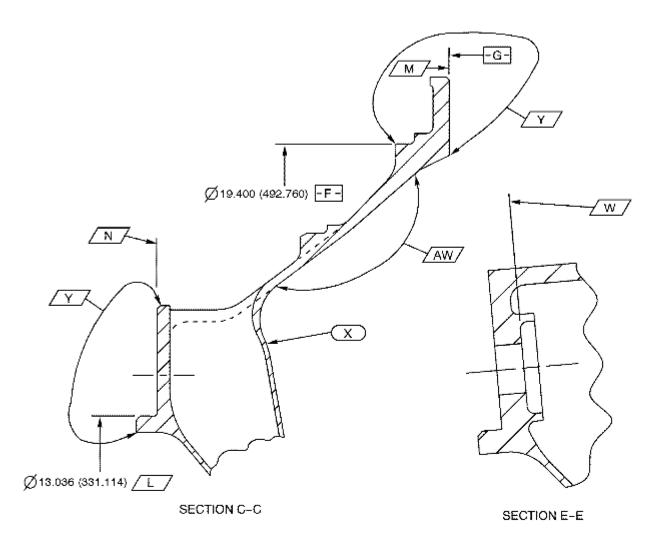
HPT DUCT REOPERATION PN 2A3914-01 TO PN 2A3487-01 (PART III) FIGURE 4, SHEET 3

IN FREE STATE SURF N IS 0.005 (0.127) & L IS 13.028 - 13.044 (330.91 - 331.32) .

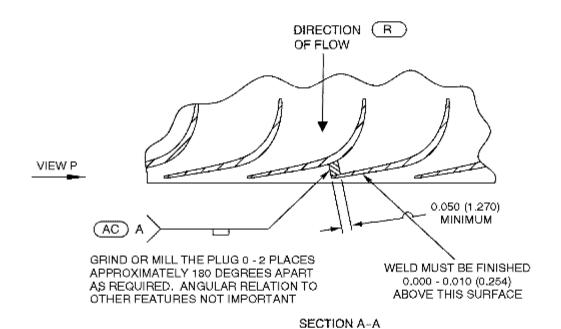
HPT DUCT REOPERATION PN 2A3914-01 TO PN 2A3487-01 (PART III) FIGURE 4, SHEET 4

AC WELD PER EM 72-44-50-300-010-REPAIR 010 (VRS3177)

- (a) Minimum Pressure Ratio is 1.508.
 - (b) Maximum Pressure Ratio is 1.558.
 - (c) Flow Parameter is 1.152.
 - (3) To achieve the required flow grind or machine the plug welds as necessary by the procedure specified in Engine Manual 72-44-50-300-010. Refer to Reference 4 or 5, Chapter/Section 72-44-50, Repair, VRS 3177.
