V2500-A1/A5/D5 SERIES PROPULSION SYSTEMS SERVICE BULLETIN

V2500-ENG-72-0478

ENGINE – REPLACE NUMBER 3 BEARING CARBON SEAL ASSEMBLY

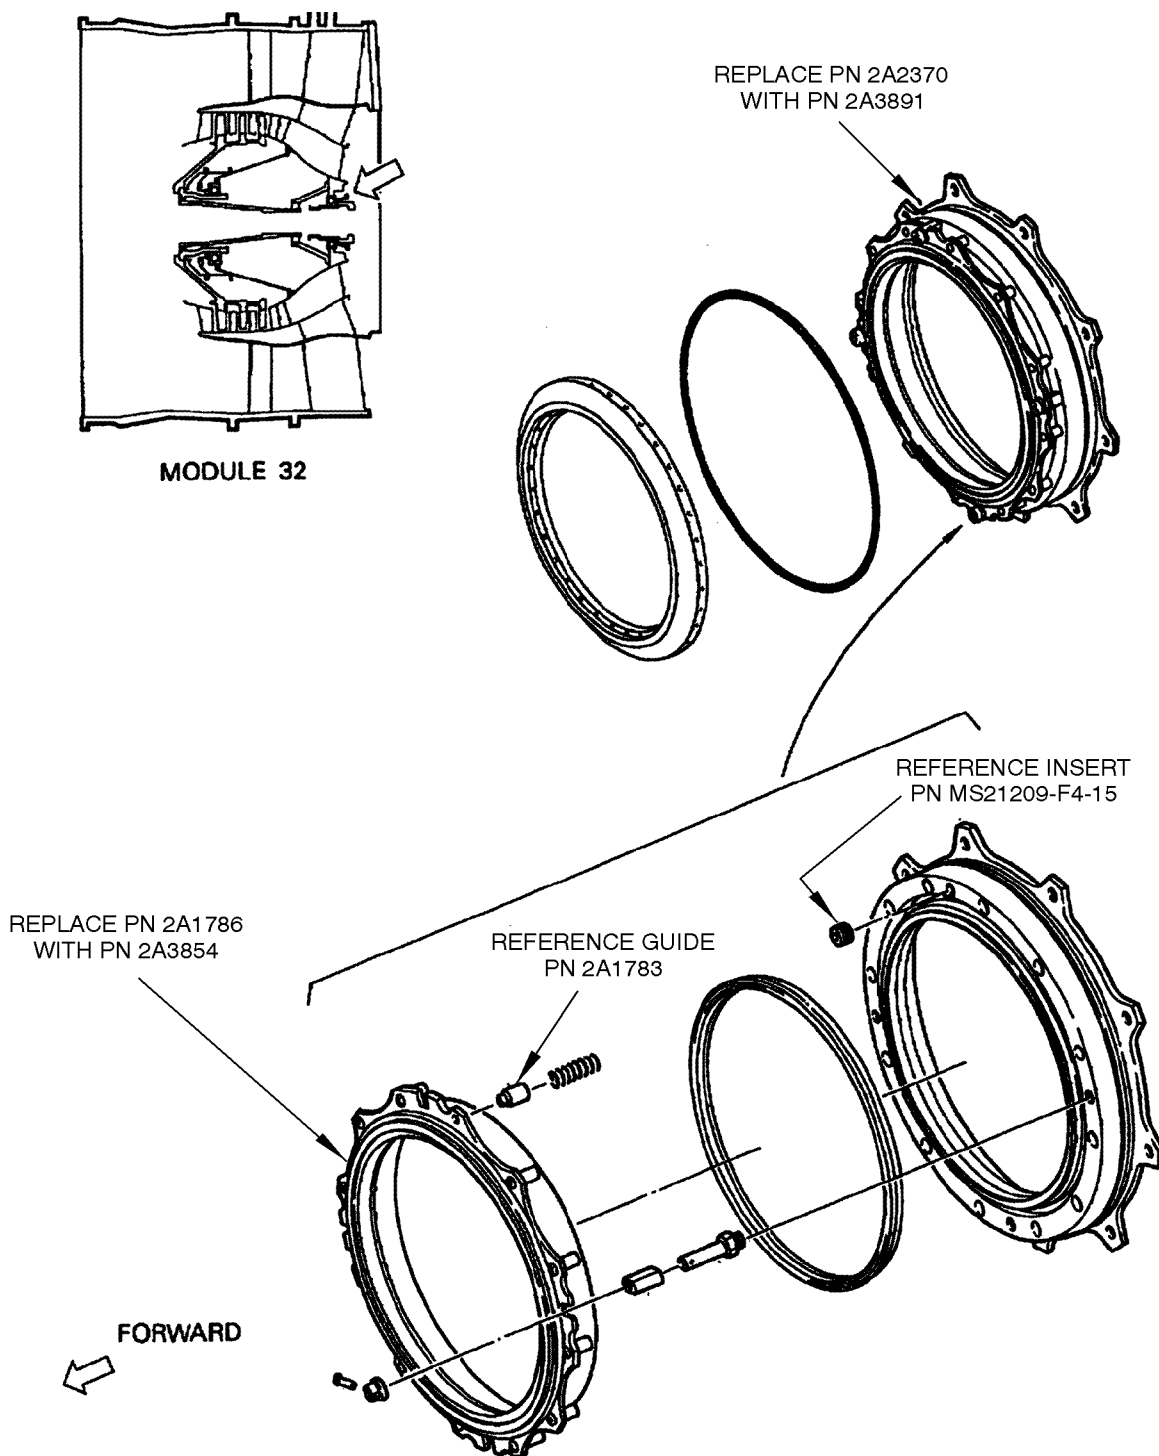
ENGINE - NUMBER 3 BEARING REAR OIL SEAL
Figure 1

- (1) Problem: Multiple engines have been found at overhaul with a severely worn carbon seal nose.
- (2) Background: V2500 Operators have identified the No. 3 Carbon Seal nose wear as a maintenance cost driver. Currently the operators are forced to access the No. 3 Carbon Seal to inspect it at each heavy maintenance overhaul. A redesigned seal with extended life could help to significantly reduce the V2500 maintenance cost.
- (3) Objective: The seal has been redesigned using a recently developed Carbon Material that has been verified through rig and engine test to significantly decrease the nose wear rate. The decreased nose wear rate significantly increases the life of the component.
- (4) Substantiation: the redesign V2500 No. 3 carbon seal has been validated by performing rig and engine testing.

(1) Modification of Seal Assembly and Seal Face Assembly

(b) Disassemble the number 3 bearing seal assembly per Engine Manual Task 72-32-25-040-001 Subtask 72-32-25-040-051 (All Models).

R (c) Send the number 3 bearing Seal Face Assembly PN 2A1786 to one of the
R authorized repair facilities referenced in 72-32-25-300-007 (VRS3393)
R for carbon seal detail replacement.

(3) Assemble the number 3 bearing seal assembly per Engine Manual Task 72-32-25-440-001 (All Models).
