V2500-A5/D5 SERIES PROPULSION SYSTEMS SERVICE BULLETIN

This document transmits the Revision 2 of Service Bulletin V2500-ENG-72-0485

V2500-ENG-72-0485

ENGINE – LP COMPRESSOR – REWORK THE INSERT HOLES OF LPC BLEED DUCT ASSEMBLY**1. Planning Information****A. Effectivity****(1) Airbus A319**

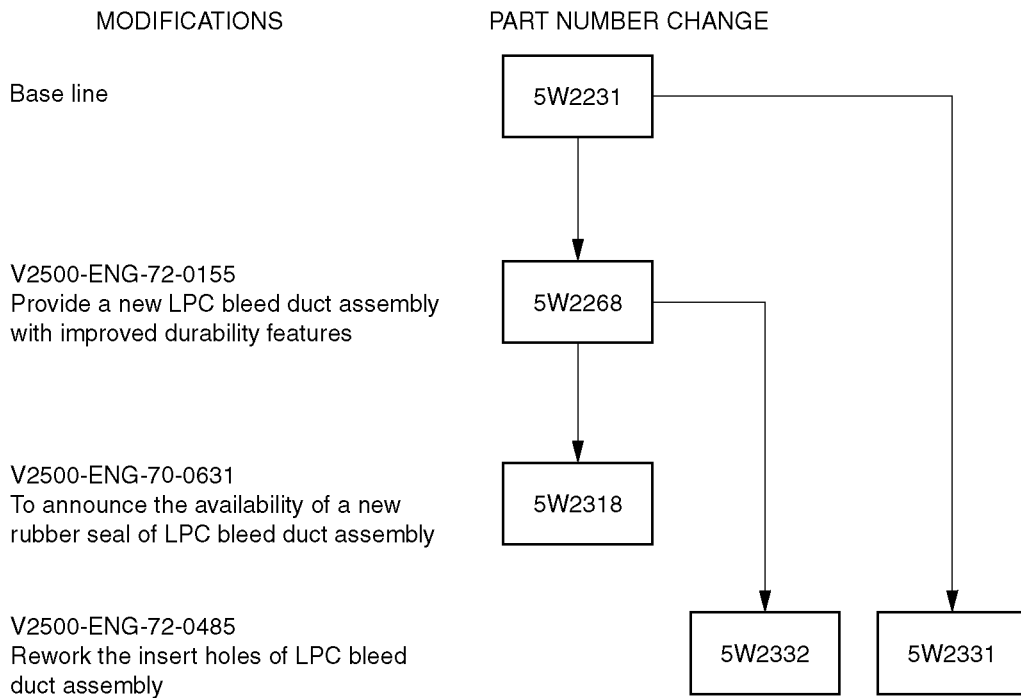
Family Tree – LPC Bleed Duct Assembly for V2500-A5 (ATA 72-32-60, Fig-Item 01-250)
Figure 3

Remove	Incorporate	Reason for change
All pages of the Service Bulletin	Pages 1 to 13 of the Service Bulletin	To revise a SB reference in Figures 3 and 4.
