V2500-A5/D5 SERIES PROPULSION SYSTEM SERVICE BULLETIN

V2500-ENG-72-0486

ENGINE - HP COMPRESSOR VARIABLE VANES - INTRODUCTION OF A REVISED VIGV WITH AN OPTIMISED SPINDLE - MOD 72-0486

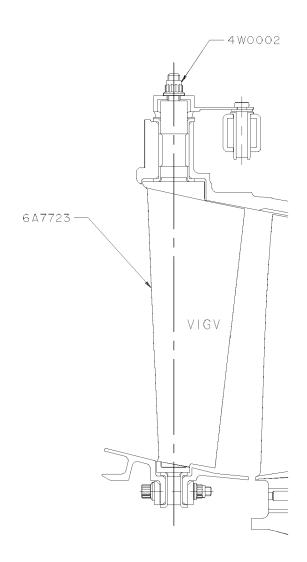
GENERAL SECTION SECTION THROUGH HP COMPRESSOR BEFORE ALTERATION TYPICAL 38 POSITIONS (LONG SPINDLE)

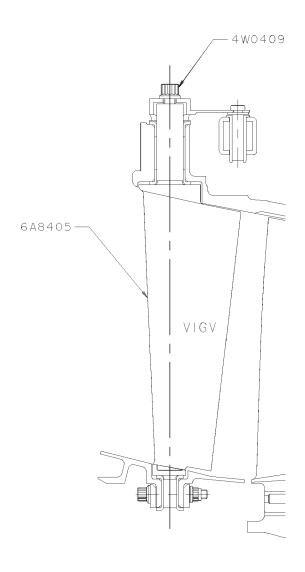
GENERAL SECTION SECTION THROUGH HP COMPRESSOR AFTER ALTERATION TYPICAL 38 POSITIONS (LONG SPINDLE)

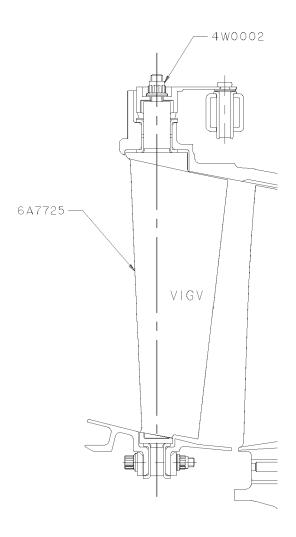
SECTION AB
BEFORE ALTERATION
TYPICAL 2 POSITIONS DESIGNATED AC
(SHORT SPINDLE)

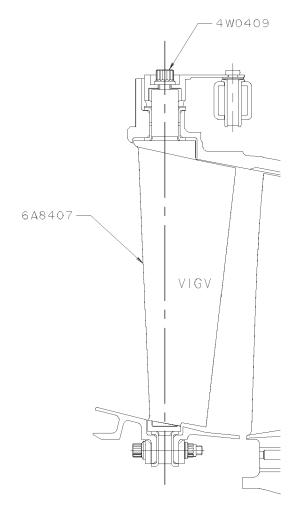
SECTION AB TYPICAL 2 POSITIONS DESIGNATED AC (SHORT SPINDLE)
