V2500-A5/D5 SERIES PROPULSION SYSTEM SERVICE BULLETIN

This document transmits Revision 2 to Service Bulletin EV2500-72-0487 and Revision 2 to the Supplement

V2500-ENG-72-0487

ENGINE – HP COMPRESSOR BLADES – INTRODUCTION OF A STAGE 3 BLADE WITH A REVISED
CLAPPER – MOD 72-0487.

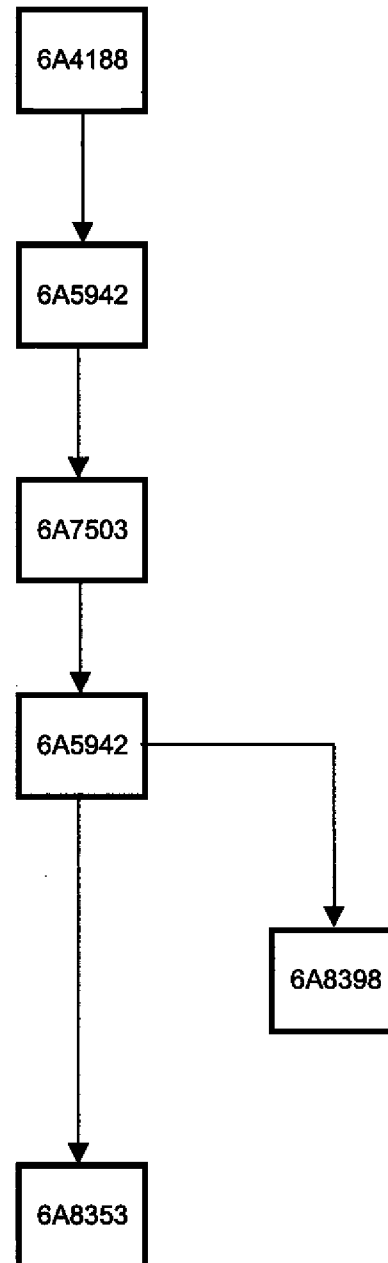
HP Compressor Stage 3 Rotor Blade Family Tree
Fig. 1

HP Compressor Stage 3 Rotor Blade Family Tree

V2500 A5 and D5 Engines

- (1) Refer to figure 1. New 6A8353 stage 3 HP compressor blades are only interchangeable as a complete set with existing stage 3 HP compressor blades.
- (2) Assemble in accordance with approved procedures, Engine Manual, 72-41-10, 72-41-00, Assembly.
