V2500-A5/D5 SERIES PROPULSION SYSTEM SERVICE BULLETIN

V2500-ENG-72-0489

ENGINE – ALLOW FOR THE USE OF REOPERATED 2ND STAGE HPT VANES IN NEWER DELIVERED
CONFIGURATIONS

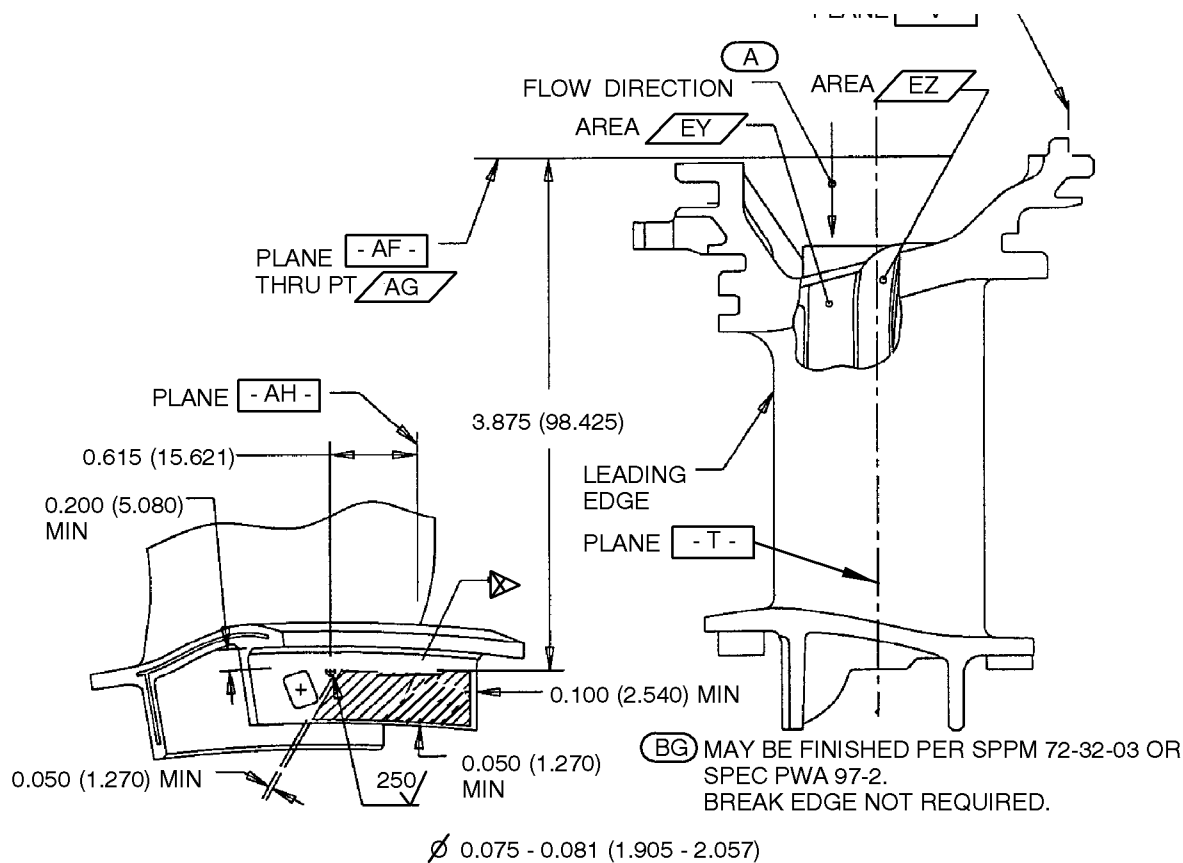
2ND STAGE HPT VANE REOPERATION
FIGURE 1 (SHEET 2 of 3)

(A) FLOW TEST PASSAGE /EY/ IN DIRECTION SHOWN WITH AREA /EZ/ AND LEADING EDGE & SHOWER HEAD (4 ROWS TOTAL) HOLES BLOCKED PER IAE 70-72-01 OR SPEC PWA 322 TO OBTAIN AIRFLOW LEVEL OF:

$\left(\frac{P_3}{P_a}\right)_{\text{MIN}}$	$\left(\frac{P_3}{P_a}\right)_{\text{TARGET REF}}$	$\left(\frac{P_3}{P_a}\right)_{\text{MAX}}$
$\frac{W\sqrt{T_3}}{P_a} = 0.184$ (4.674)	BSC LIMIT	1.412 (35.865)	1.500 (38.100)	1.621 (41.173)

- (a) Set-up and machine one Hole to 0.075-0.081 in. (1.905-2.057 mm) diameter.

- (b) Flow test passage EY in direction shown with area EZ and leading edge shower head (4 rows total) holes blocked by the procedure specified.

Refer to Reference (9) or (10). See Figure 1 Sheets 1 and 2.

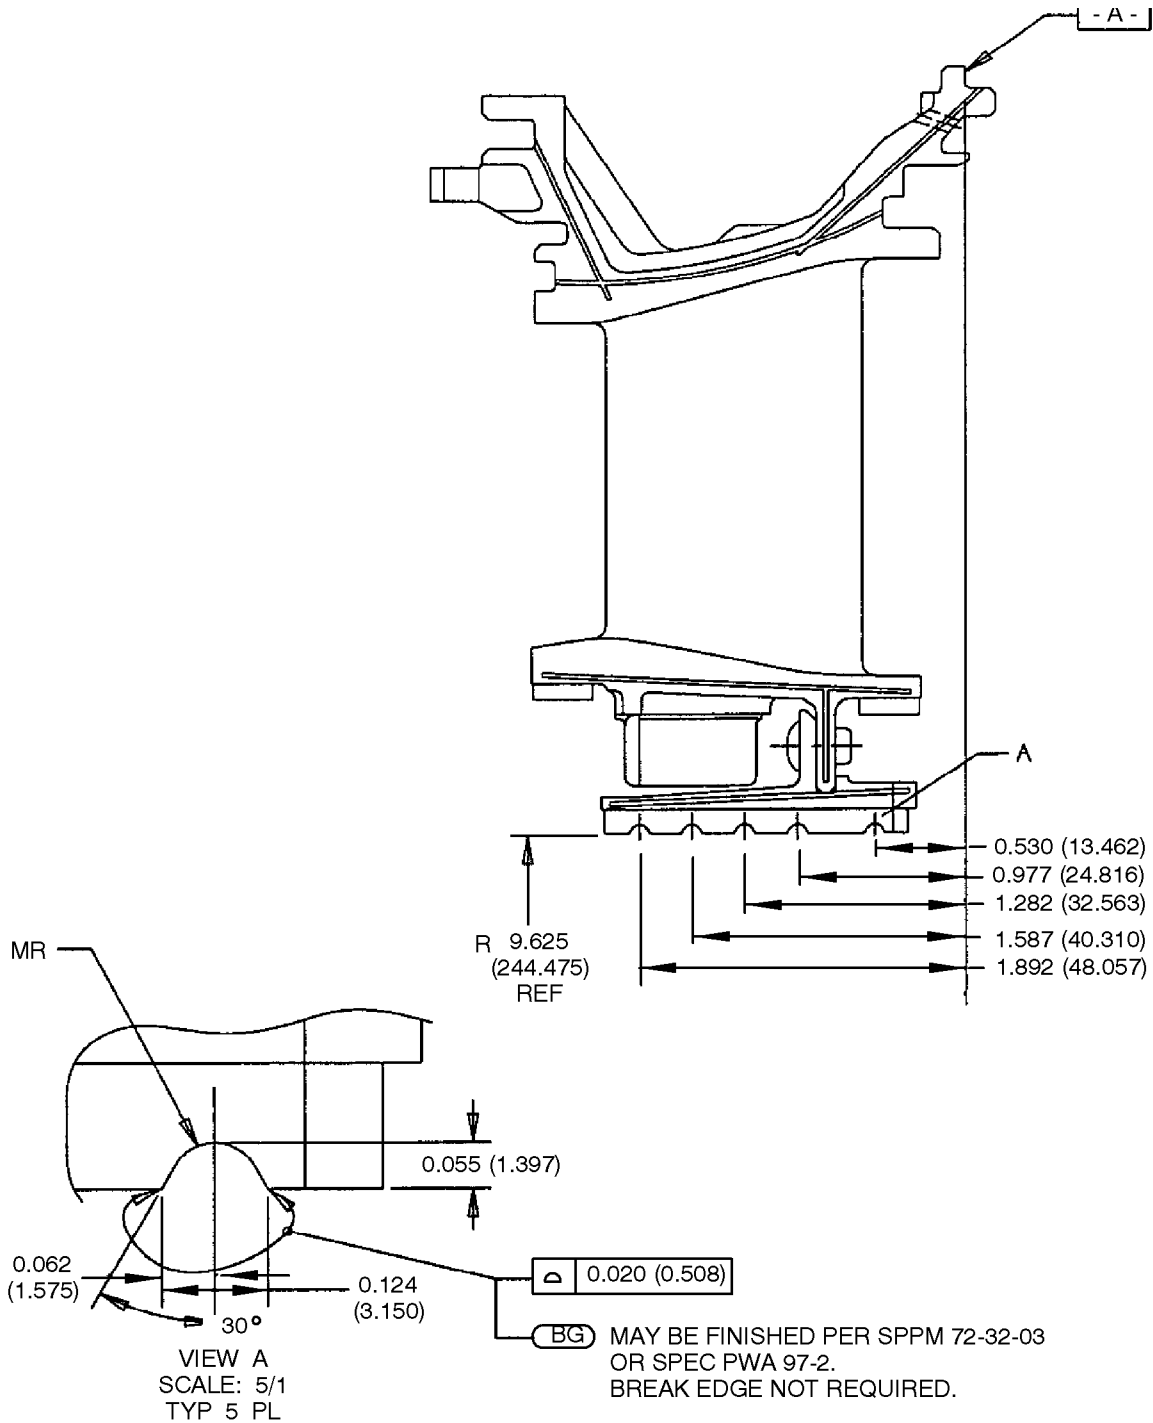
2ND STAGE HPT VANE REOPERATION
FIGURE 1 (SHEET 3 of 3)

SURFACE TEXTURE PER SPEC IAE 70-35-09 OR PWA 388. UOS ALL SURFACES 125/
UOS BREAK EDGES 0.030 (0.762) MAXIMUM.

(i) When using Seal PN 2A1106-01 machine per Figure 1 Sheet 3
