V2500 A1/A5/D5 SERIES PROPULSION SYSTEM SERVICE BULLETIN

V2500-ENG-72-0491
Transmittal - Page 1 of 3

NON - MODIFICATION SERVICE BULLETIN - BORESCOPE INSPECTION OF HIGH PRESSURE TURBINE
(HPT) STAGE 2 AIR SEAL

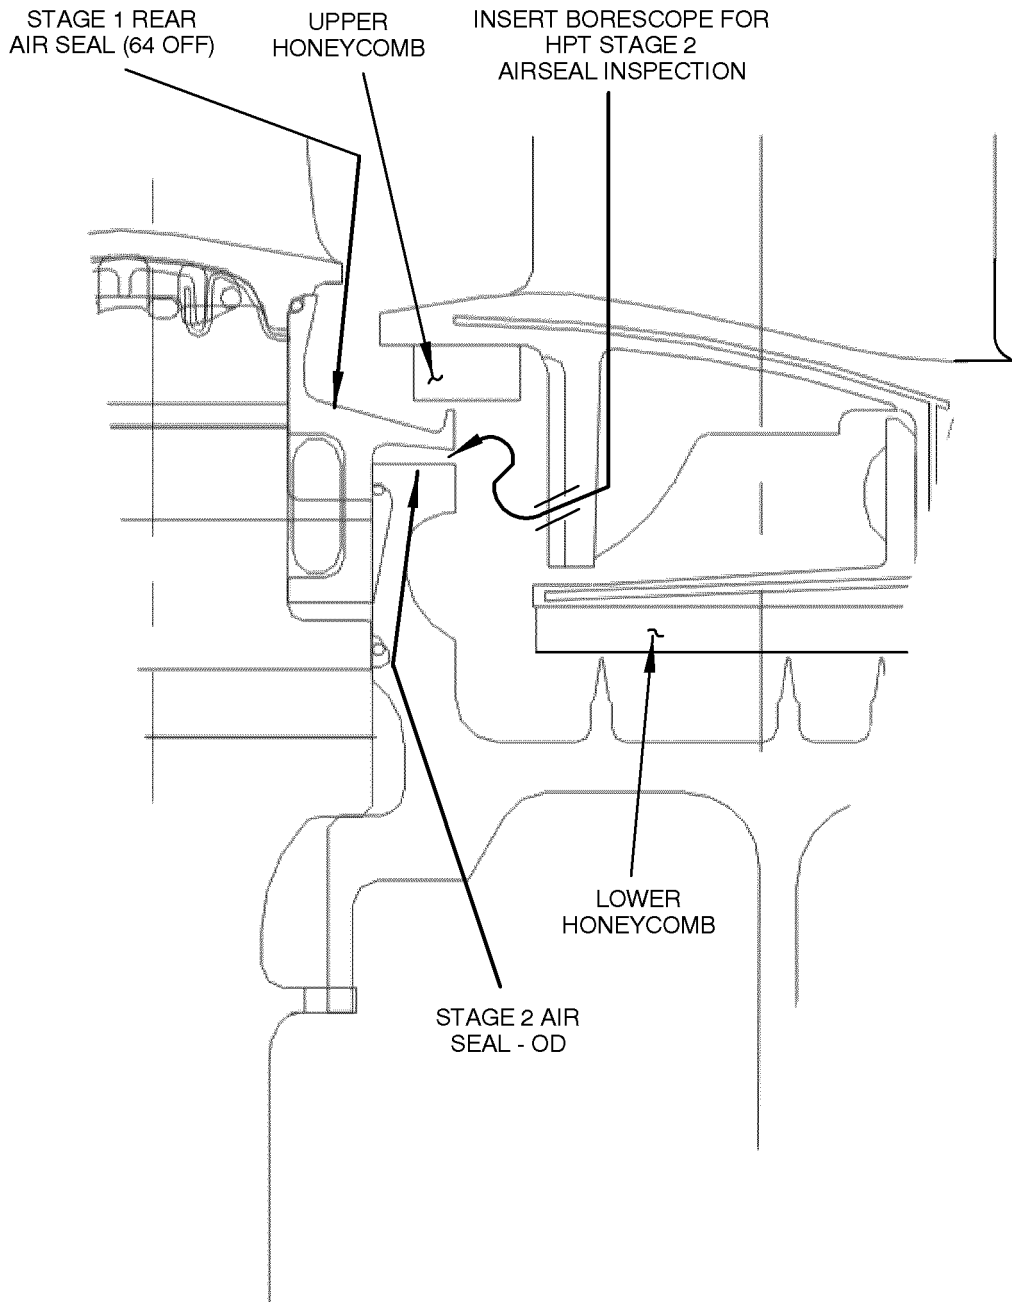
HIGH PRESSURE TURBINE STAGE 2 SEAL INSPECTION AREA
Figure 1

(1) **Problem:** There have been occurrences of cracks in the High Pressure Turbine (HPT) stage 2 Airseal (ATA 72-45-00 01-080). When a crack develops in the HPT stage 2 air seal front fillet radius, an increasing trend in N2 vibration occurs and the front OD of the seal contacts with the HPT air seal (PN 2A0045 /ATA 72-45-15 01-020). The crack can propagate and result in a fracture of a piece of the HPT stage 2 air seal, which could result in significant damage to the HPT and LPT.

(3) **Objective:** This document provides a borescope procedure to inspect the OD surface of the HPT stage 2 air seal for contact (an indication that the seal is cracked).

- (viii) Rotate the gearbox slowly. Ensure that the rotor is turning toward the borescope.
- (ix) Inspect the surface of the outer flange outside diameter of the Stage 2 turbine airseal (hammer head) for indications of fretting. Fretting will appear as dark irregular linear patches at various places along this surface.
- (x) Inspect HPT Stage 2 Airseal the described in Figure 1. Turn 360 degree. No fretting is permitted. Fretting would have an appearance of chafing or wear marks on the surface.
