V2500-D5 SERIES PROPULSION SYSTEM SERVICE BULLETIN

This document transmits Revision 2 to Service Bulletin EV2500-72-0493 and Revision 2 to the Supplement

V2500-ENG-72-0493

ENGINE - NUMBER 4 COMPARTMENT SCAVENGE ELBOW REDESIGN - MOD 72-0493**1. Planning Information****A. Effectivity**

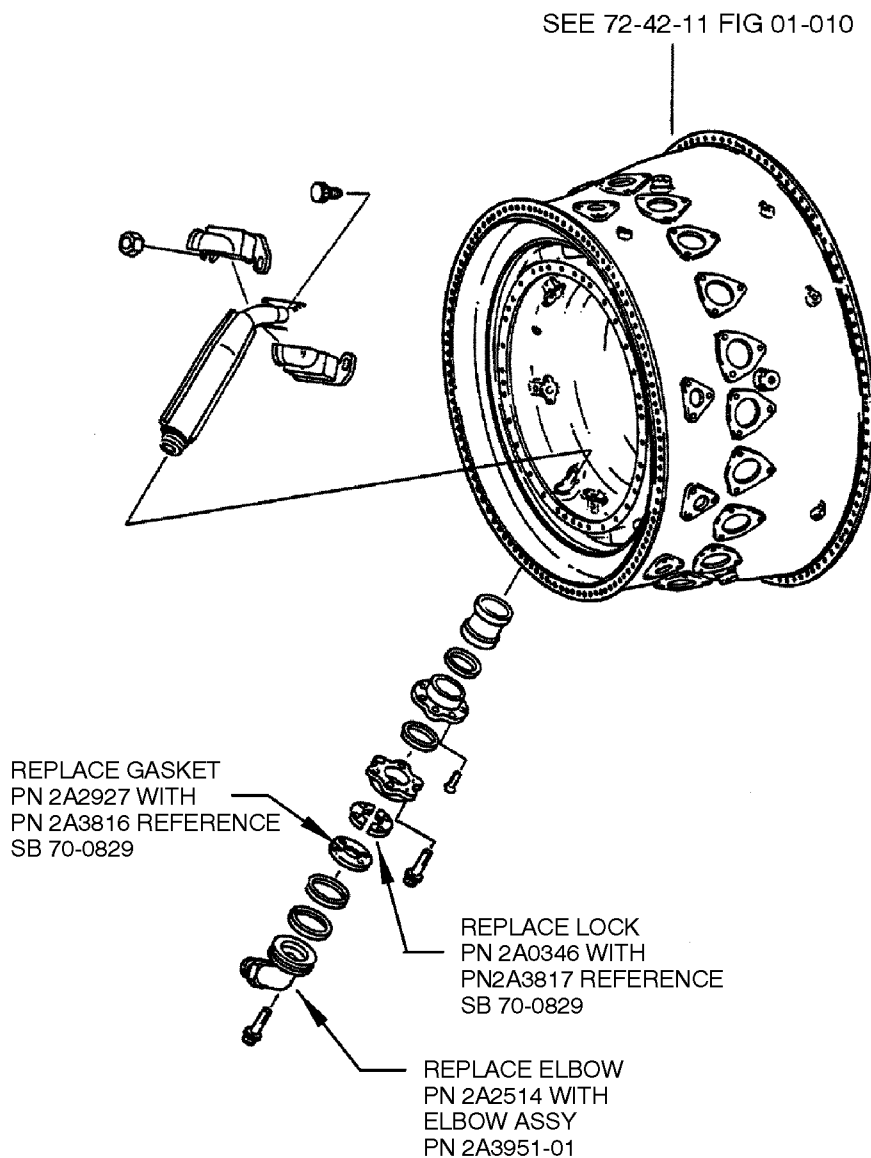
LOCATION OF ELBOW GASKET AND LOCK
Figure 1

Engines have been found with the No. 4 Scavenge Elbow Gasket mis-assembled. This can impact the scavenge capacity of the No. 4 Bearing Compartment and could lead to No. 4 Oil Loss and High Pressure Turbine (HPT) thermal distress. As a part of the V2500-A1/V2500-A5 oil in the HPT corrective action, an alignment pin was added to the external scavenge elbow to prevent gasket mis-assembly.

- (1) Replace the Elbow PN 2A2514, with a new Elbow Assy PN 2A3951-01 Containing Pin PN MS9390-280. Refer to engine manual Task 72-42-00-430-001 Subtask 72-42-00-430-067. See Figure 1.
- (2) Recording Instructions
 - (a) A record of accomplishment is required.
