V2500-A5 SERIES PROPULSION SYSTEM NON-MODIFICATION SERVICE BULLETIN

V2500-ENG-72-0495

NON – MODIFICATION – ENGINE – GEARBOX – SCAVENGE OIL FILTER HOUSING ASSEMBLY –
THERMOCOUPLE THREAD INSPECTION/REWORK

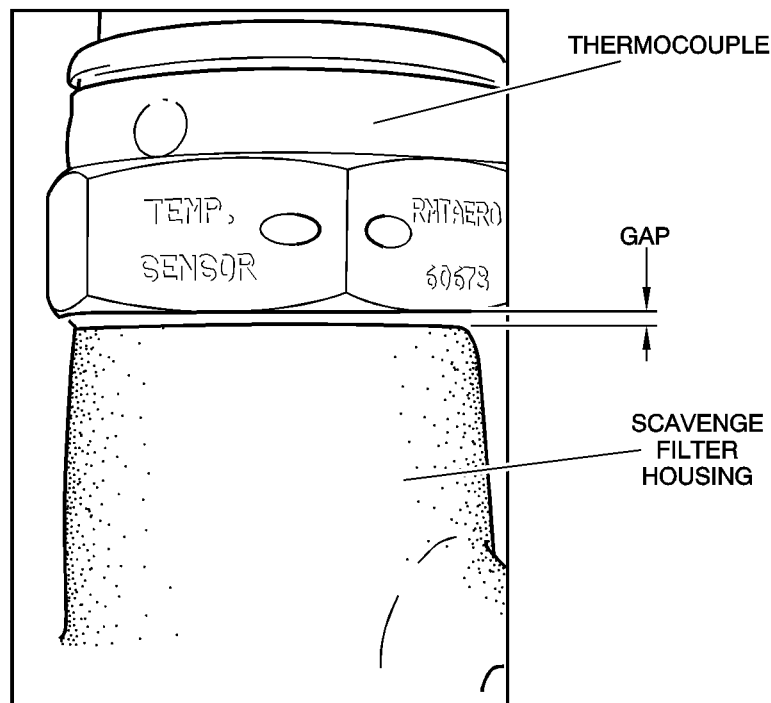
FIG. 1

It has been found that the internal thread for the scavenge oil thermocouple on the oil scavenge filter housing has been tapped too shallow. On some of the affected engines this may result in an o-ring (Ref. EIPC 79-32-16 Fig 01 Item 020) not being compressed enough to provide a fully effective seal, giving slight oil leakage.

- (1) Visually inspect the oil temperature thermocouple / filter housing interface and check for any gap between the two faces using feeler gauges. If the gap is greater than 0,030 inch (0,762 mm) then proceed with rework instructions of part 3.B. If the gap is less than or equal to 0,030 inch (0,762 mm) no rework is needed. Refer to Fig.1.

LOCATION OF THE GAP BETWEEN THE OIL SCAVENGE FILTER HOUSING AND THE SCAVENGE OIL THERMOCOUPLE

- (3) Rework the internal screw thread on the oil scavenge filter housing for the oil scavenge thermocouple. The thread is 0.6250-18UNJF-3B and should have minimum axial length of 0,61 inch (15,5 mm). Carefully engage the screw tap in the thread and slowly turn the tap clockwise for 11 turns. Turn the screw tap counterclockwise to extract it. Be careful to avoid debris entering the oil scavenge filter housing.
