DATE: Feb. 17/10

V2500-A5/D5 SERIES PROPULSION SYSTEM NON-MODIFICATION SERVICE BULLETIN

V2500-ENG-72-0496

NON-MODIFICATION SERVICE BULLETIN – ENGINE – HP COMPRESSOR, STAGE 3 ROTOR – REPEAT INSPECTION OF CLAPPERS

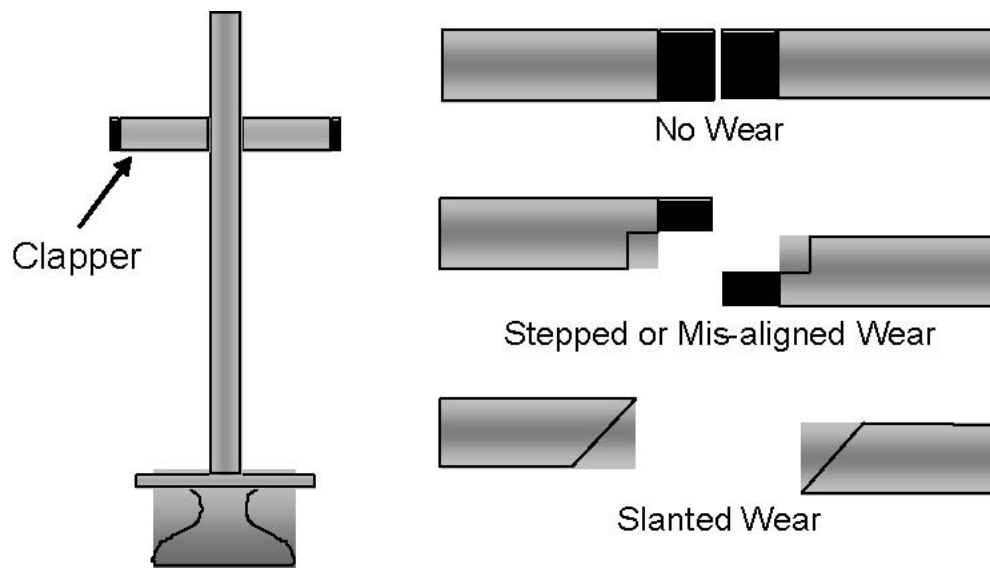
Figure 1: Axial View of Clapper Showing Types of Wear

- (3) **Vertical Wear** – wear/erosion of the mating clapper faces usually due to loss of hard-face coating on one or both faces. The clapper faces are not slanted. Refer to figure 1.

- (4) **Slanted Wear** – wear between the clapper faces which is at an angle (usually 45 degrees). This type of wear shows a condition for the clappers to slide on top/under each other and become shingled. Refer to figure 1.

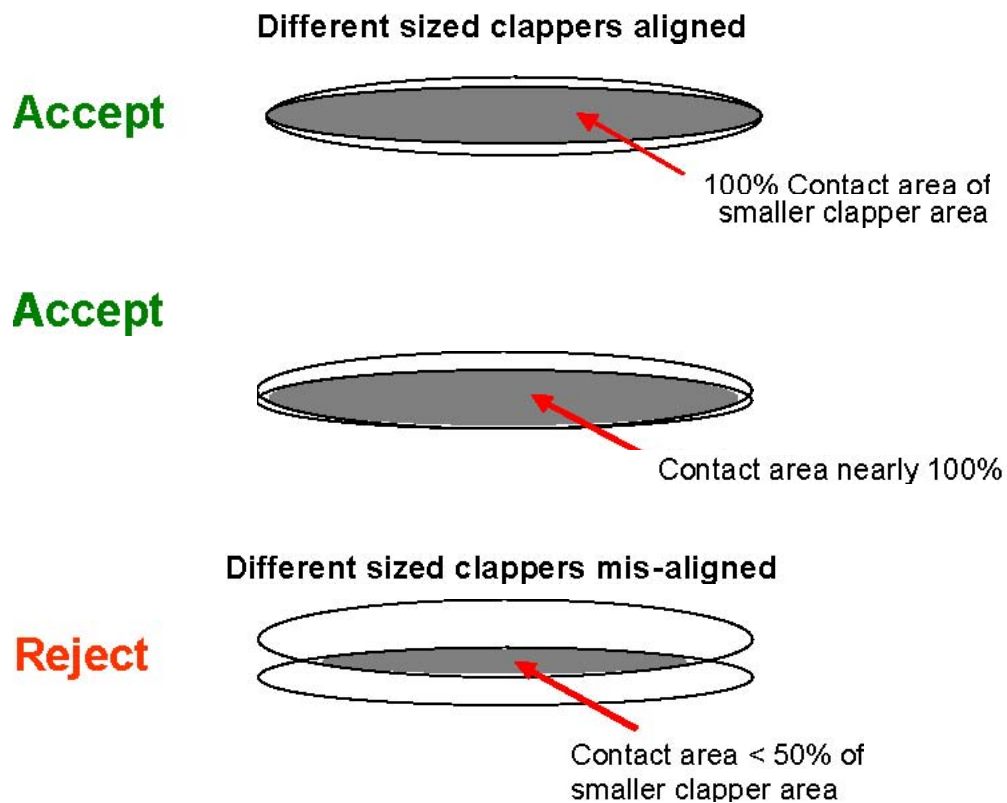
Figure 2: Clapper alignment Criteria

- (1) **Radial Alignment** – how completely the faces of the two contacting clappers are covering each other. This is given as a percentage with 100% alignment meaning they are completely aligned. Refer to figure 2.

(a) **Aligned** – clappers which are at least 50% aligned of the contact surface.

(b) **Mis-aligned** – clappers less than 50% aligned of the contact surface.

NOTE: There are differences in the clapper face areas between blade vendors. As a result, the clapper face of one blade may 'go across' the face of the mating blade on both the top and bottom. If this occurs, use the smaller of the two faces for determining the percentage of alignment.

NOTE: 50% alignment usually is related to 0.040 in. (1 mm) of exposed clapper face in the radial direction.

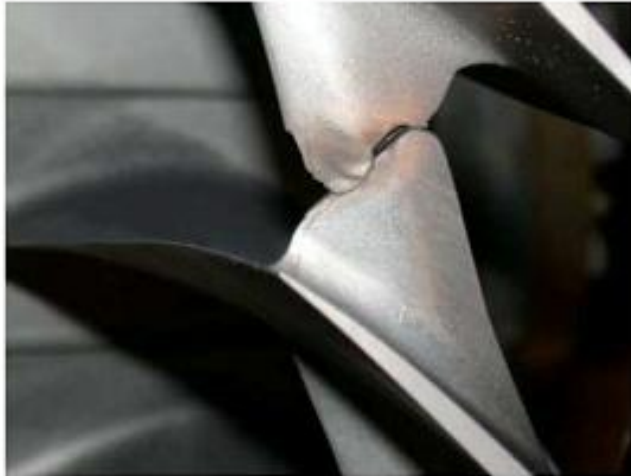
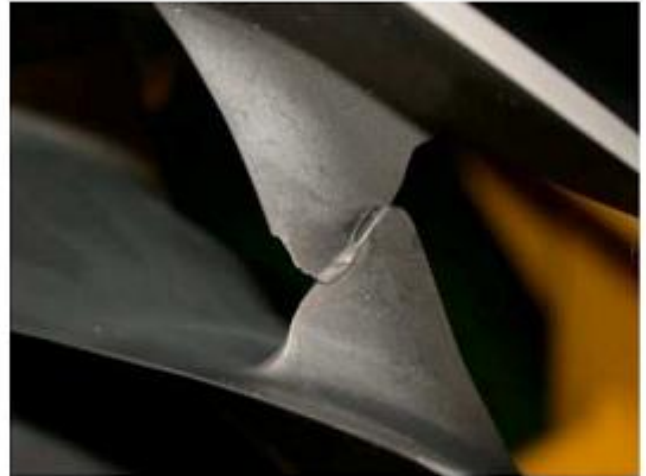
Aligned Severe Irregular Wear – Reject within 10 cycles

Cracking and Material Missing – Reject Immediately

Severe Irregular Wear Material Missing and Cracking

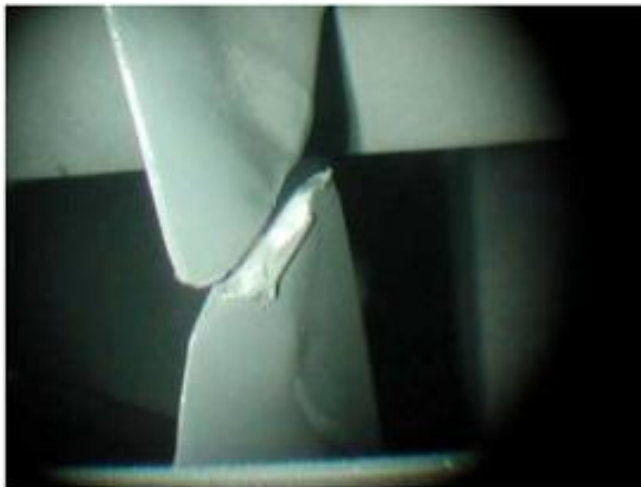
Material Peeling that indicates clapper override (horizontal surface) or uniform peeling along the full width of the clapper contact face – Reject within 10 cycles

Material Peeling

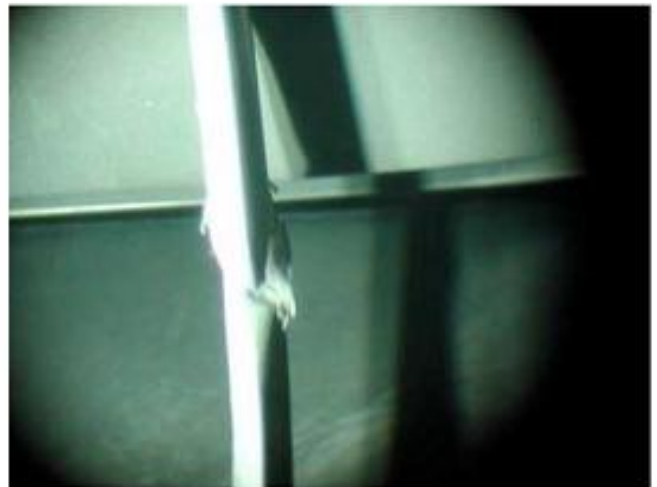
Material Peeling

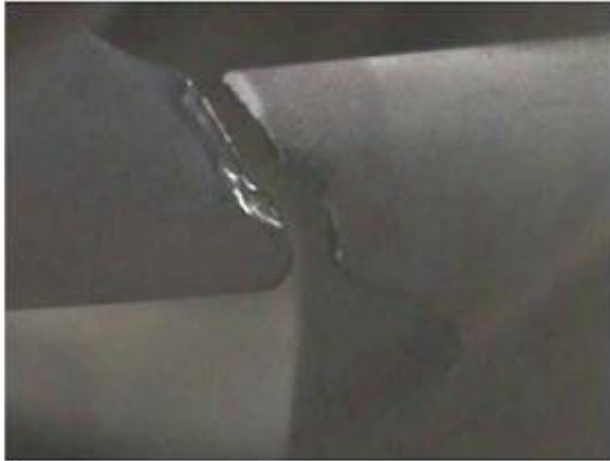
Mis-Aligned Stepped Wear

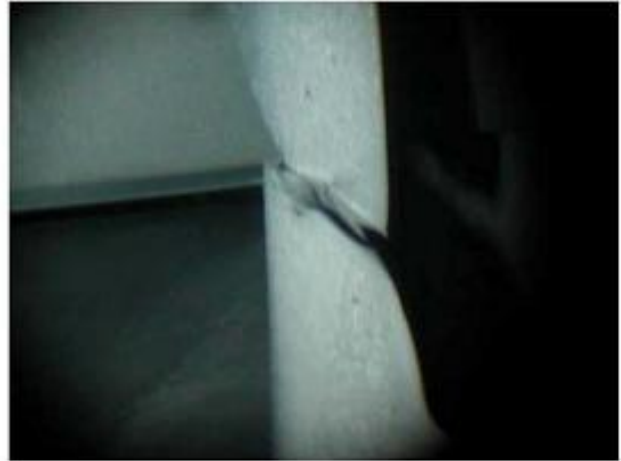
Irregular Wear Leading to
Slanted Wear

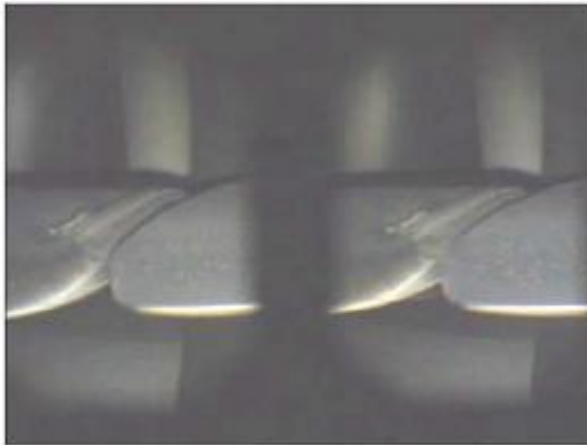
Slanted Wear with Evidence of
Material Peeling that indicates
Clapper Override

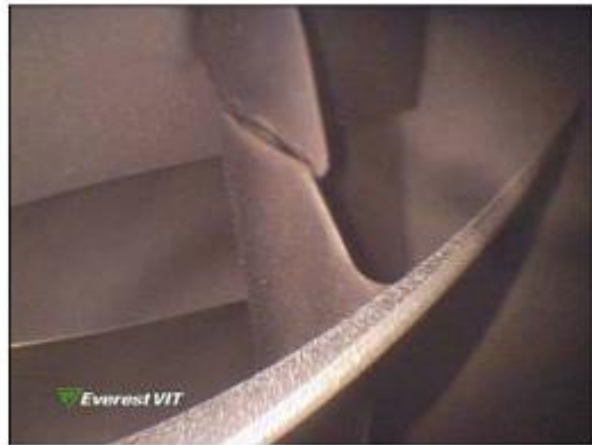
Has the appearance of Slanted Wear:
Review from other angles

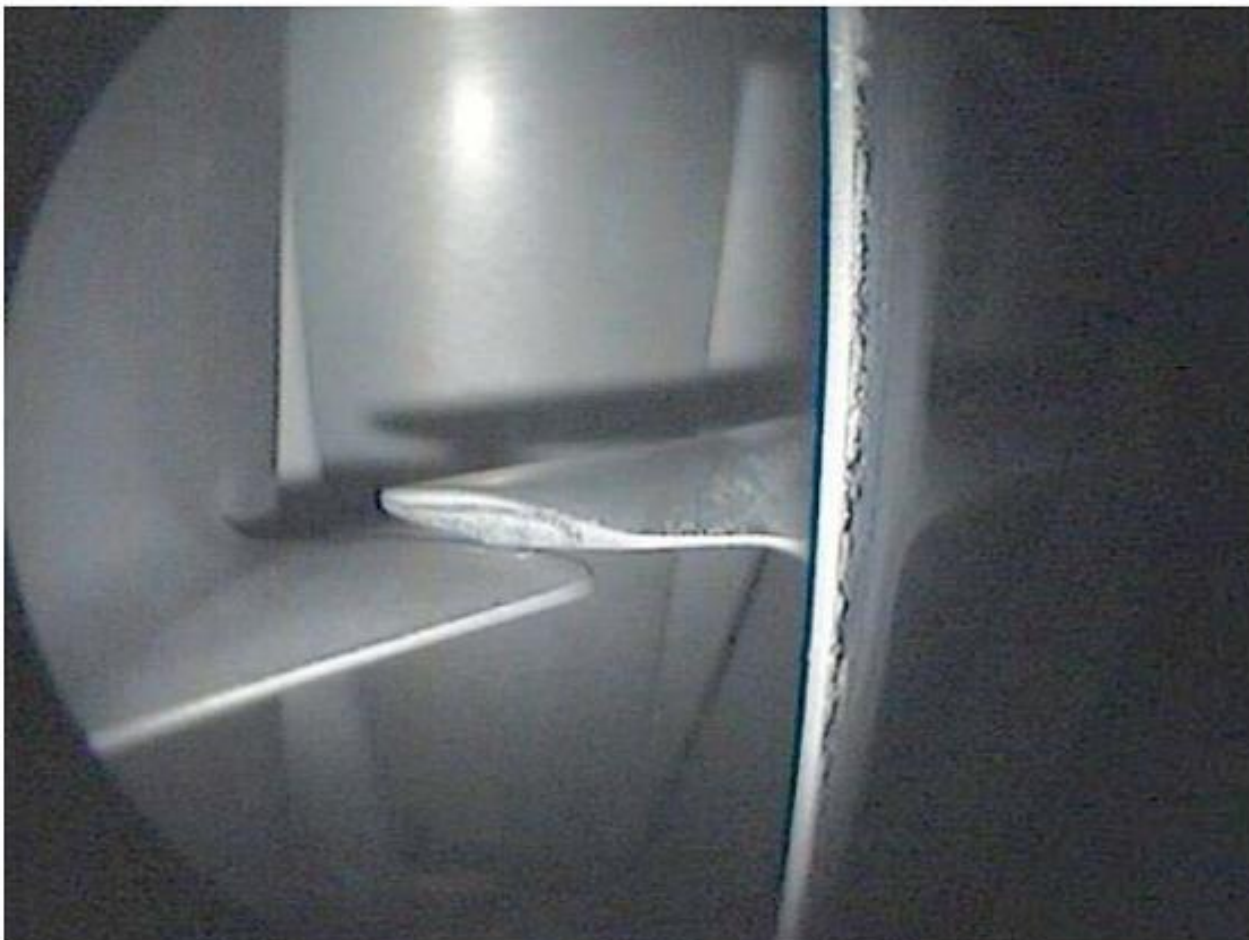
Clapper Shingling – Reject Immediately

Shingled

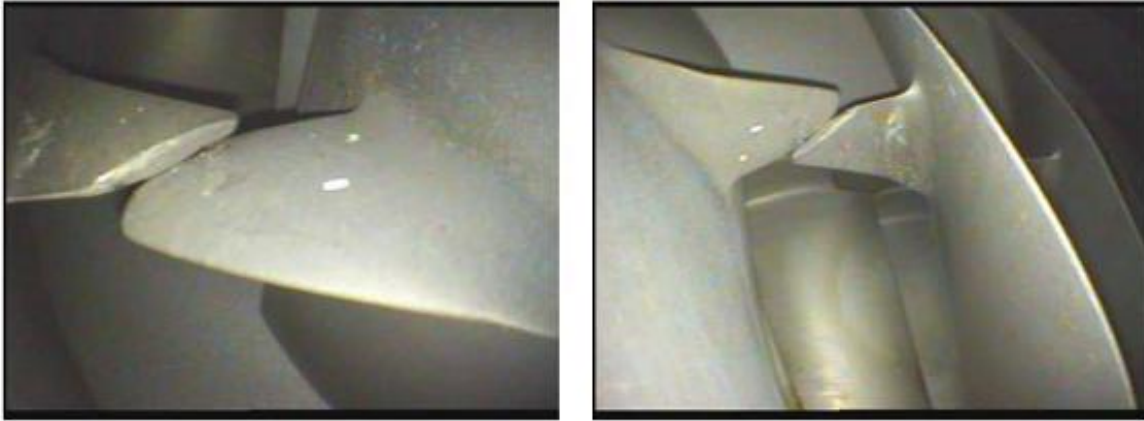
Shingled as a Result of Bird Strike

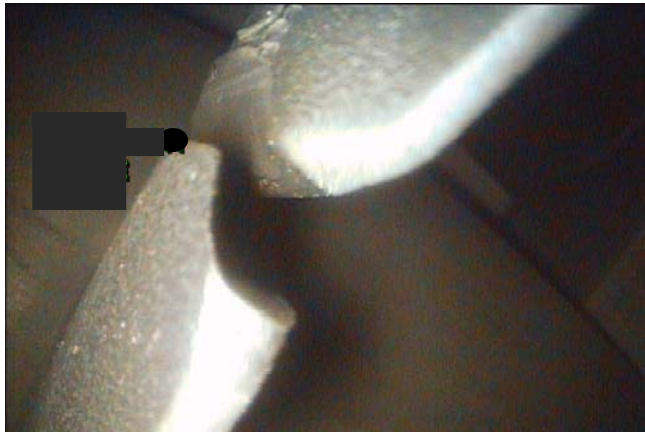
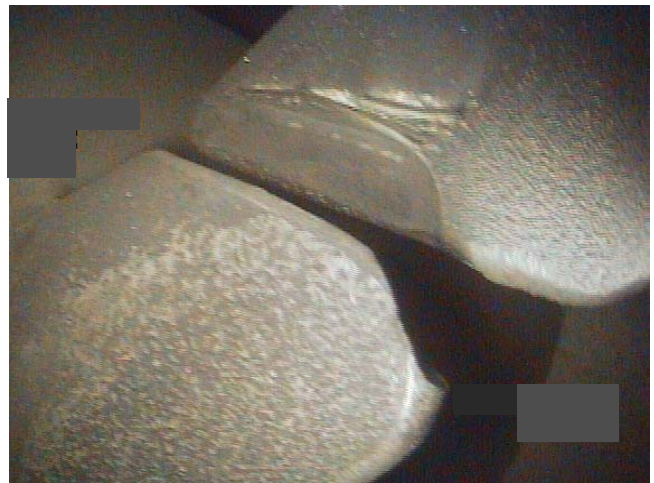
**Peeling Material along large section of clapper horizontal surface –
evidence of clapper override**

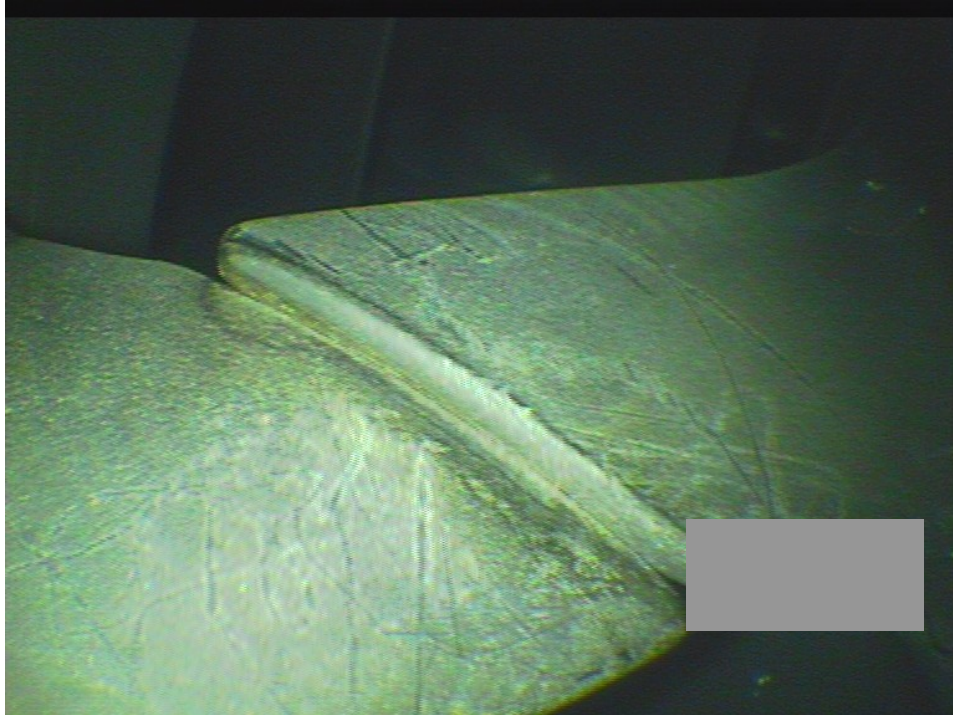
Mis-Aligned > 50% – Reject Immediately

Mis-Aligned > 50%

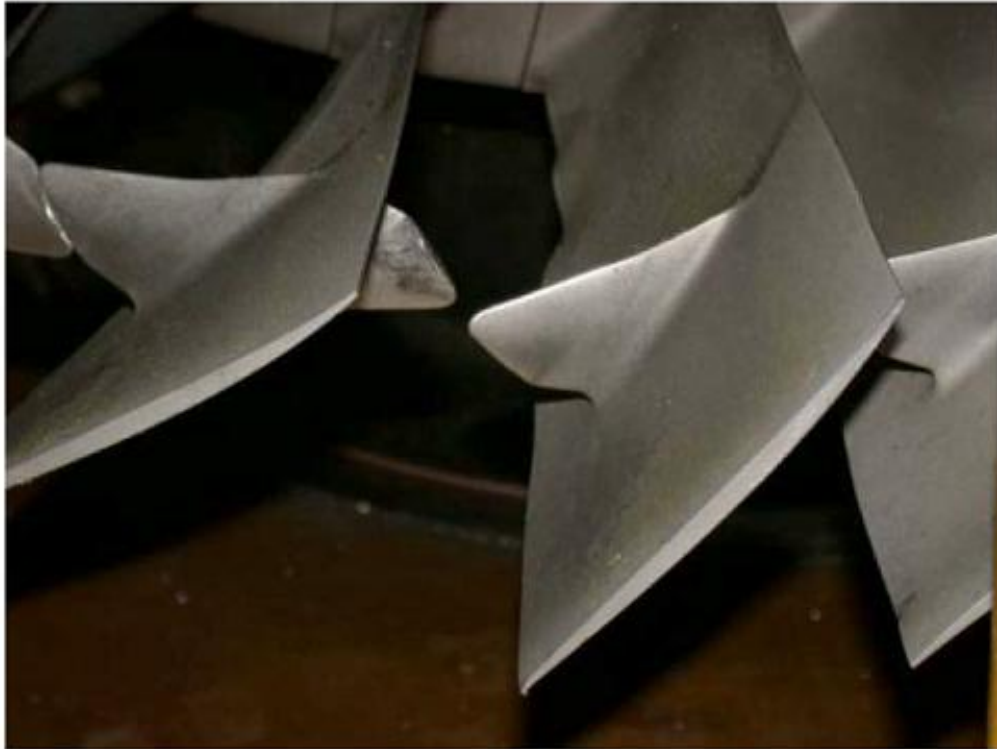
Bent or Totally Mis-Aligned Clappers – Reject Immediately

Clappers Totally Mis-Aligned and Blade Bent
Result of Bird Strike

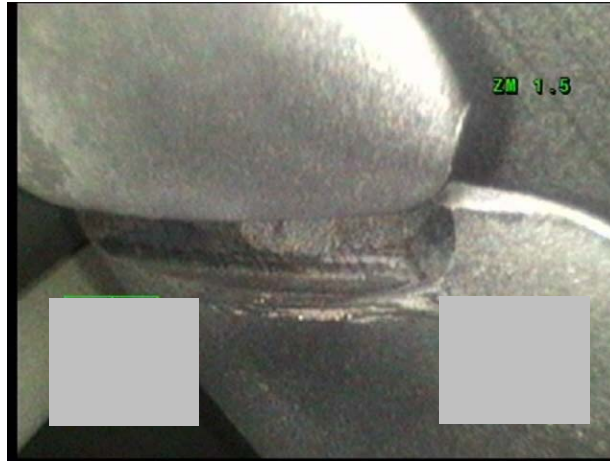
Severe Stepped Wear – Reject within 10 cycles

Aligned with severe stepped wear

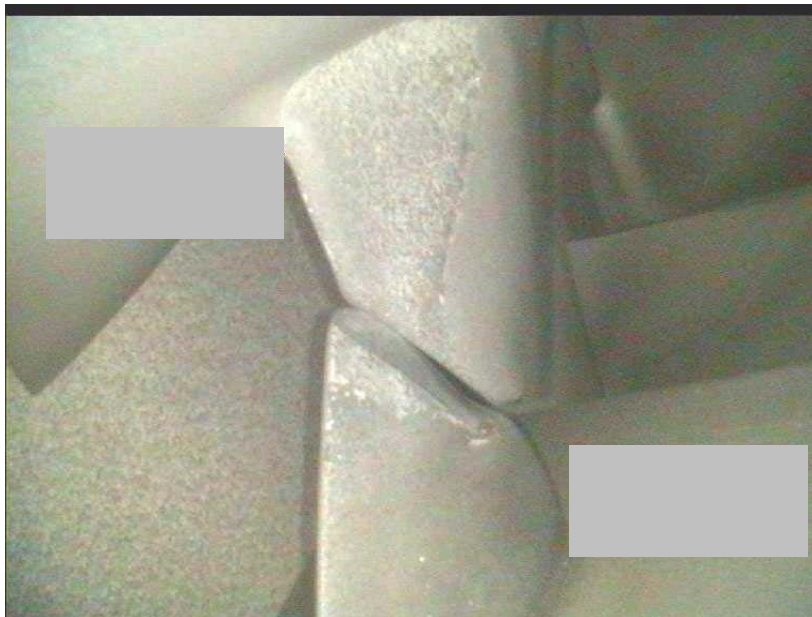
Slanted Wear – Reject within 10 cycles

Slanted wear

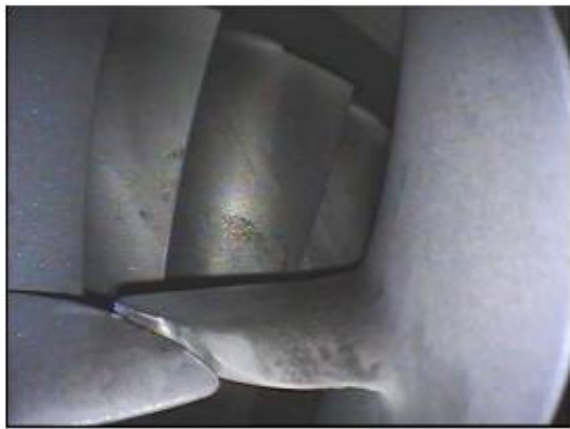
Irregular

Note: Once R3 blade clapper wear has been classified as AMBER, the Engine MUST be removed within 500 cycles.

ACCEPT, RE-INSPECT WITHIN 100 CYCLES

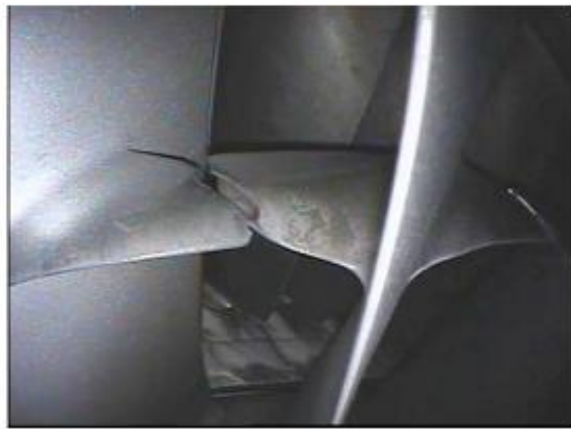
Irregular

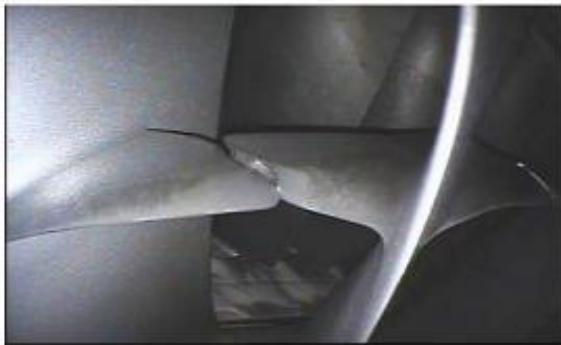
Irregular

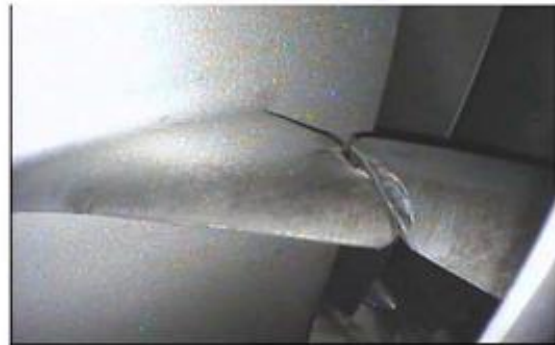
Irregular and stepped

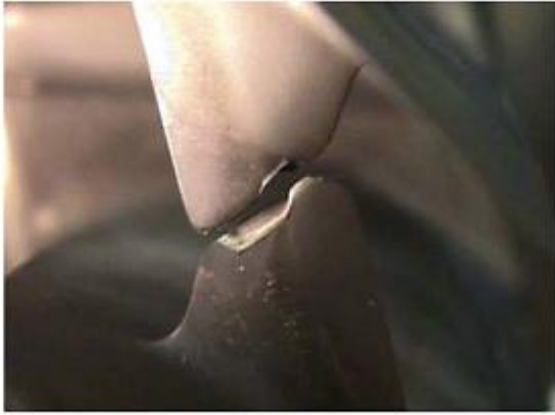
Irregular and Stepped

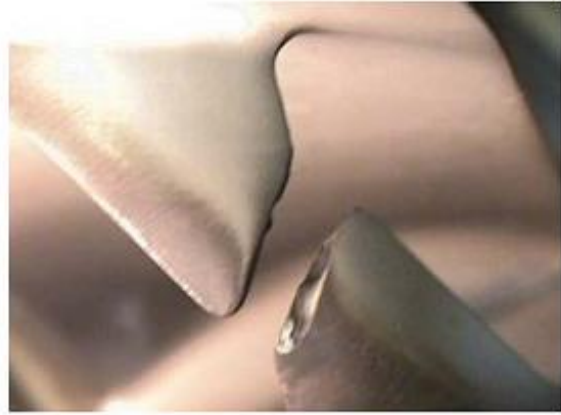
Irregular Hollowing

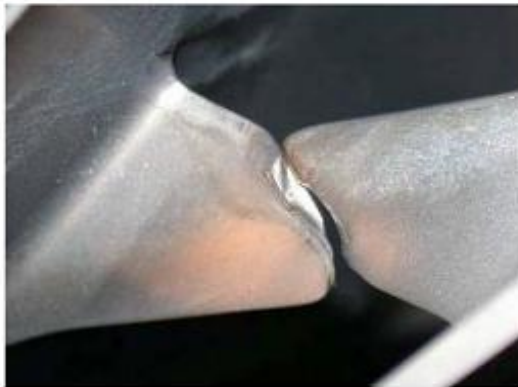
Irregular and Stepped

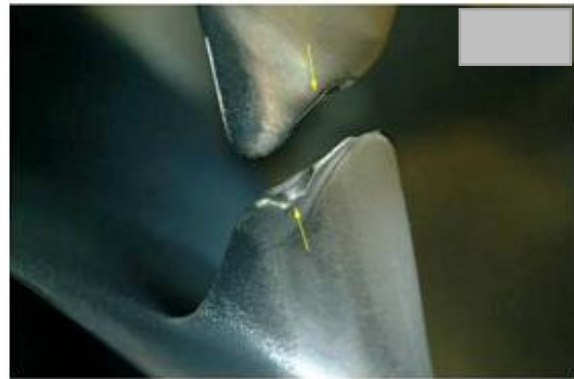
Irregular and Stepped

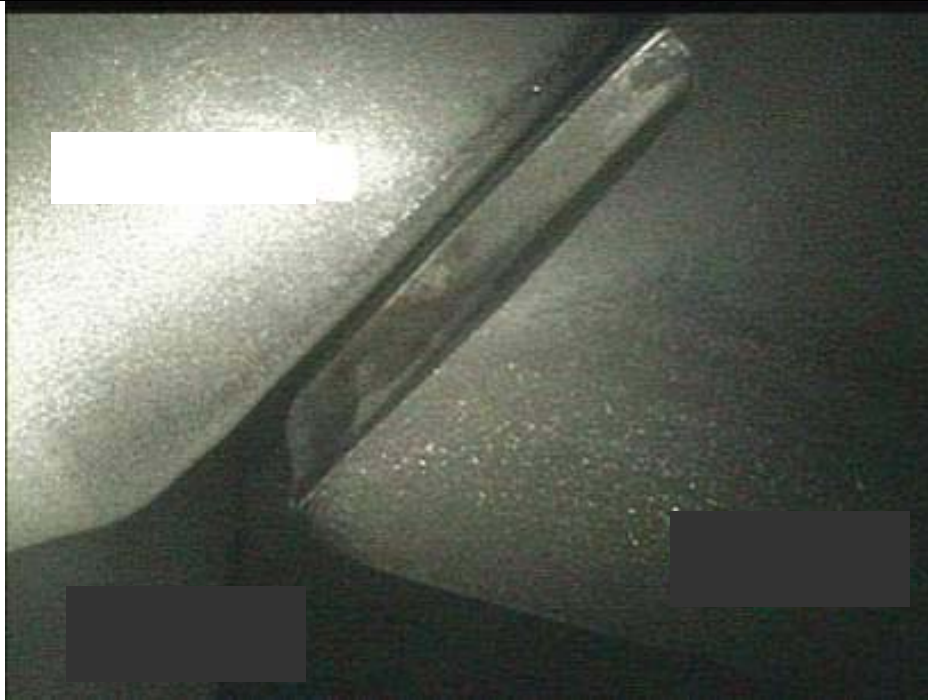
Aligned Stepped Wear

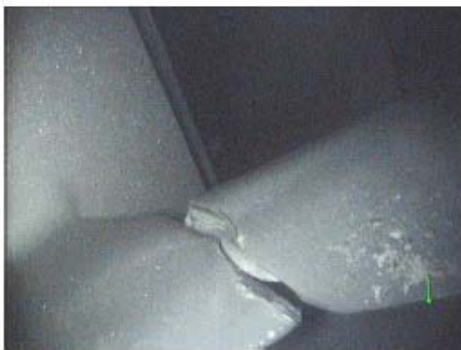
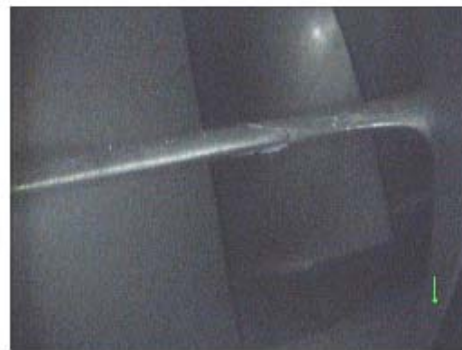
Advanced Aligned Irregular Wear to same pair of blades

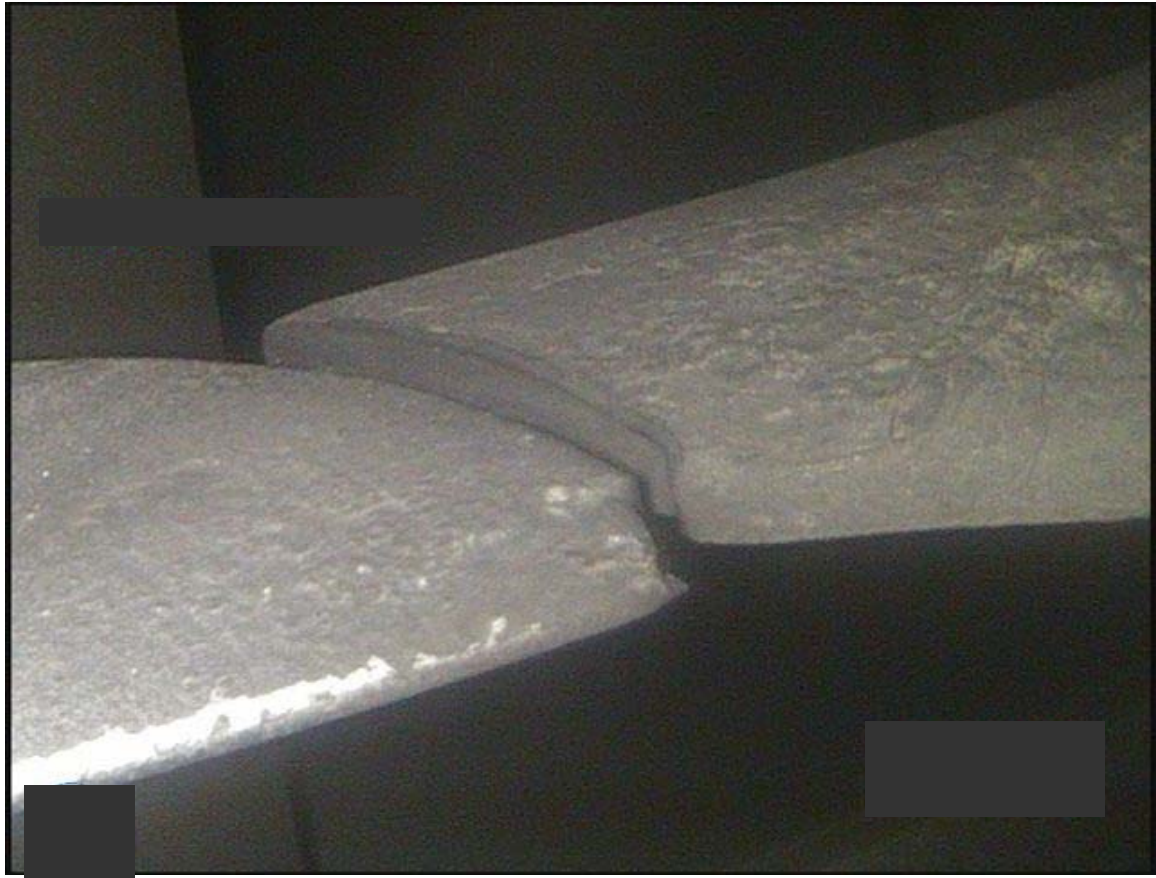
Advanced Aligned Vertical Wear

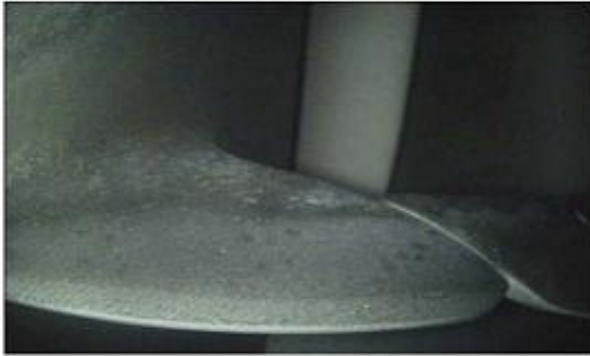
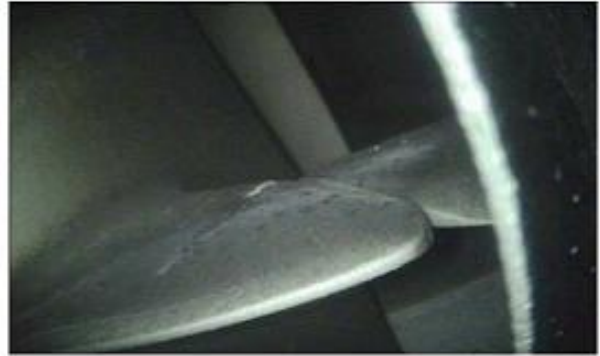
CLAPPERS WITH GOOD ALIGNMENT NO OBVIOUS WEAR

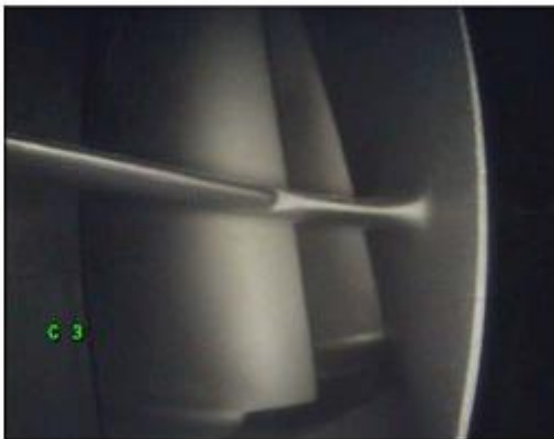
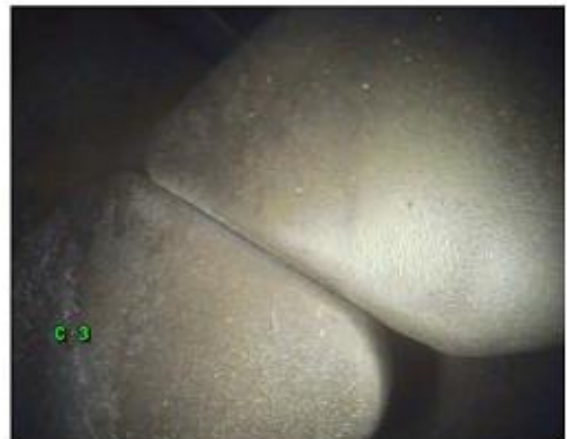
CLAPPERS WITH GOOD ALIGNMENT NO OBVIOUS WEAR

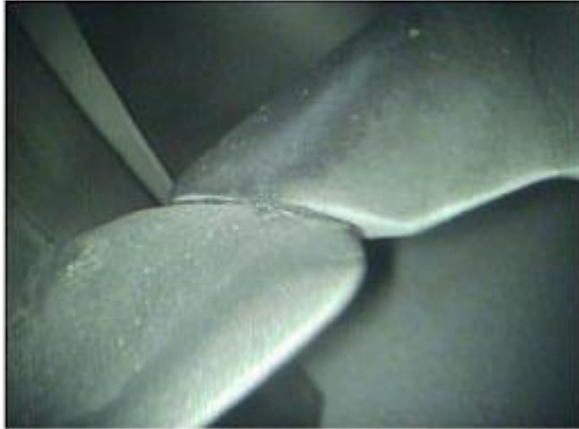
COULD BE HIDING
SOME WEAR REVIEW

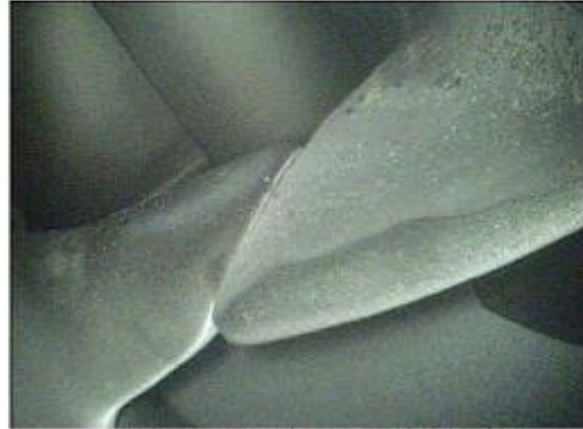
GOOD ALIGNMENT NO
OBVIOUS WEAR

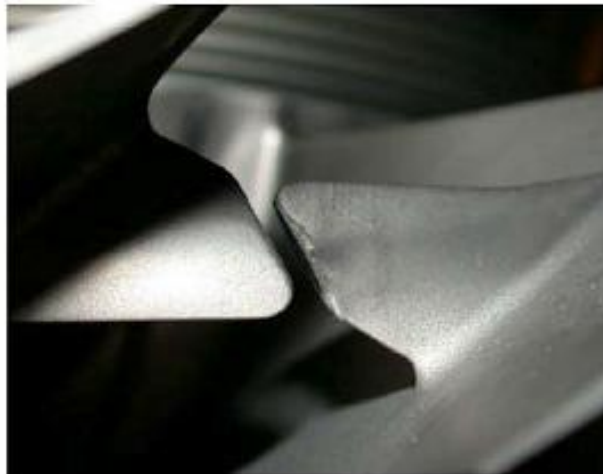
Normal

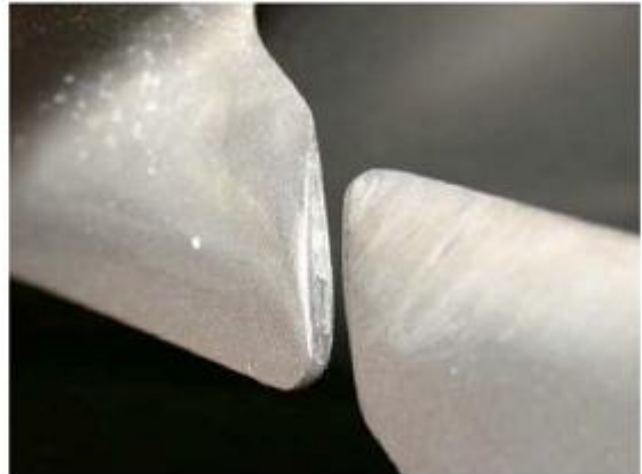
Normal

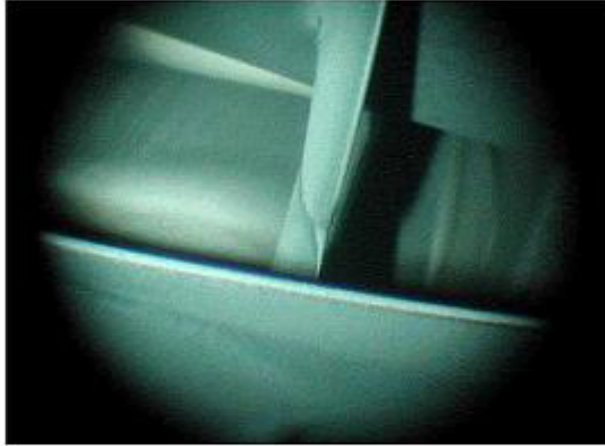
Aligned

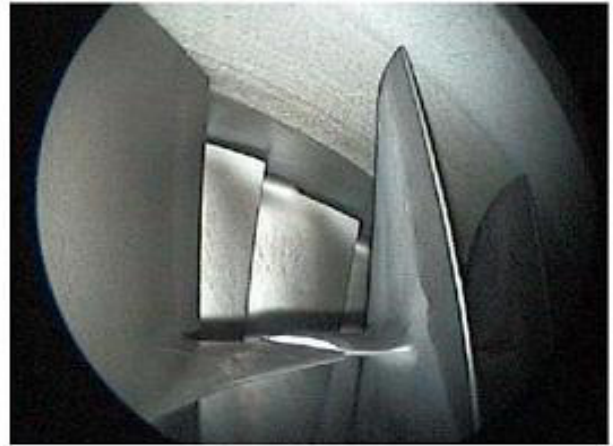
Greater than 50% Aligned

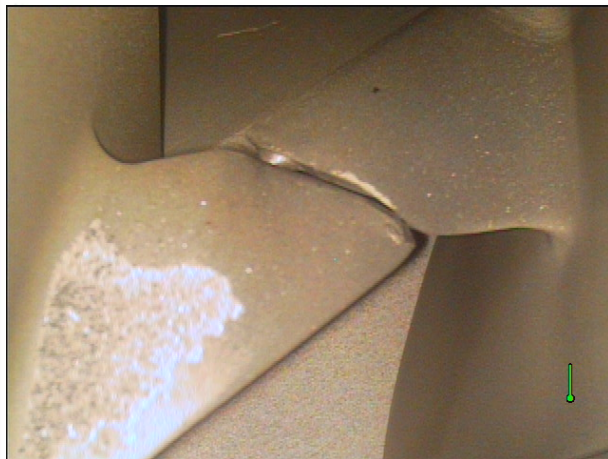
Aligned Irregular Wear

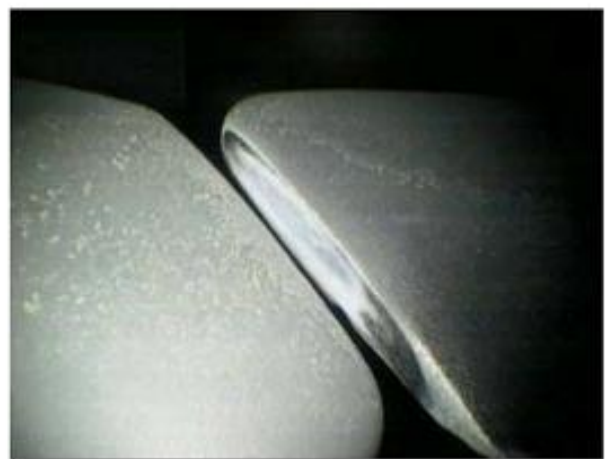
Aligned Hollowing of Face

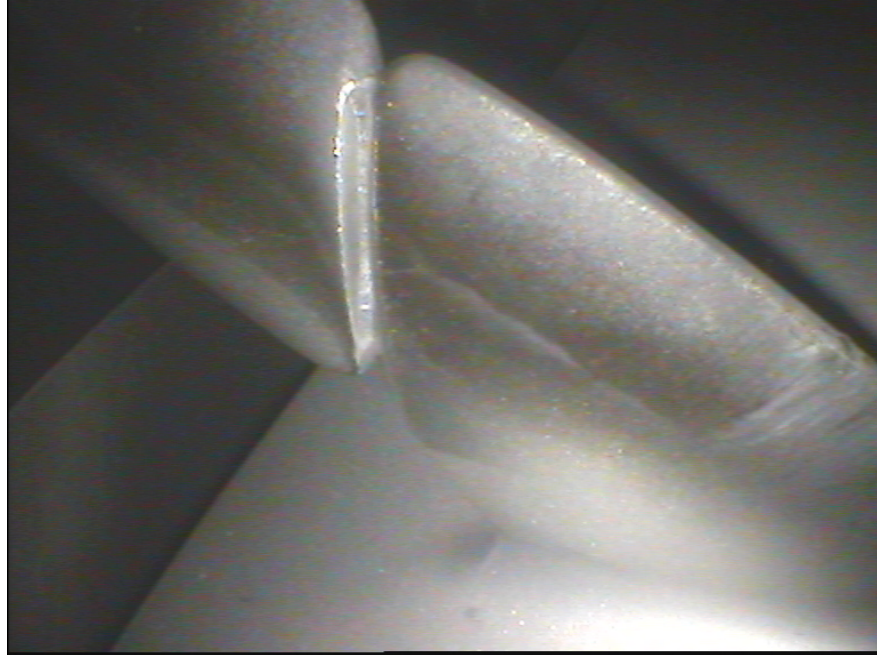
Aligned Stepped Wear

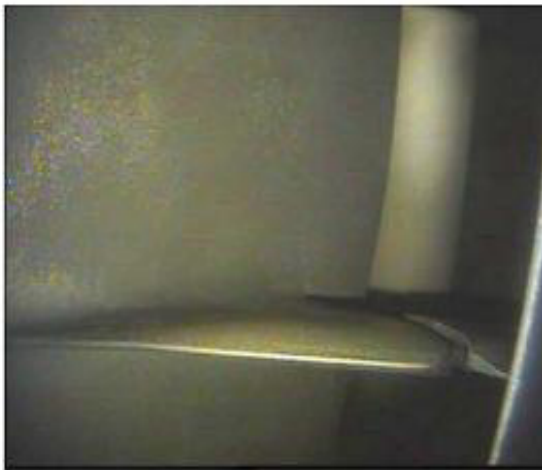
Aligned Vertical wear
