V2500-A1/A5/D5 SERIES PROPULSION SYSTEMS SERVICE BULLETIN

This document transmits Revision 1 to Service Bulletin EV2500-72-0497 and Revision 1 to the Supplement

V2500-ENG-72-0497

ENGINE – REDESIGNED NUMBER 4 BEARING COMPARTMENT OIL NOZZLE BOLT RETENTION

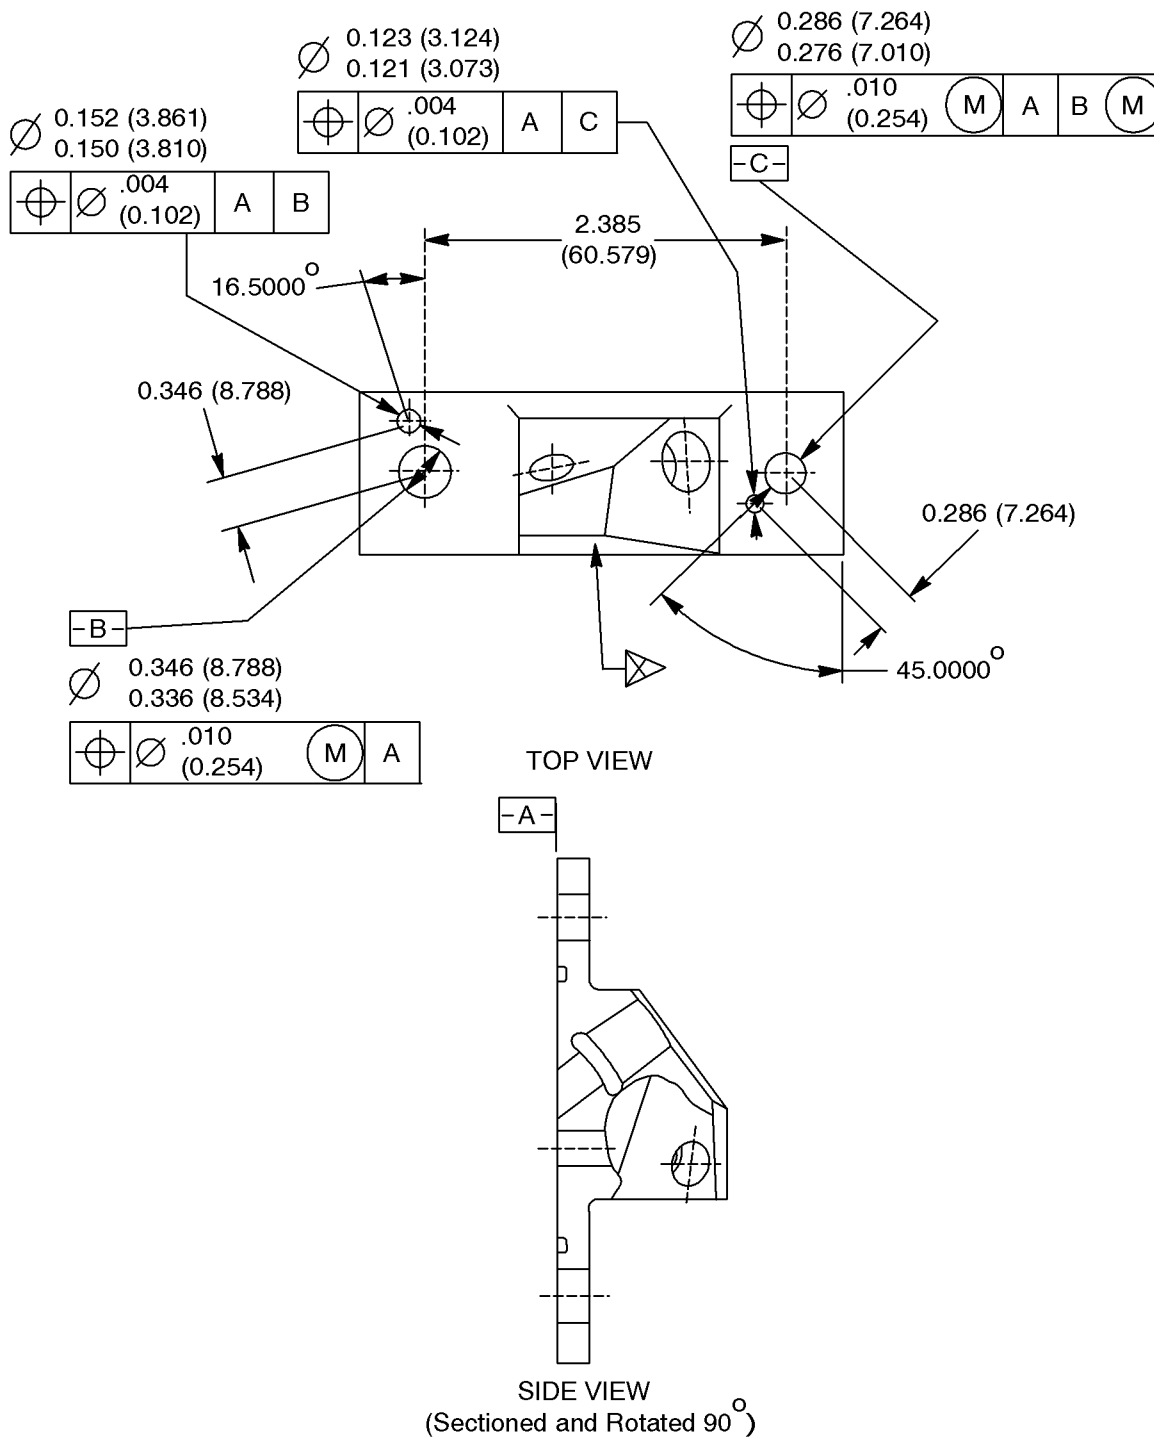
NUMBER 4 BEARING NOZZLE ASSEMBLY
Figure 1

(1) Problem: A Liberated Number 4 Bearing Compartment Oil Nozzle Bolt has been reported on five first-run engines in revenue service. The liberated bolt could cause damage to other bearing compartment components, which could result in oil loss and High Pressure Turbine (HPT) thermal distress.

- (c) Cover oil inlet hole to prevent chips from entering the orifices and drill locking tab locating holes thru as specified in Figure 1.
 - (d) Break edges .003 - 0.015 (0.08 - 0.38 mm) .

MARK IDENT PER V2500 SPPM TASK 70-09-00-400-501, SUBTASK 70-09-00-400-001 IN AREA ADJACENT TO EXISTING MARKING
