V2500 D5 SERIES PROPULSION SYSTEM NON-MODIFICATION SERVICE BULLETIN

This document transmits Revision 2 to Service Bulletin EV2500-72-0499

V2500-ENG-72-0499

ENGINE – HP COMPRESSOR – BORESCOPE INSPECTION OF STAGES 6 TO 8 ROTOR BLADES AND
STAGES 6 TO 7 STATOR VANES – NON-MODIFICATION SERVICE BULLETIN

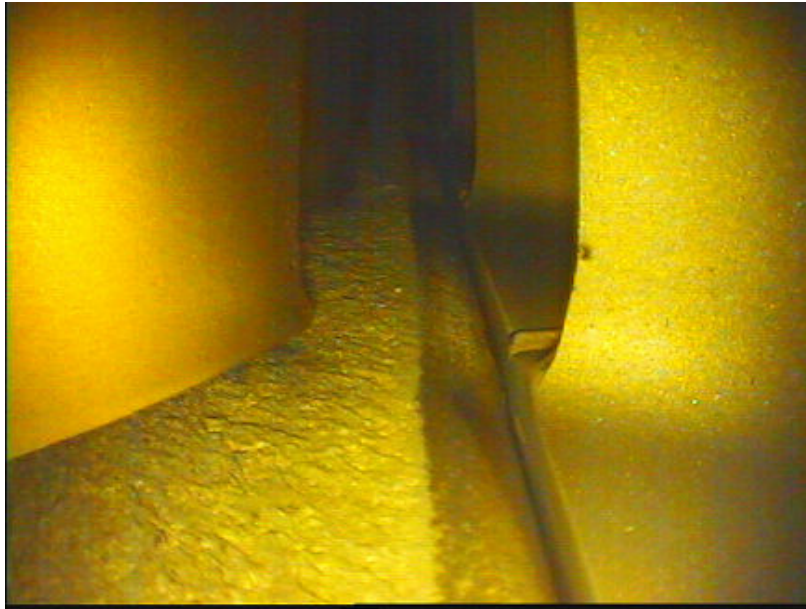
R HPC stage 6 stator vane with nick at the T/E, dimension of the nick
R 0.014 in. (0,36 mm), no material removal allowed
R Figure 6

- R (a) Nicks, tears or dents on individual airfoils (Refer to Figure 6)

R	A	Not more than 0.016 in. (0,4 mm) in radial or axial dimension and not in the area of T/E material loss	Repeat borescope inspection within 500 cycles.
R	B	More than A, but not more than 0.024 in. (0,6 mm) in radial or axial dimension and not in the area of T/E material loss	Repeat borescope inspection within 250 cycles.
R	C	More than B but not more than 0.036 in. (0,92 mm) in radial or axial dimension and not in the area of T/E material loss	Repeat borescope inspection within 125 cycles.
R	D	More than C, but not more than 0.039 in. (1 mm) in radial or axial dimension	Reject within 10 cycles.
R	E	More than D	Reject.

R (a) Nicks, tears or dents on individual airfoils (Refer to Figure 6)

R	A	Not more than 0.016 in. (0,4 mm) in radial or axial dimension and not in the area of T/E material loss	Repeat borescope inspection within 500 cycles.
R	B	More than A, but not more than 0.022 in. (0,55 mm) in radial or axial dimension and not in the area of T/E material loss	Repeat borescope inspection within 250 cycles.
R	C	More than B but not more than 0.028 in. (0,7 mm) in. radial or axial dimension and not in the area of T/E material loss	Repeat borescope inspection within 125 cycles.
R	D	More than C, but not more than 0.039 in. (1 mm) in radial or axial dimension	Reject within 10 cycles.
R	E	More than D	Reject.

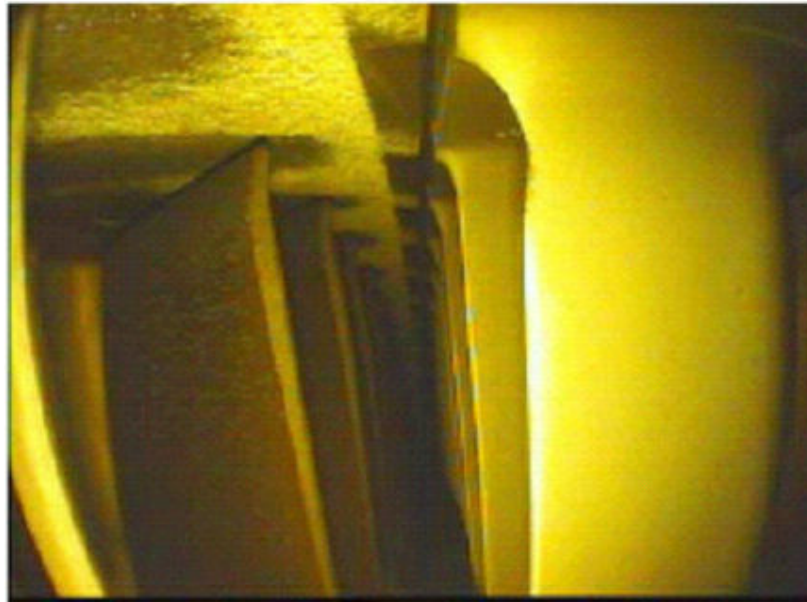
R HPC stage 6 stator vane; smooth loss of material without a jagged T/E
R Figure 7

(c) Loss of material from trailing edge with or without a jagged trailing edge profile (Refer to Figures 7 and 8)

A	Not more than 0.006 in. (0,15 mm) in axial depth	Repeat borescope inspection within 500 cycles.
B	More than A, but not more than 0.016 in. (0,4 mm) in axial depth	Repeat borescope inspection within 250 cycles.
C	More than B, but not more than 0.035 in. (0,9 mm) in axial depth	Repeat borescope inspection within 125 cycles.
D	More than C, but not more than 0.079 in. (2 mm) in axial depth	Reject the engine within 10 cycles.
E	More than D	Reject.

(c) Loss of material from trailing edge with or without a jagged T/E profile (Refer to Figures 7 and 8)

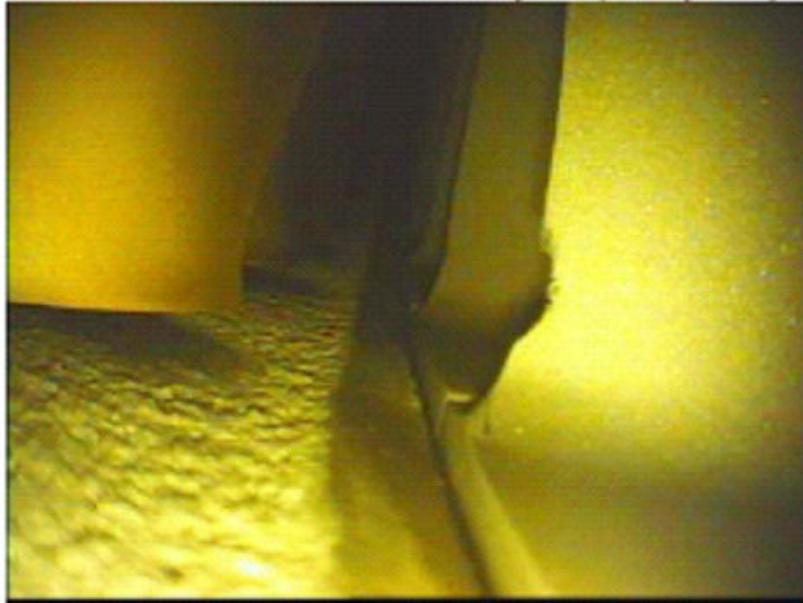
HPC stage 6 stator vane; loss of material with a jagged T/E profile
Figure 8

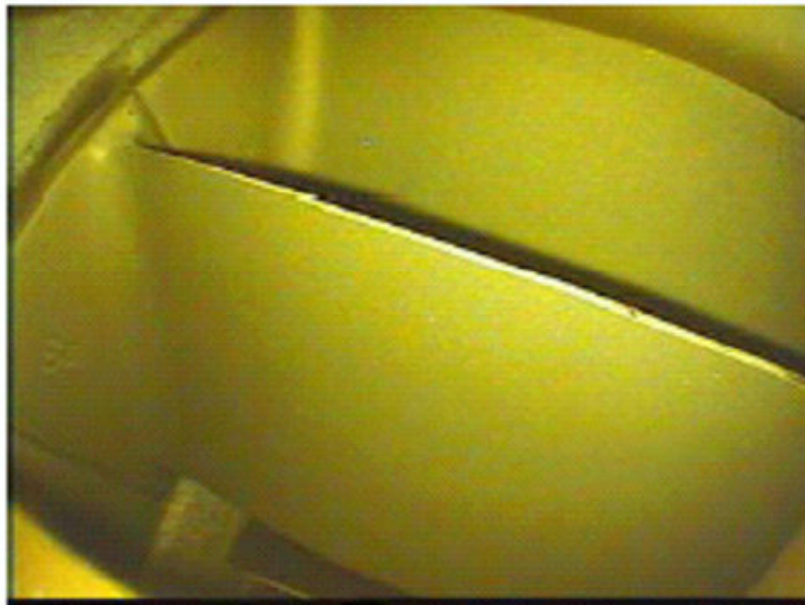
HPC stage 7 stator vane with a thin T/E which remains straight
Figure 9

(d) Sharp, thin trailing edge that remains straight (Refer to Figure 9)

- Repeat borescope inspection within 500 cycles.

– Repeat borescope inspection within 500 cycles.

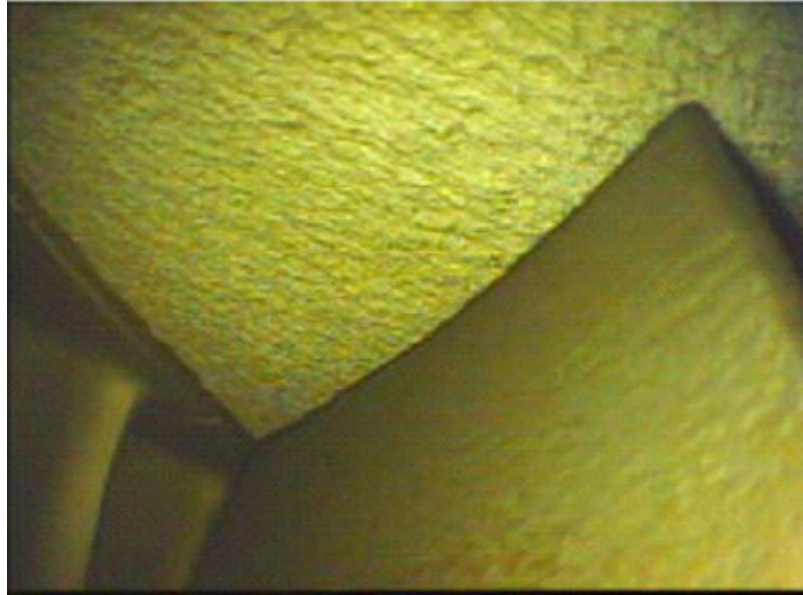
HPC stage 6 rotor blade without blade tip erosion
Figure 10

R (a) Repeat borescope inspection within 500 cycles if the chordal extent of the erosion is less than 25 percent of the remaining chord (Refer to Figures 10 and 11).

(a) Repeat borescope inspection within 500 cycles if the chordal extent of the erosion is less than 25 percent of the remaining chord (Refer to Figures 10 and 11).

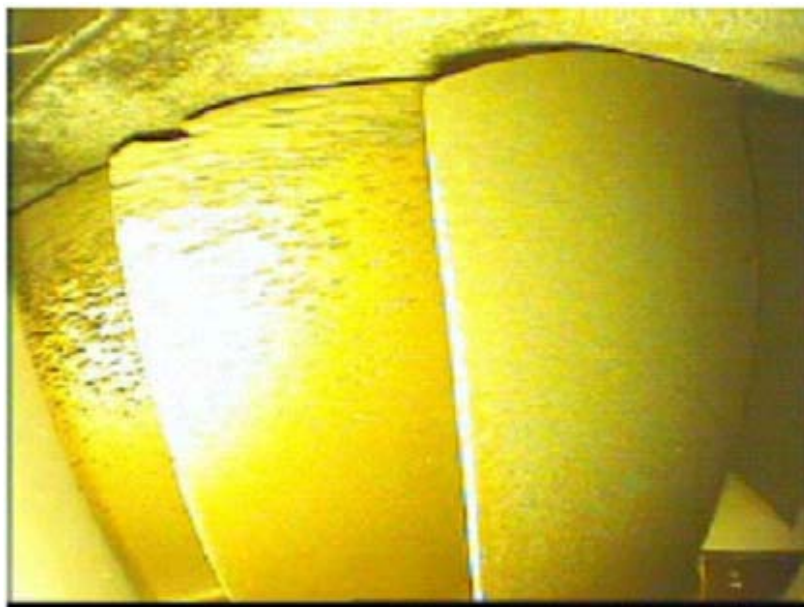
HPC stage 7 rotor blade with tip erosion not more than 25 percent
Figure 11

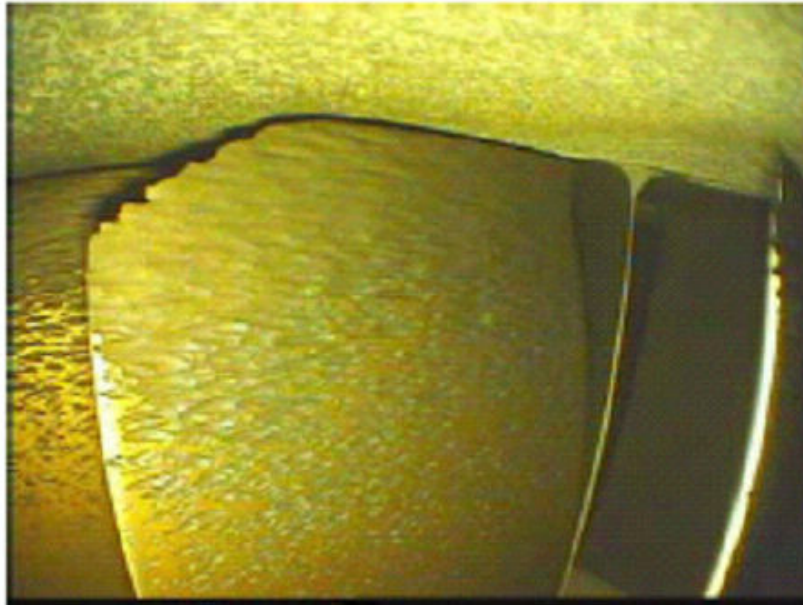
Figure 12

HPC stage 7 rotor blade with blade tip erosion with more than 25 percent
but not more than 50 percent

R (b) Repeat borescope inspection within 125 cycles if the chordal extent of the erosion is greater than 25 percent but less than 50 percent of the remaining chord (Refer to Figure 12).

(b) Repeat borescope inspection within 125 cycles if the chordal extent of the erosion is greater than 25 percent but less than 50 percent of the remaining chord (Refer to Figure 12).
