V2500 A1/A5 SERIES PROPULSION SYSTEM NON-MODIFICATION SERVICE BULLETIN

V2500-ENG-72-0500 Transmittal - Page 1 of 2

# NON-MODIFICATION SERVICE BULLETIN - N2 VIBRATION MONITORING FOR THE HIGH PRESSURE TURBINE (HPT) STAGE 2 AIR SEAL

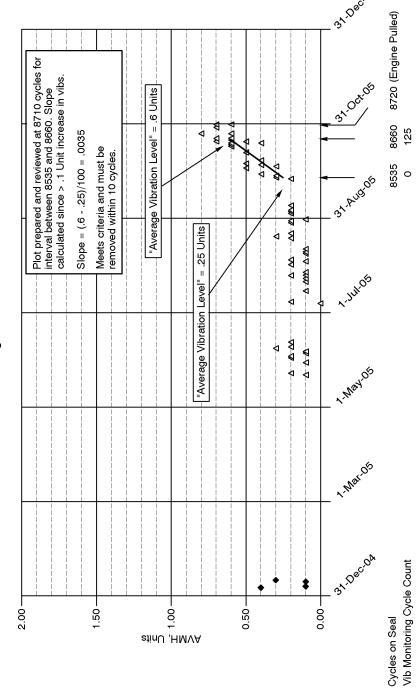
R R N2 Vibration Data Figure 2

(i) The HPT Stage 2 Airseal is suspect of being cracked and the engine needs to be removed within 10 cycles of when the slope was calculated (Figure 2 shows the plot of an engine which needs to be removed within 10 cycles).

N2 Vibration Data Figure 2
