V2500-A1/A5 SERIES PROPULSION SYSTEM SERVICE BULLETIN

This document transmits Revision 2 to Service Bulletin EV2500-72-0503 and Revision 2 to the Supplement

V2500-ENG-72-0503

ENGINE – LP COMPRESSOR – INTRODUCTION OF NEW BRACKET FOR MODIFIED FB FLANGE OF FAN
CASE ASSEMBLY

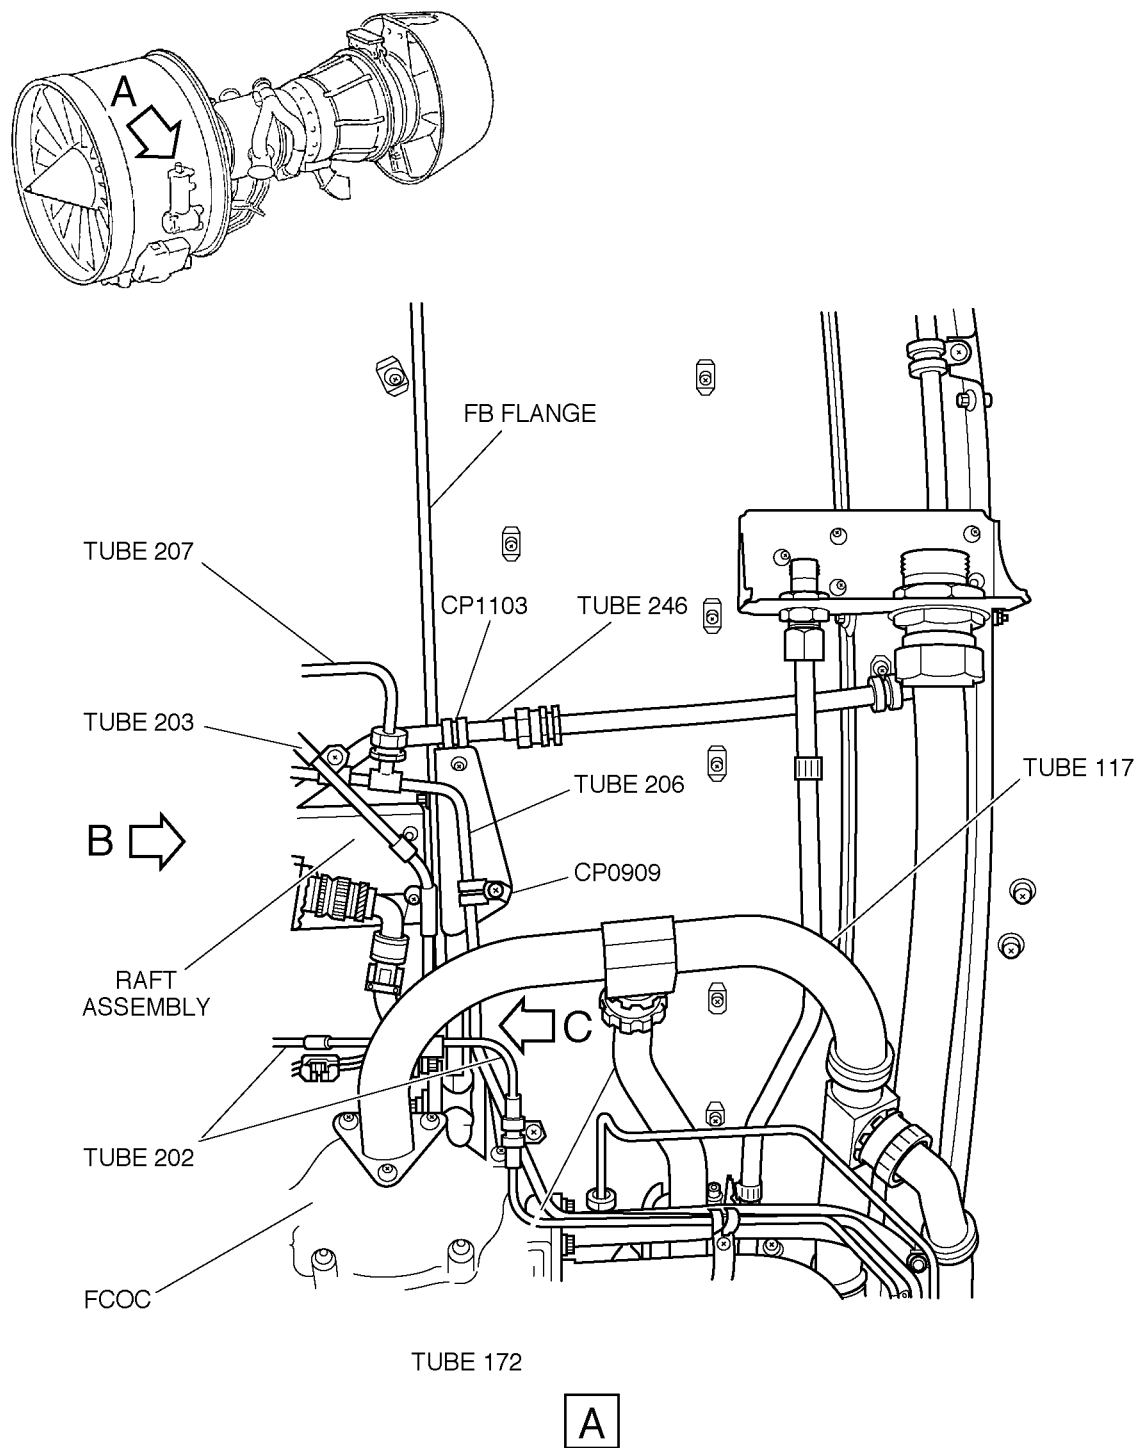
Rework details and related parts
Figure 1

Premature deterioration of the Fan case assembly may occur, which in extreme cases can result in cracking of the FB flange.

A. Prepare the raft assembly and damaged area of the FB flange on the fan case, refer to Figure 1 and 2.

- (1) Remove the clipping point 1103 and 0909 and tubes 117, 172, 202, 203, 206, 207 and 246 from the engine. Refer to the applicable Engine Manual (EM) Chapter/Section 72-00-32, Removal-03.
- (2) Remove the FCOC (Fuel Cooled Oil Cooler) from the engine. Refer to the applicable Engine Manual (EM) Chapter/Section 72-00-32, Removal-29.
- (3) Remove the raft assembly (71-51-43, 05-990), attachment angle (71-51-43, 05-870), and bracket (79-22-49, 13-900) from the FB flange. Refer to the applicable Engine Manual (EM) Chapter/Section 72-00-32, Removal-05.

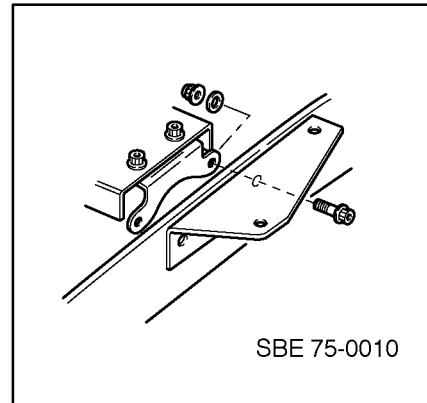
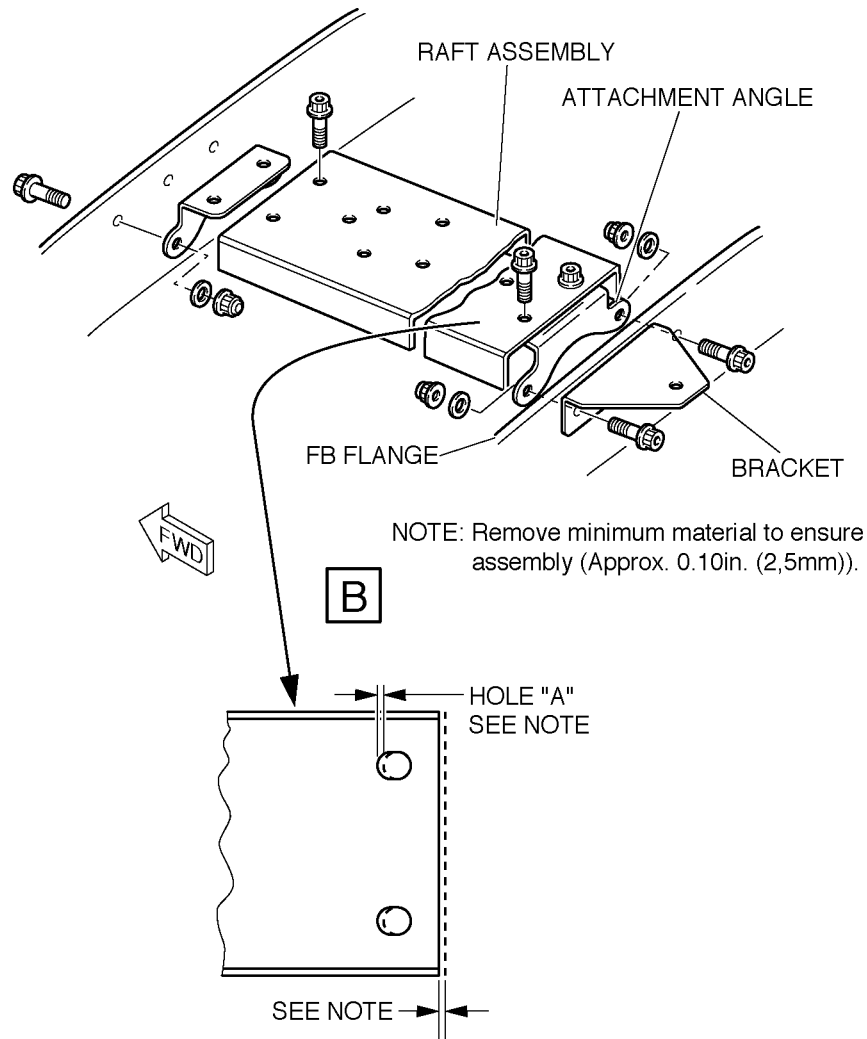
Rework details for the raft assembly
Figure 2

(i) The length of the raft assembly abutment side is decreased to ensure assembly, see Figure 2.

(ii) The holes of the raft assembly are elongated in the forward direction by a minimum amount to allow assembly, see Figure 2.

- (a) Enlarge hole 'A' 2 places in raft assembly. See Figure 2.
- (b) Remove the edge of the raft assembly in the FB flange side. See Figure 2.
- (c) Cancel existing part number and re-identify with new part number which is followed by the letters assy adjacent to existing part number.
 - (i) Use the vibro-peen method, refer to Figure 2 and SPM TASK 70-09-00-400-501.

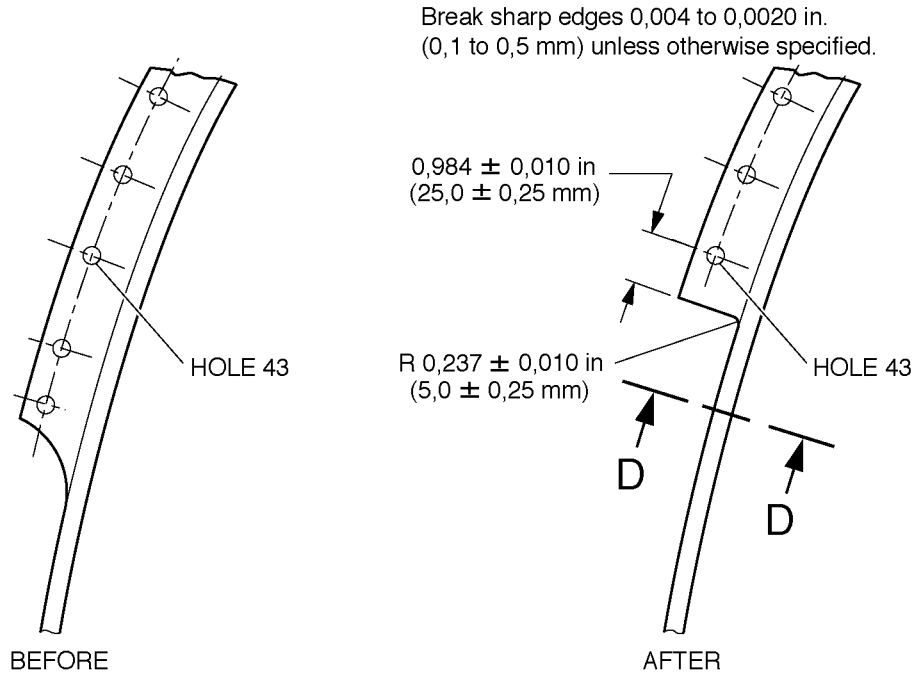
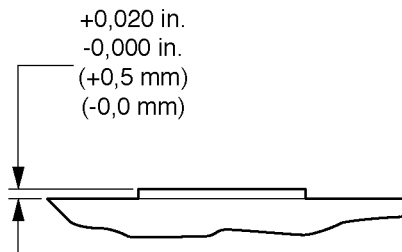
Rework details for the FB flange
Figure 3

- (d) Modification of the existing fan case assembly is introduced, similar to the existing fan case assembly except for the length of the FB flange (FCOC top mount location) which is decreased to allow assembly of the extension bracket (P/N 5R0294), see Figure 3.

- (a) Clean the fan case assembly, refer to SPM TASK 70-11-26-300-503.
- (b) Crack test on the damaged area, refer to Figure 3 and SPM TASK 70-23-05-230-501. Use CoMat 06-063 fluorescent penetrant or CoMat 06-064 fluorescent penetrant. Record all cracks.

(c) Remove the damaged flange material, refer to Figure 3.

- (ii) Blend any burred, galled, cracked or chafed material in the region of the original fracture area. Use portable grinding equipment and CoMat 05-021 waterproof silicon carbide abrasive paper to remove damage.

- (iii) Polish the blended area. Use CoMat 05-020 waterproof silicon carbide abrasive paper to make the blended surface as smooth as the initial surface.

(d) Crack test again, do step (3)(a) and (b). The blend area must satisfy dimension given in Figure 3. If necessary, do step (3)(c) again.

- (i) Use the vibro-peen method, refer to Figure 3 and SPM TASK 70-09-00-400-501.
