V2500-A1/A5 SERIES PROPULSION SYSTEMS SERVICE BULLETIN

V2500-ENG-72-0504

ENGINE – MAIN GEARBOX ASSEMBLY – TO ANNOUNCE A NEW DEOILER CASING1. Planning InformationA. Effectivity

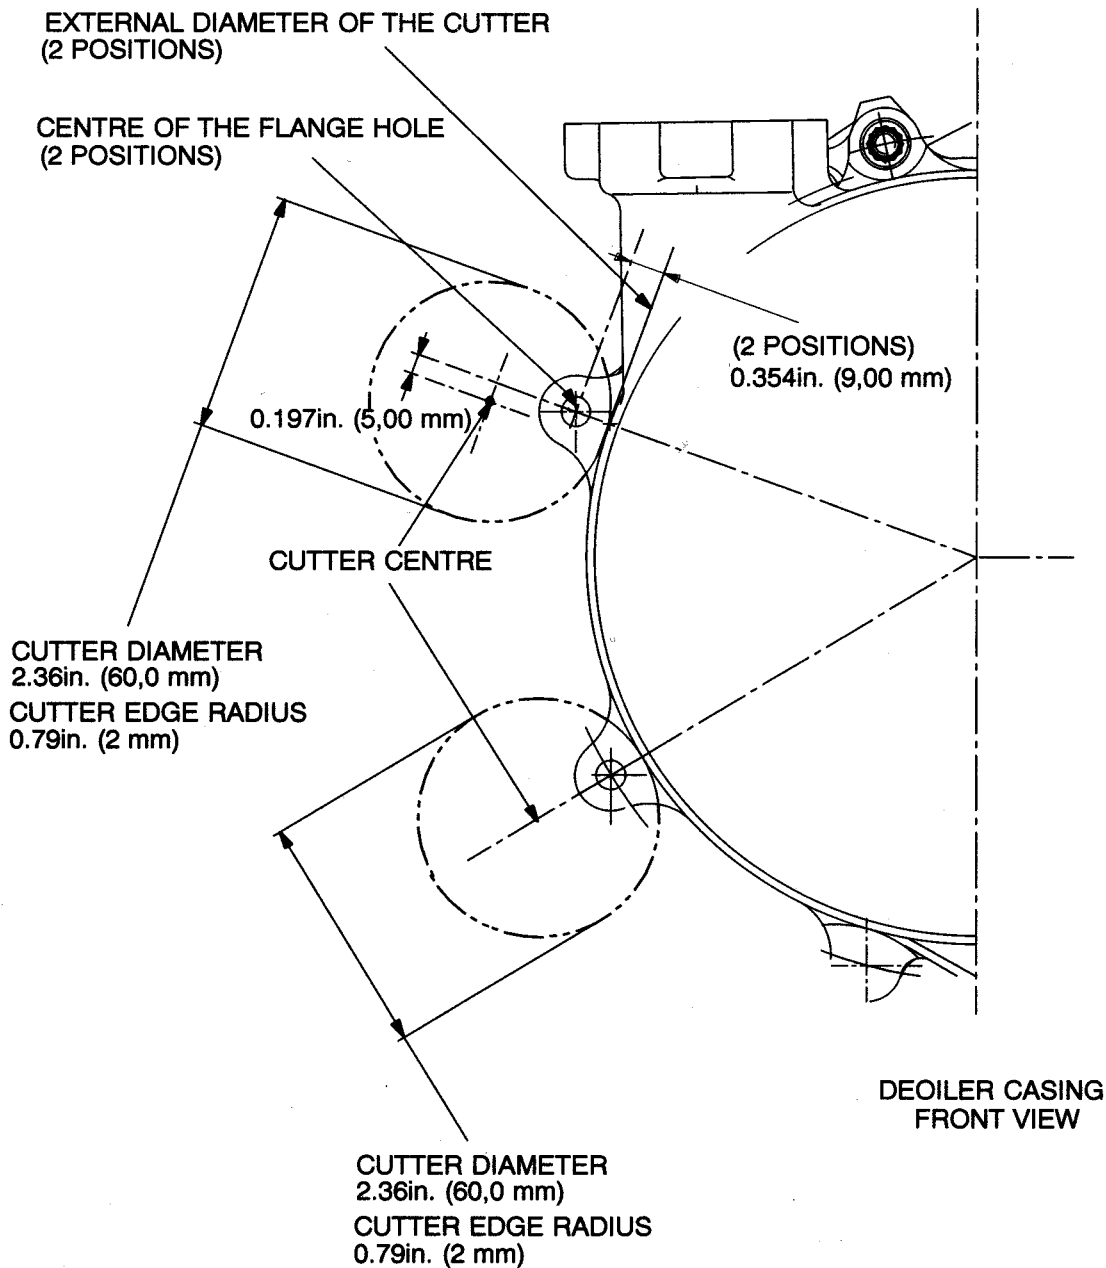
Rework of the Deoiler Casing
Figure 1

There is interference between the new bracket, P/N 6A8166 (72-60-10, 01-457) and the material around the flange of the deoiler housing.

A local rework of the deoiler housing is required.

- (3) Use the center line of the air port as dimensional reference.
- (4) Machine the deoiler casing around the two flange holes at positions 8 and 10 o'clock, front view of the deoiler casing, looking afterwards. Refer to the scheme of Fig.1. Use a cutting tool with a diameter of 2.36in. (60,0 mm) and an edge radius of 0.08in. (2 mm). It is not required to use a specific tool. If the cutting tool touches the rough surface of the deoiler casing, the thickness of the casing will be equal or more than 0.35in. (9 mm). Make sure you do not decrease the thickness of the flange. Surface finish must be 1,6 micron.
