V2500-A5/D5 SERIES PROPULSION SYSTEMS SERVICE BULLETIN

This document transmits the Initial Issue of Service Bulletin EV2500-72-0511 and the Initial Issue of the Supplement

V2500-ENG-72-0511

ENGINE – NEW 1ST STAGE ROTOR ASSEMBLY WITH METERING PLUGS REMOVED AND NEW 1ST STAGE
HPT SEAL

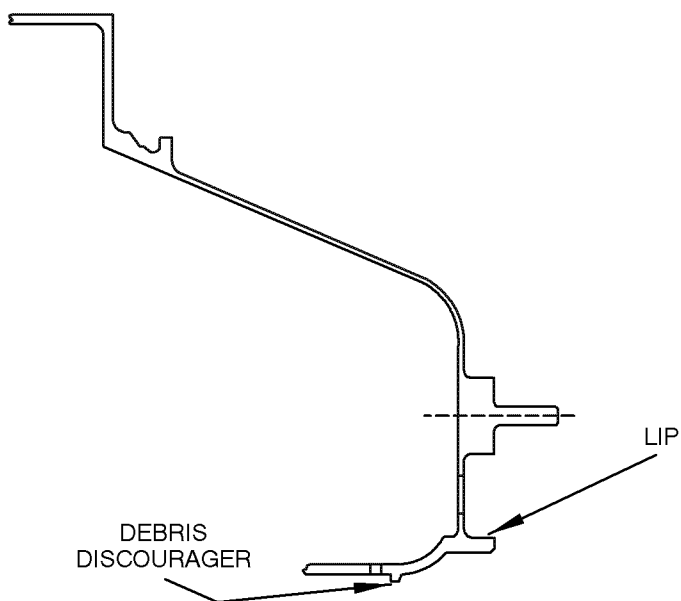
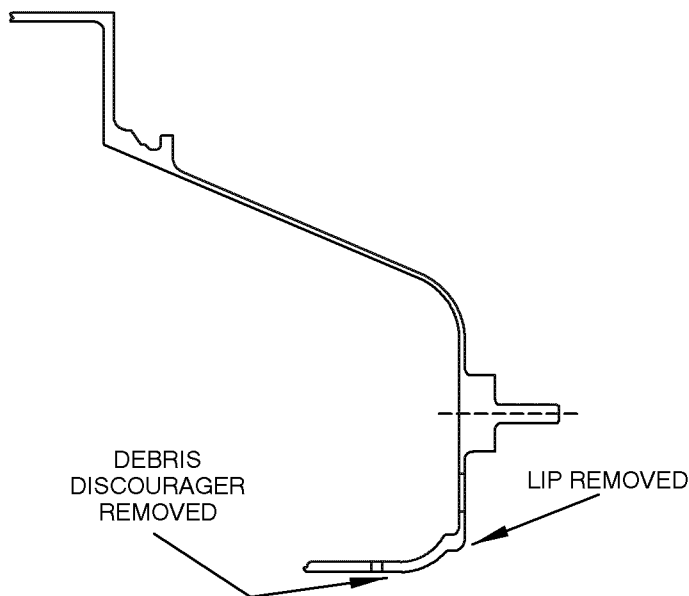
Figure 1

NUMBER 4 BEARING COOLING DUCT ASSEMBLY
PRIOR TO INCORPORATION OF V2500-72-0190

NUMBER 4 BEARING COOLING DUCT ASSEMBLY
AFTER INCORPORATION OF V2500-72-0190

NUMBER 4 BEARING COOLING DUCT ASSEMBLY PRIOR TO AND AFTER SERVICE BULLETIN
V2500-ENG-72-0190

NOTE: Check the number 4 Bearing Rear Cooling Duct Assembly to insure the intent of V2500-ENG-72-0190 Service Bulletin is incorporated. If debris discourager and lip require removal, reoperate and reidentify per V2500-ENG-0190. See Fig.1.

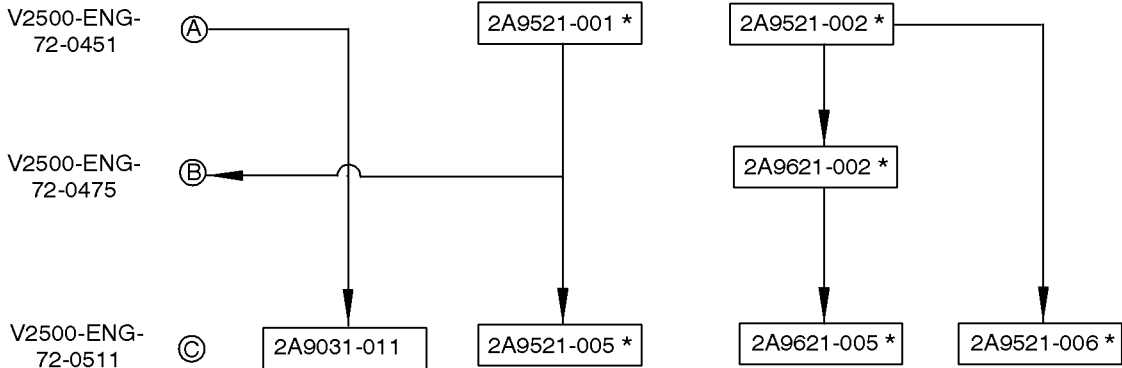
FAMILY TREE – TURBINE ROTOR 1ST STAGE ASSEMBLY OF REF. CATALOG SEQUENCE NO. 72-45-10
 FIGURE 01 ITEM 010
 CHART A (Sheet 2 of 2)

* DO NOT USE IN MODEL V2533-A5
