**International Aero Engines  
NON-MODIFICATION  
SERVICE BULLETIN**

**ENGINE – ANGLE GEARBOX ASSEMBLY – TO ANNOUNCE A NEW GEARBOX WITH PARTIAL  
HEAT TREATED BEARING SUPPORT – NON-MODIFICATION SERVICE BULLETIN**

**V2500-A5 SERIES PROPULSION SYSTEMS NON-MODIFICATION SERVICE BULLETIN**

**V2500-ENG-72-0527**

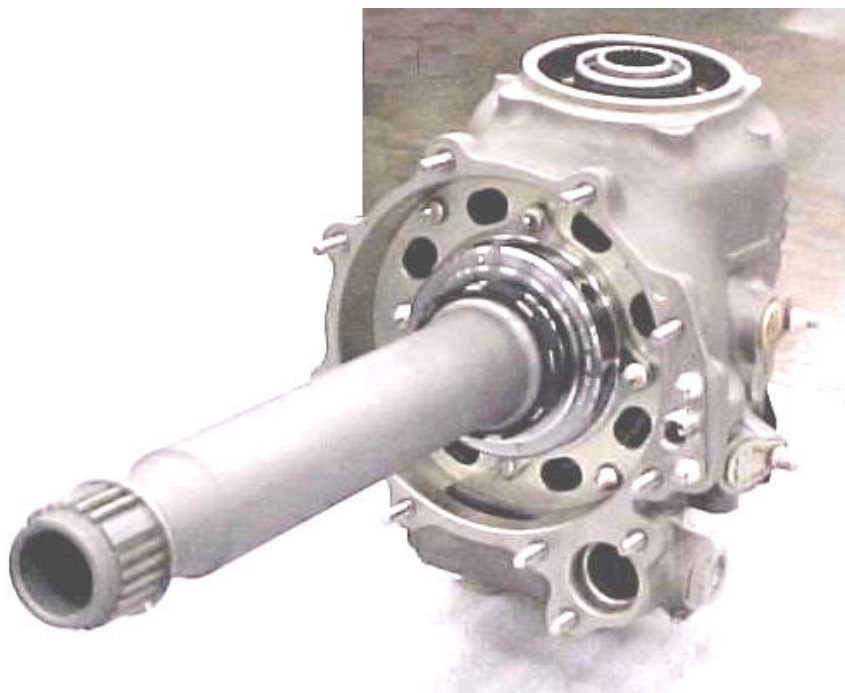
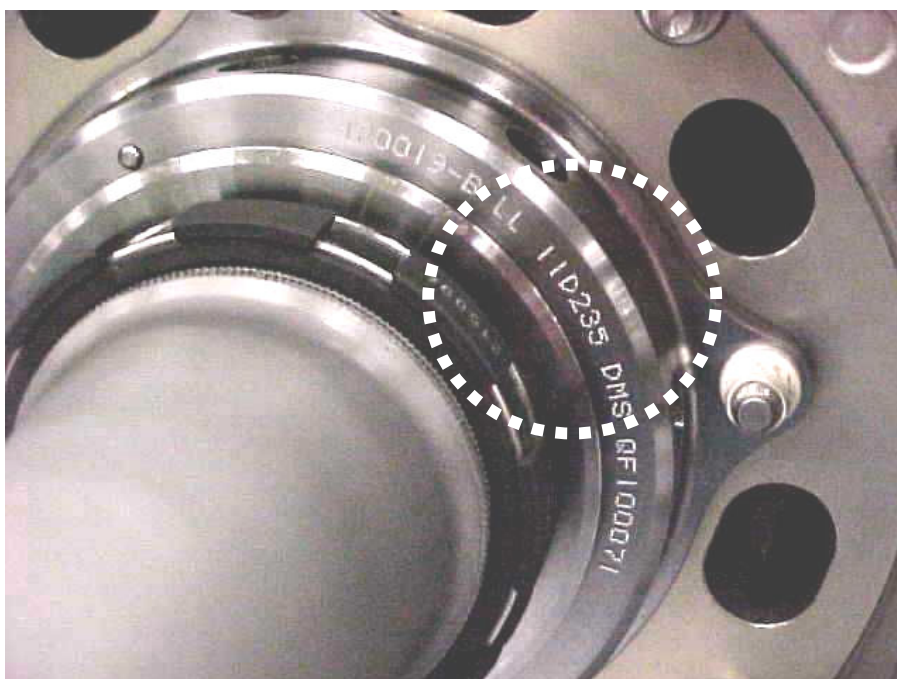
Inspection of the (01-090) Bearing Housing Batch  
Figure 2

A quantity of three off partially heat treated Angle Gearbox (AGB) bearing housings, p/n 4B0019, 72-60-43-01-090, were inadvertently released to production.

A total quantity of six bearing housings received from a vendor were identified as having been annealed but not hardened and tempered. A search was initiated and three of the parts were found in stock and quarantined. The remaining three parts had already been used for production and the assembled modules shipped for engine build.

- (4) Remove the Angle Gearbox from the Main Gearbox. Refer to EM 72-60-00-030-065.
- (5) Visually examine the data engraved on the front of AGB Bearing Housing 01-090. Refer to Fig.2. If the data include LL10X002 you must replace the part. Do steps (6) to (14). If datum LL10X002 is not indicated, refit the AGB, go to step (12).

- (6) Disassemble the Angle Gearbox Assembly. Refer to EM 72-60-40-040-001. Stop disassembly after SUBTASK 72-60-40-040-054.
- (7) Disassemble the Angle Gearbox Driven Gear and Layshaft Assembly. Refer to EM 72-60-43-040-01. Stop disassembly after SUBTASK 72-60-43-040-054 and discard the Bearing Housing 01-090.

- (10) Assemble the Angle Gearbox Driven Gear and Layshaft Assembly. Use a new Bearing Housing. Refer to EM 72-60-43-440-001 and start with SUBTASK 72-60-43-440-052.
