V2500-A5 SERIES PROPULSION SYSTEMS SERVICE BULLETIN

This document transmits Revision 1 to Service Bulletin EV2500-72-0535

V2500-ENG-72-0535

ENGINE – COMPRESSOR NON MODULAR – INTRODUCTION OF A CABLE FEED – THROUGH ADAPTER FOR
THE FUEL LACQUER AND TEMPERATURE SURVEY INVESTIGATION

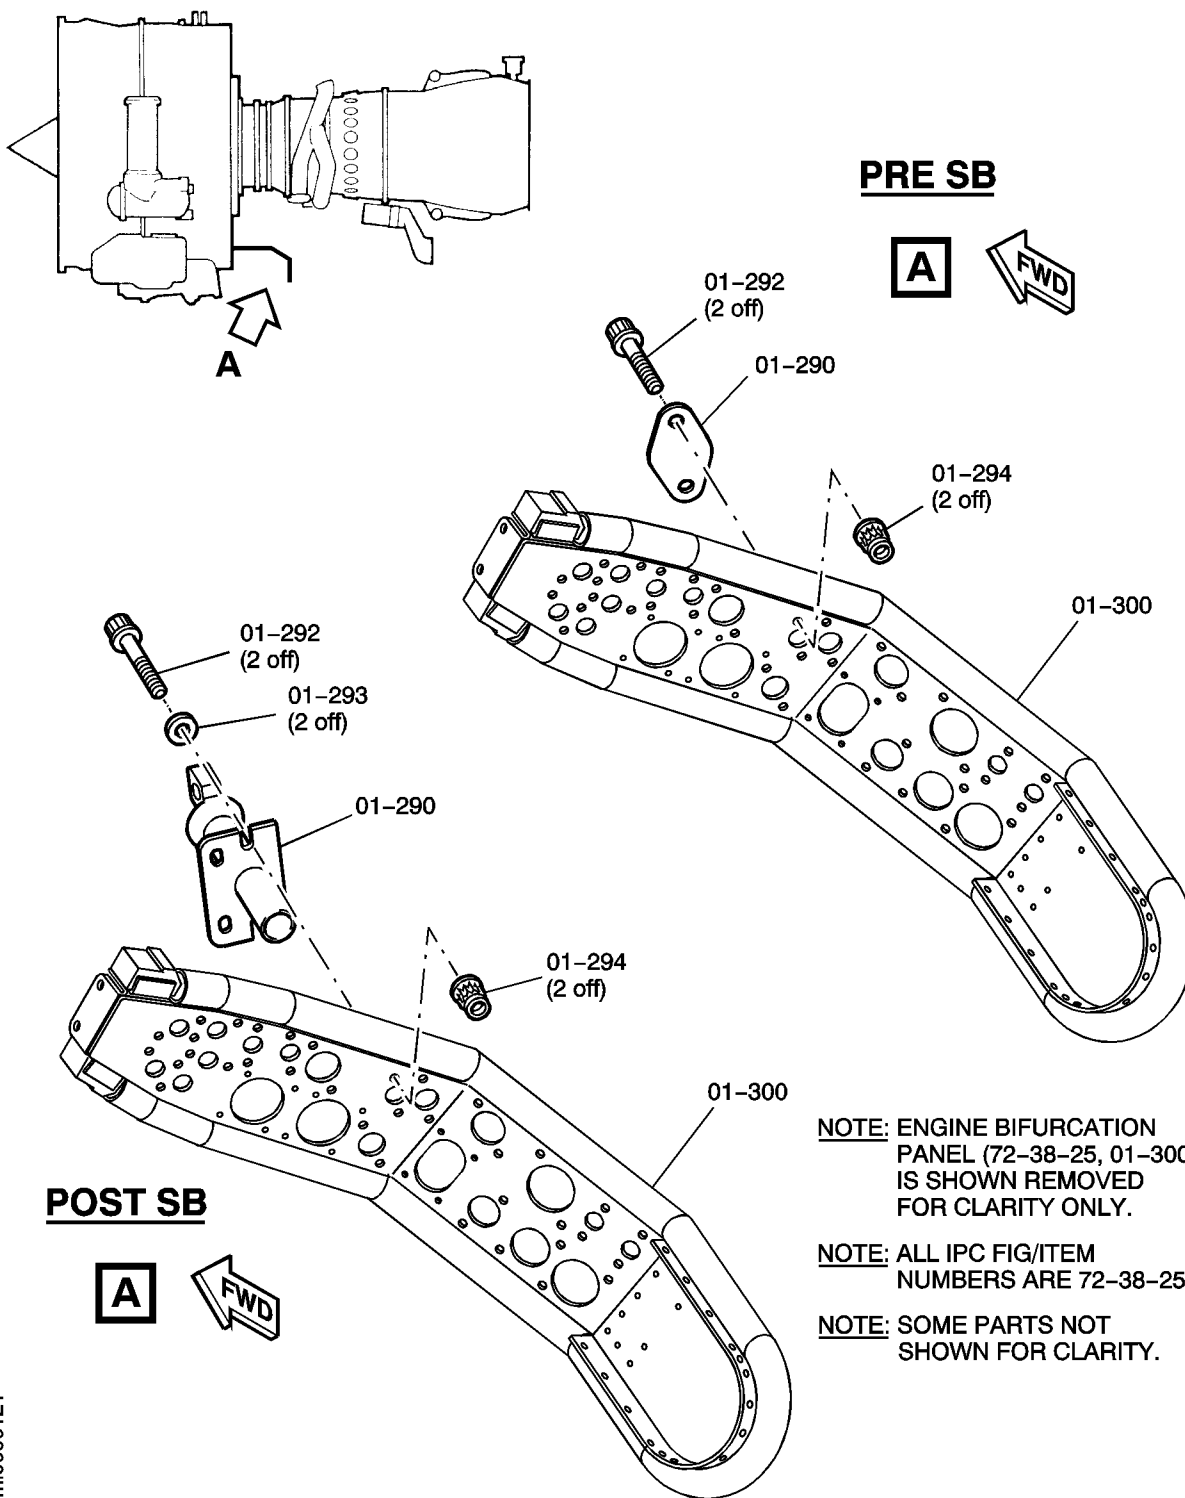
Installation of the Instrumentation Adapter (72-38-25, 01-290)
Figure 1

As part of the investigation of fuel lacquering problems on the Variable
Stator Vane Actuator (VSVA), Booster Stage Bleed Valve Master Actuator
(BSBMA) and the Active Clearance Control Actuator (ACC Actuator) a
temperature survey during a revenue service flight will be performed. A
number of thermocouples will be fitted onto and close to the VSVA, BSBMA
and ACC Actuator to gain a better understanding of the temperature
involved in the formation of fuel lacquer. The thermocouple wires will be
routed through an adaptor, which is fitted to a vacant position on the
bifurcation panel.

- (3) Replace the cover with the instrumentation adapter (Refer to Figure 1)
- (a) Remove the blanking plate (72-38-25, 01-290)
- (i) Remove the two nuts (72-38-25, 01-294) and the two old bolts (72-38-25, 01-292), P/N 4W0163 that attach the blanking plate (72-38-25, 01-290) to the engine bifurcation panel (72-38-25, 01-300).

- (ii) Remove the old blanking plate (72-38-25, 01-290), P/N LK62478 from the engine bifurcation panel (72-38-25, 01-300).
- (b) Install the instrumentation adapter (72-38-25, 01-290)

- (iv) Install the new instrumentation adapter (72-38-25, 01-290), P/N 6A9099 to the engine bifurcation panel (72-38-25, 01-300).
- (v) Apply a thin layer of engine oil (Material No. V10-077) to the threads of the two new bolts (72-38-25, 01-292), P/N 4W0165 and the two nuts (72-38-25, 01-294).

- (vi) Install the two new bolts (72-38-25, 01-292), P/N 4W0165, the two new washers (72-38-25, 01-293), P/N 4W2622 and the two nuts (72-38-25, 01-294) that attach the instrumentation adapter (72-38-25, 01-290) to the engine bifurcation panel (72-38-25, 01-300).

- (vii) Torque the two nuts (72-38-25, 01-294) to between 85 and 105 lbf in. (10 and 12 Nm).
- (viii) Remove any unwanted sealant compound from the joint area. Use a clean cloth made moist with acetone (Material No. V01-031).
