V2500-D5 SERIES PROPUSION SYSTEMS NON-MODIFICATION SERVICE BULLETIN

This document transmits Revision 1 to Service Bulletin EV2500-72-0536

V2500-ENG-72-0536

<u>ENGINE - HP COMPRESSOR - ONE-OFF BORESCOPE INSPECTION OF STAGES 6 TO 8 BLADES AND STAGES 6 TO 8 VANES - NON-MODIFICATION SERVICE BULLETIN</u>

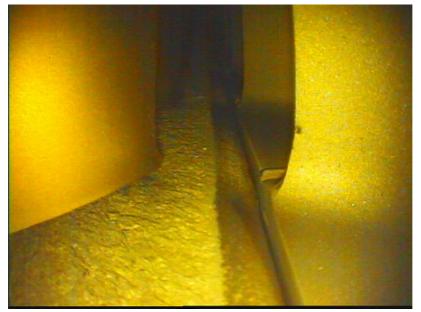
- (i) Nicks, tears or dents on individual airfoils (Refer to Figure 7)

HPC stage 6 vane with nick at the T/E, dimension of the nick 0.014 in. (0,36 mm), no material removal allowed Figure 7

Not more than 0.016 in. (0,4 mm) in radial or axial dimension and not in the area of T/E material loss	Repeat borescope inspection within 500 cycles.
		More than A, but not more than 0.039 in. (1 mm) in radial or axial dimension	Reject within 10 cycles.
ſ	С	More than B	Reject.

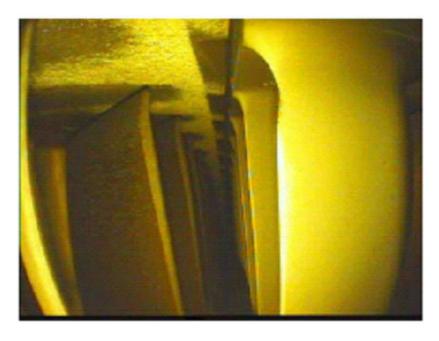
(iii) Loss of material from trailing edge with or without a jagged T/E profile (Refer to Figures 8 and 9)

HPC stage 6 vane; smooth loss of material without a jagged T/E Figure 8

Α	Not more than 0.006 in. (0,15 mm) in axial depth	Repeat borescope inspection within 500 cycles.
В	More than A, but not more than 0.016 in. (0,4 mm) in axial depth	
С	More than B, but not more than 0.035 in. (0,9 mm) in axial depth	
D	More than C, but not more than 0.079 in. (2 mm) in axial depth	Reject the engine within 10 cycles.
Ε	More than D	Reject.

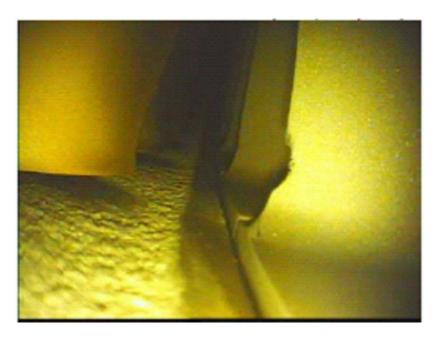
HPC stage 6 vane; loss of material with a jagged T/E profile Figure 9

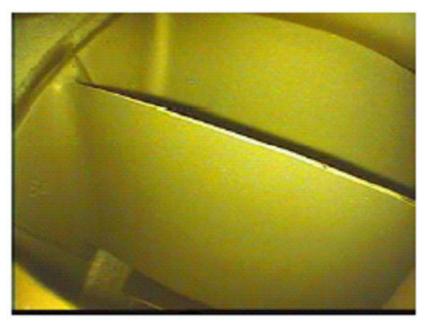
HPC stage 6 vane with a thin T/E which remeins straight Figure 10

- (iv) Sharp, thin trailing edge that remains straight (Refer to Figure 10) Place engine on 500 cycle repeat borescope inspection.
- (4) Borescope Inspection of Stage 7 Blade
 - (a) Insert the borescope through access port D (AMM reference: Figure 601/72-00-02-990-801).
 - (b) Carry out borescope inspection in accordance with AMM TASK 72-00-02-290-801.

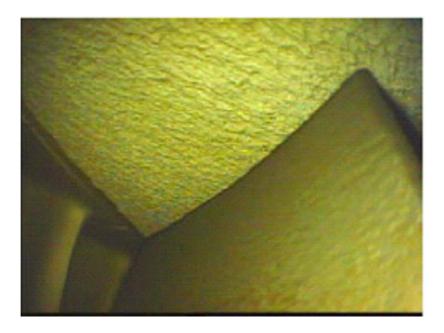
HPC stage 6 blade without blade tip erosion Figure 11

- R (c) Tip Erosion (Refer to Figures 11 to 13)
 - (i) Re-inspect the engine in 500 cycles if the chordal extend of the erosion is less than 25 percent of the remaining chord.

- (ii) Re-inspect the engine in 125 cycles if the chordal extend of the erosion is greater than 25 percent but less than 50 percent of the remaining chord.

- (iii) Reject the engine within 10 cycles if chordal extend of the erosion is greater than 50 percent of the remaining chord.
 - (3) Borescope Inspection of Stage 6 Vane

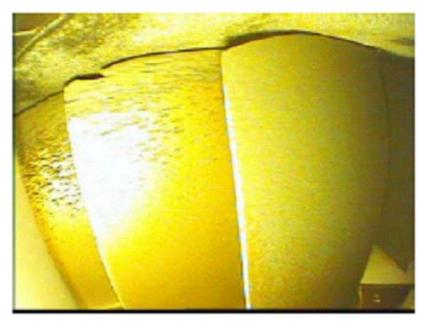
HPC stage 7 blade with tip erosion not more than 25 percent Figure 12

- (c) In addition to the AMM requirements, inspect each blade in turn for tip erosion, according to the limits shown below (Refer to Figures 11 to 13):
 - (i) Re-inspect the engine in 500 cycles if the chordal extend of the erosion is less than 25 percent of the remaining chord.
 - (ii) Re-inspect the engine in 125 cycles if the chordal extend of the erosion is greater than 25 percent but less than 50 percent of the remaining chord.
 - (iii) Reject the engine if chordal extend of the erosion is greater than 50 percent of the remaining chord.

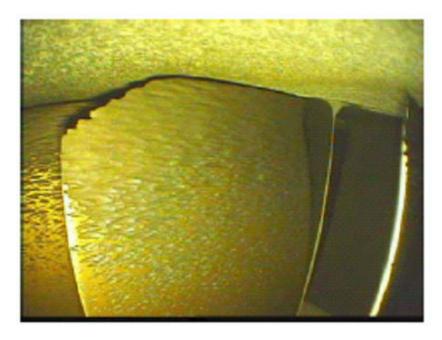
HPC stage 7 blade with blade tip erosion with more than 25 percent but not more than 50 percent Figure 13
