V2500-A1 SERIES PROPULSION SYSTEMS NON-MODIFICATION SERVICE BULLETIN

V2500-ENG-72-0539

ENGINE – LP COMPRESSOR – TAPPING INSPECTION OF FRONT ANTI ICE IMPACT PANELS OF PRE SB
V2500-ENG-72-0103 STANDARD FAN CASE ASSEMBLY – NON-MODIFICATION SERVICE BULLETIN

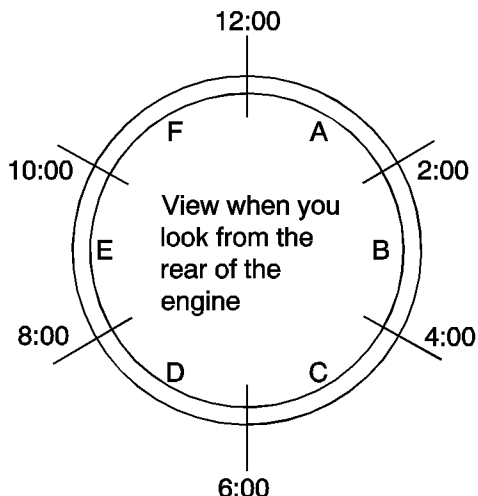
Damage Map for Front Anti Ice Impact Panel
Figure 1

Mark unbonded areas by shading
