V2500-A1 SERIES PROPULSION SYSTEMS SERVICE BULLETIN

V2500-ENG-72-0542

ENGINE – NEW FIRST STAGE DUCT SEGMENTS AND HPT VANE SUPPORT**1. Planning Information****A. Effectivity**

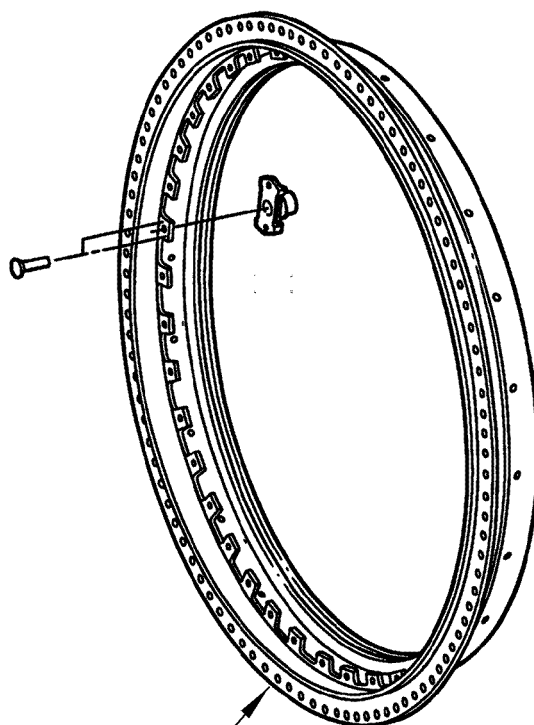
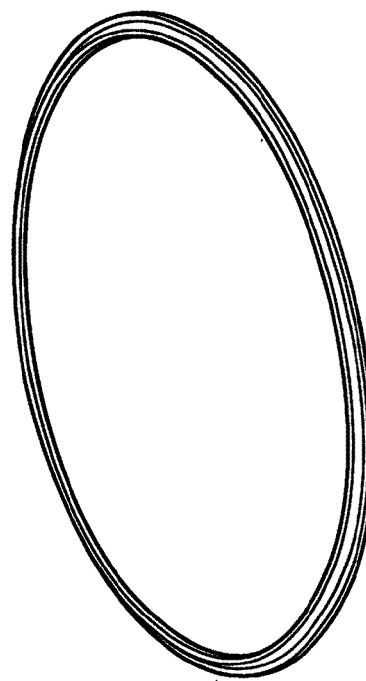
LOCATION OF THE STAGE 1 HIGH PRESSURE TURBINE SUPPORT ASSEMBLY
Figure 1

INSTALL THE 2A4027 STAGE 1
HPT SUPPORT ASSEMBLY (1OFF)

USE THE 2A3328 STAGE 1
HPT SEAL (1OFF)

- (a) Do a modification of the Stage 1 HPT Support Assembly (72-44-10, 01-010), P/N 2A3360
 - (i) Remove the Stage 1 HPT Seal (72-44-10, 01-060), P/N 2A3328 (Refer to Figure 1 and 2).
