V2500-A1/A5 SERIES PROPULSION SYSTEMS NON-MODIFICATION SERVICE BULLETIN

V2500-ENG-72-0543

R ENGINE – REPLACEMENT OF PN 2A2493-01 NUMBER 4 BEARING COMPARTMENT OIL PRESSURE TUBES
– NON-MODIFICATION SERVICE BULLETIN

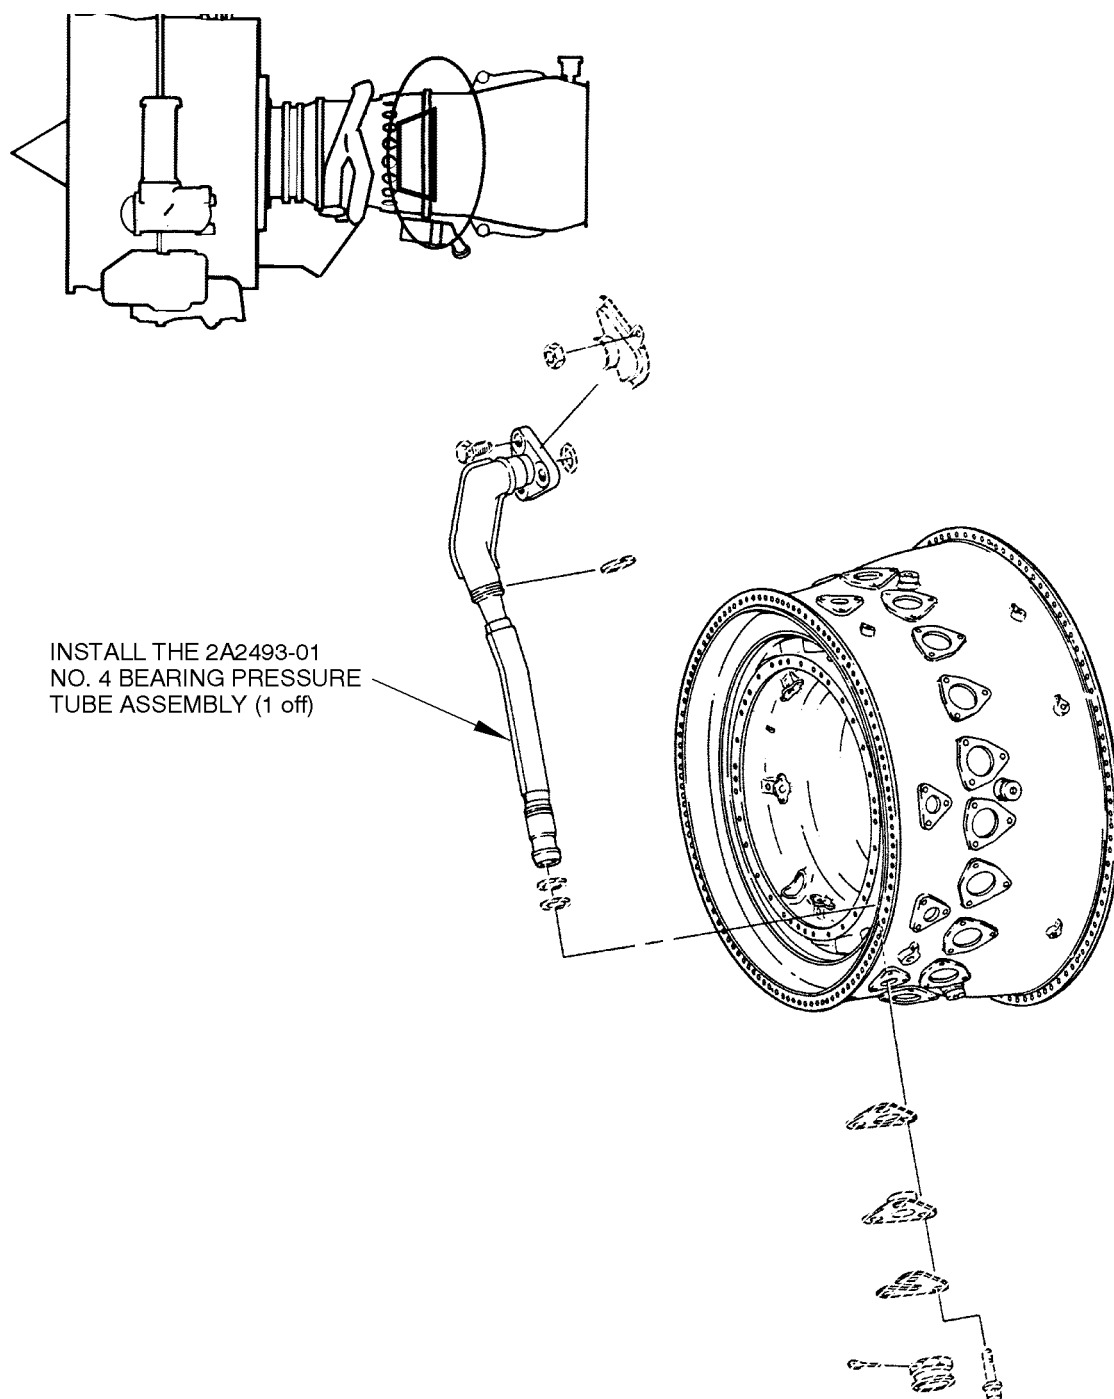
LOCATION OF THE NO. 4 BEARING PRESSURE TUBE ASSEMBLY
Figure 1

The affected population of PN 2A2493-01 Number 4 Bearing Oil Pressure Tube did not receive a required x-ray inspection following a repair.

A repair for PN 2A2493-01 tubes was introduced by a non-IAE third party vendor that included an x-ray inspection of a weld that is created as part of the repair.

This x-ray inspection was missed on twelve tubes. Three have already been removed from service.

- (1) Disassemble the engine sufficiently to remove the No. 4 Bearing Oil Pressure Tube. Refer to Engine Manual Section 72-42-00, Disassembly.
- (2) Replace PN 2A2493-01 No. 4 Bearing Oil Pressure Tube with a new PN 2A2493-01 No. 4 Bearing Oil Pressure Tube. Refer to Figure 1
- (3) Assemble the engine per the Engine Manual Reference 3, Chapter Section 72-42-00, Assembly.
- (4) Recording Instructions
 - (a) A record of accomplishment is required.
