**International Aero Engines
NON-MODIFICATION
SERVICE BULLETIN**

ENGINE – HP COMPRESSOR, STAGE 3 ROTOR – REPEAT INSPECTION OF CLAPPERS – NON-MODIFICATION SERVICE BULLETIN

V2500-D5 SERIES PROPULSION SYSTEMS NON-MODIFICATION SERVICE BULLETIN

V2500-ENG-72-0545

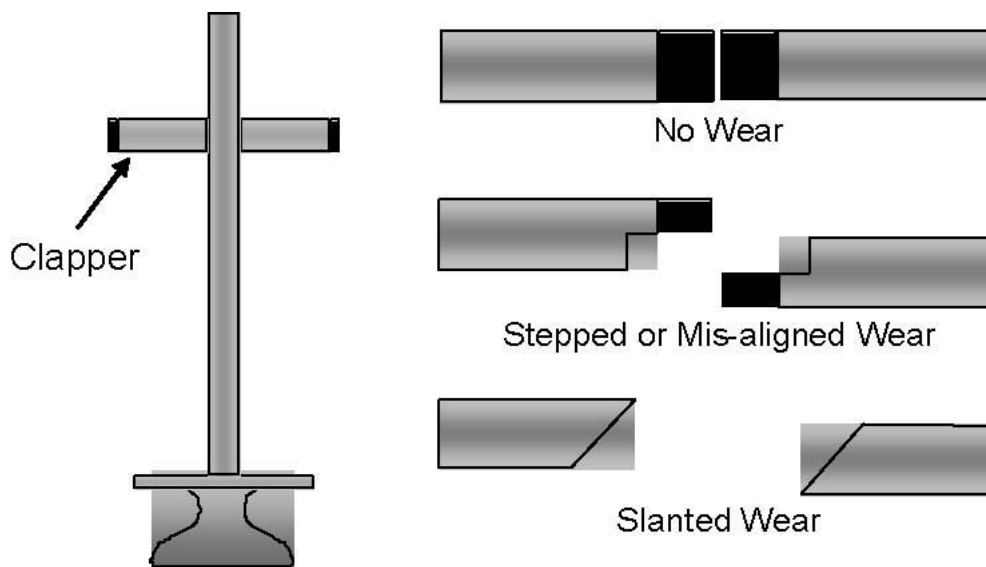
Fig 1: Axial views of clapper showing types of wear

- (c) **Vertical Wear** – wear/erosion of the mating clapper faces usually due to loss of hard-face coating on one or both faces. The clapper faces are not slanted. Refer to figure 1.
 - (i) **Regular Wear** – wear into the clapper faces which is flat or even, but is not slanted.
 - (ii) **Irregular Wear** – uneven wear into clapper faces when seen from the radial or axial direction.
 - (iii) **Stepped Wear** – wear into clapper faces which causes a step shape. The step can be in the radial direction, or along the face of the clapper (in the direction of the airflow). The wear between the two clapper faces is vertical (radial) – not slanted.
- (d) **Slanted Wear** – wear between the clapper faces which is at an angle (usually 45 degrees). This type of wear shows a condition for the clappers to slide on top/under each other and become shingled. Refer to figure 1.

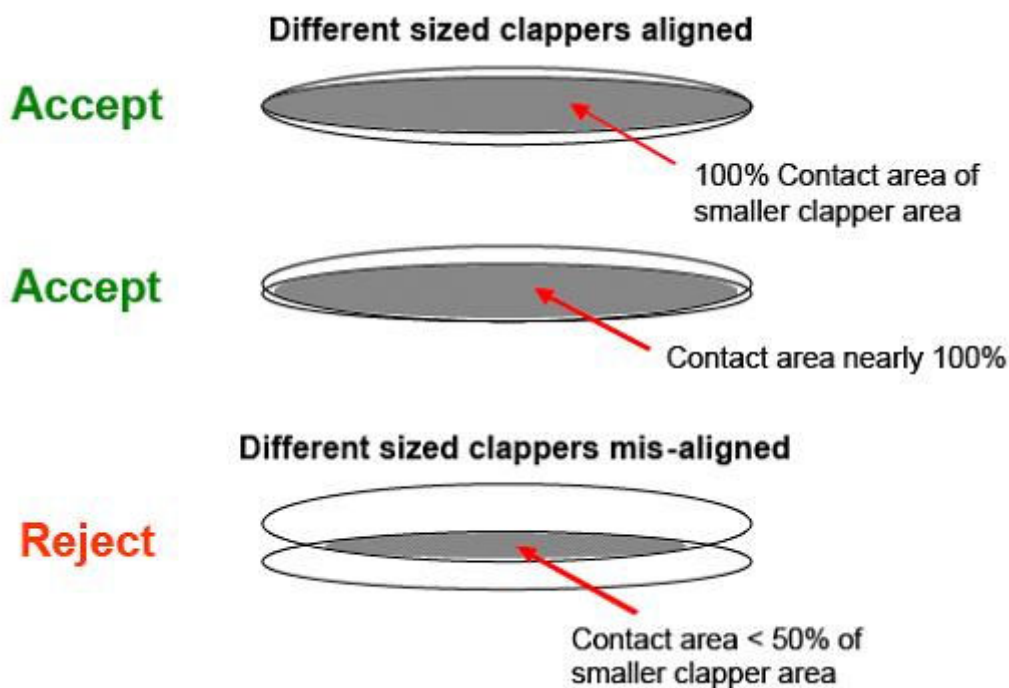
Fig 2: Clapper alignment criteria

- (a) **Radial Alignment** – the faces of the two contacting clappers are covering each other completely. This is given as a percentage with 100% alignment. Refer to figure 2.

(i) **Aligned** – clappers which are at least 50% aligned of the contact surface.

(ii) **Mis -aligned** – clappers less than 50% aligned of the contact surface.

NOTE: There are differences in the clapper face areas between blade vendors. As a result, the clapper face of one blade may 'go across' the face of the mating blade on both the top and bottom. If this occurs, use the smaller of the two faces for determining the percentage alignment.

NOTE: 50% alignment usually is related to 0.040 in. (1 mm) of exposed clapper face in the radial direction.

- (5) Mis-aligned: Reject the engine immediately. Refer to the red section
- (6) Aligned with no wear: Accept. Refer to the green section

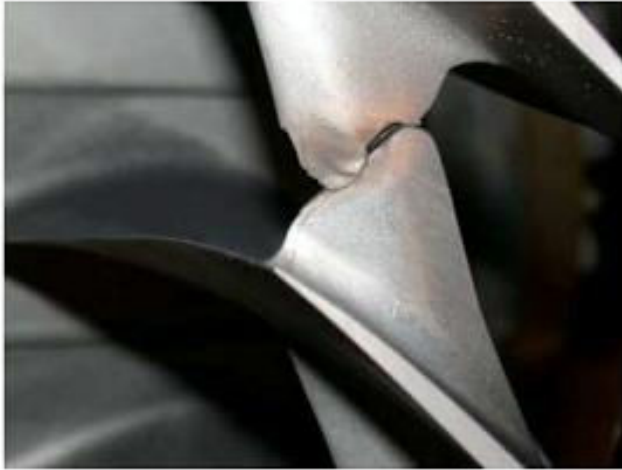
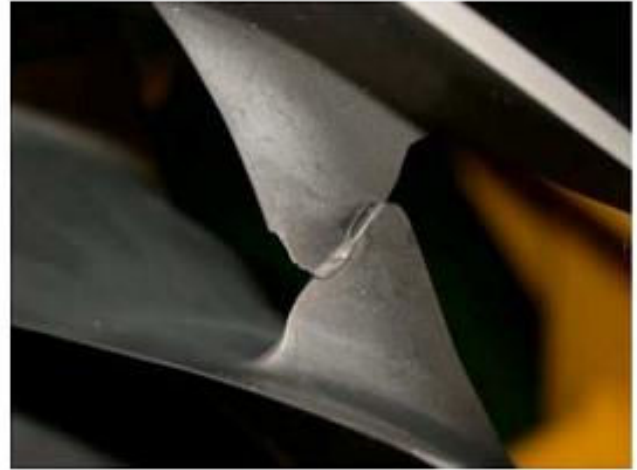
Severe Irregular Wear Material Missing and Cracking

- (2) Shingled Clappers: reject the engine immediately if any shingled clappers are found. Refer to the red section
- (3) Cracks or loss of material in non-contact areas: reject the engine immediately. Refer to the red section
- (4) Peeling of material that indicates clapper override (e.g. Peeling of material on the clapper horizontal surface), or uniform heavy peeling along the full width of the clapper contact face indicating significant loss of hard coating: reject the engine within 10 cycles. Refer to the red section

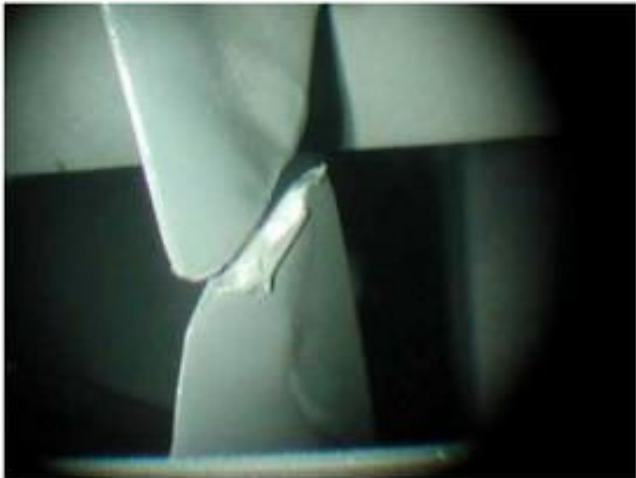
Material Peeling

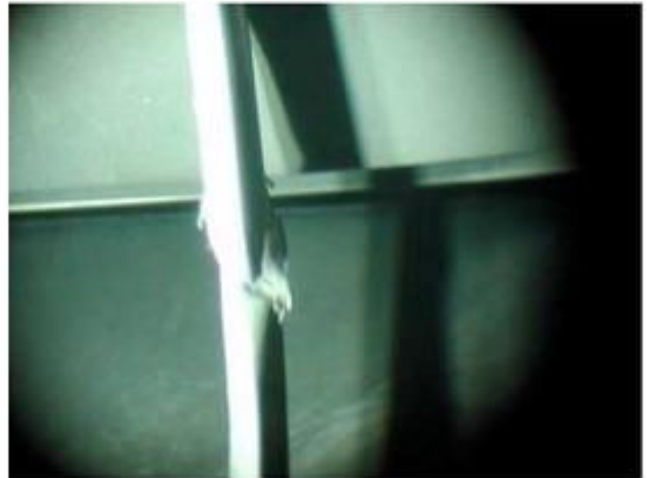
Material Peeling

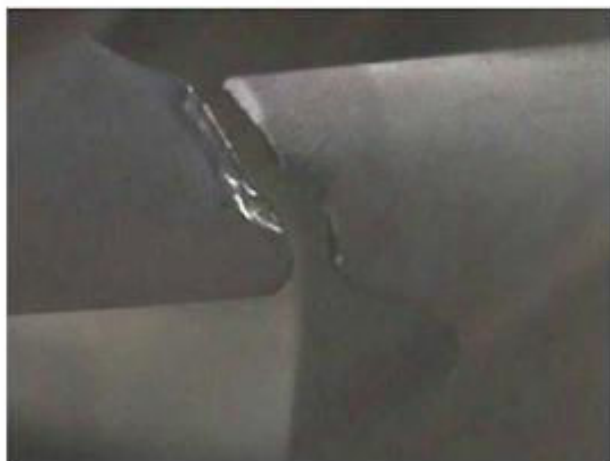
Mis-Aligned Stepped Wear

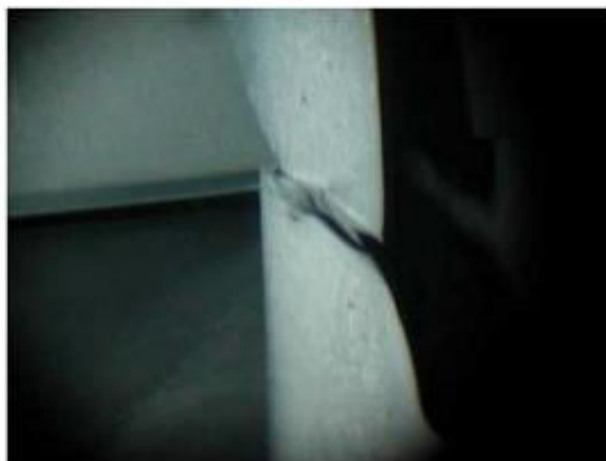
Irregular Wear Leading to
Slanted Wear

- (7) Aligned with mild vertical regular, irregular or stepped wear: Accept. Refer to the green section
- (8) Aligned with advanced vertical regular, irregular or stepped wear: Accept and do an inspection again within 100 cycles. IAE experience suggests that once clapper wear is in the amber region, the engine will typically require removal within 500 cycles. Refer to the Amber section
- (9) Aligned with slanted wear: Reject the engine within 10 cycles. Refer to the red section

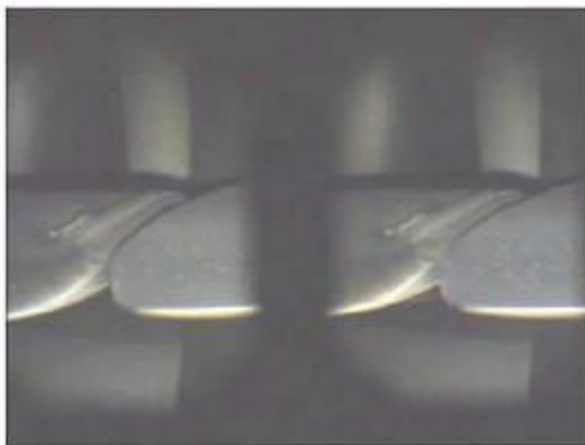
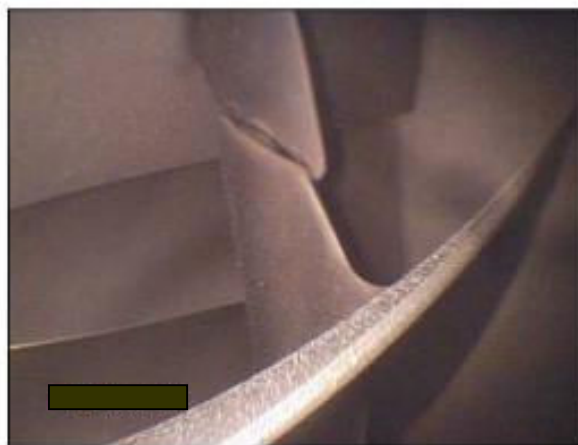
HAS THE APPEARANCE OF SLANTED WEAR REVIEW
FROM OTHER ANGLES

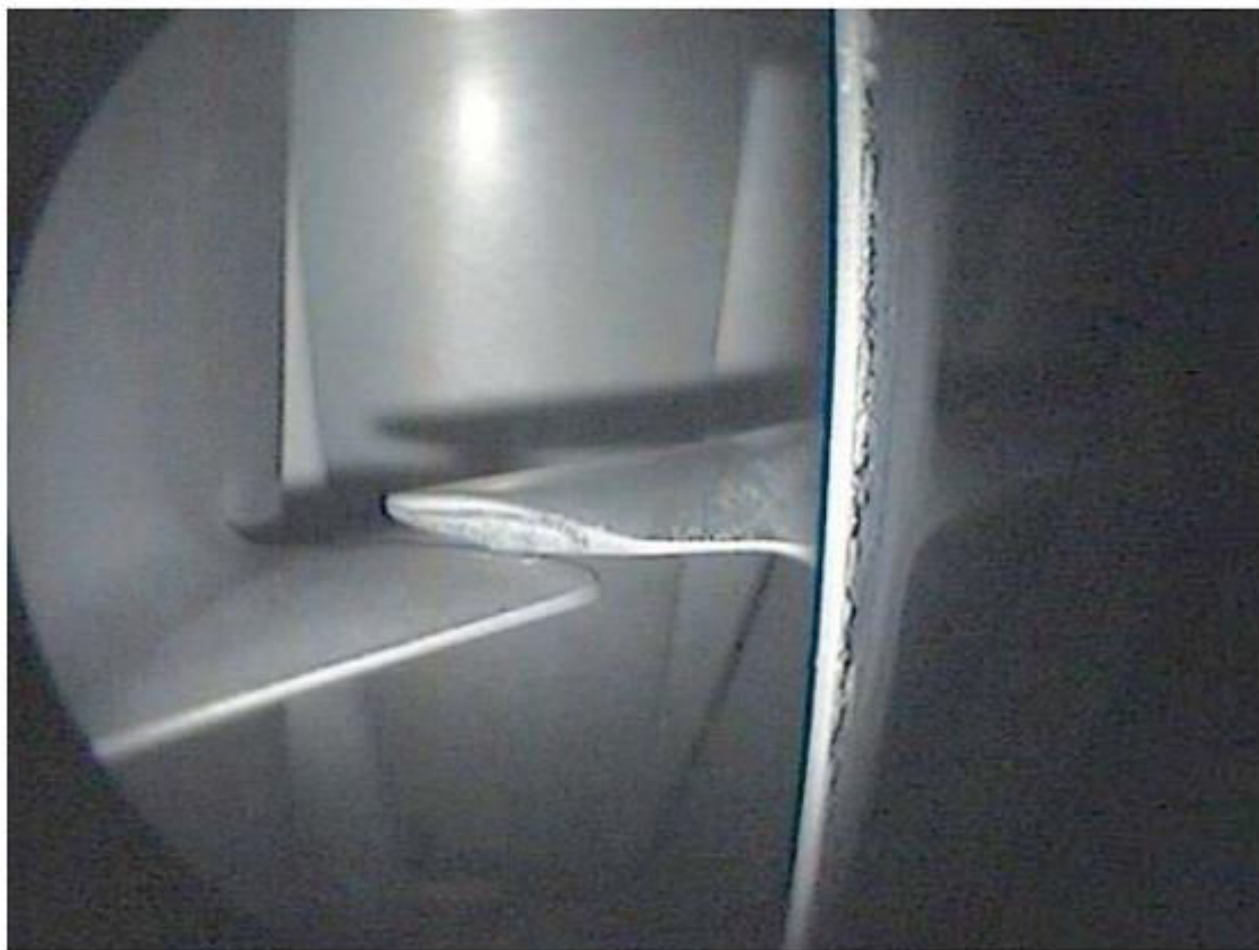
Shingled

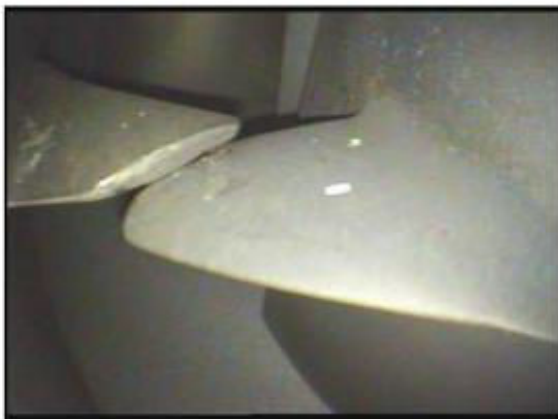
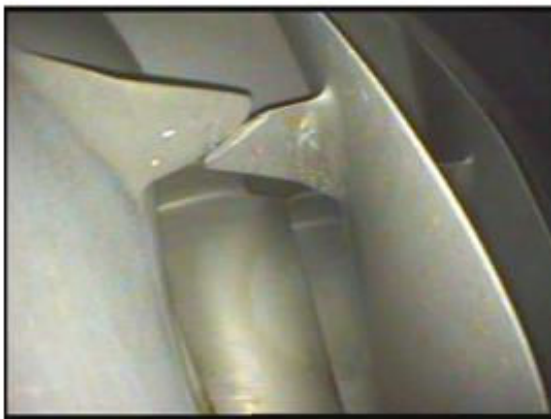
Shingled as a Result of Bird Strike

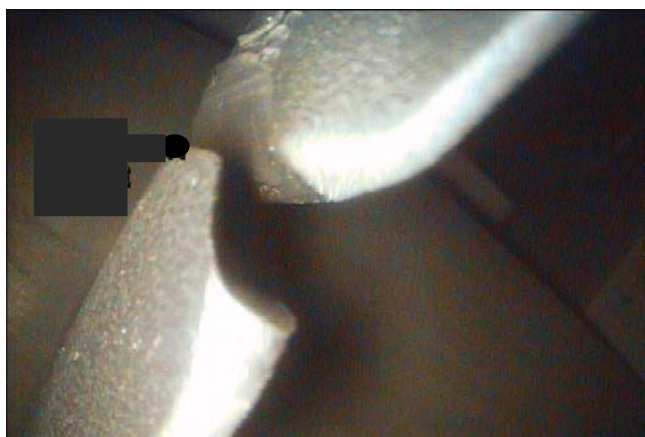
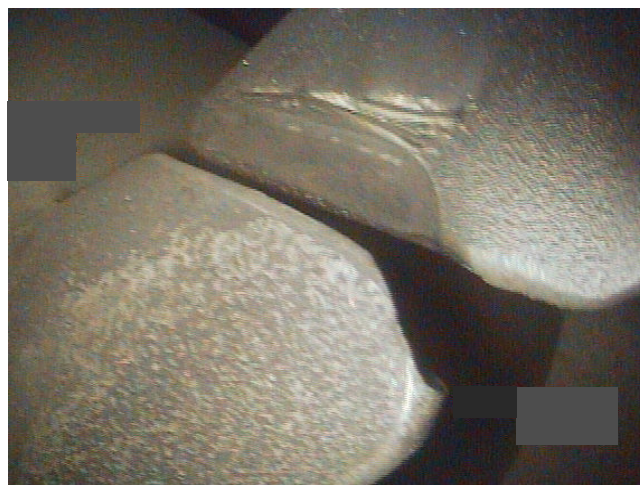
Peeling Material along large section of clapper horizontal surface – evidence of clapper override

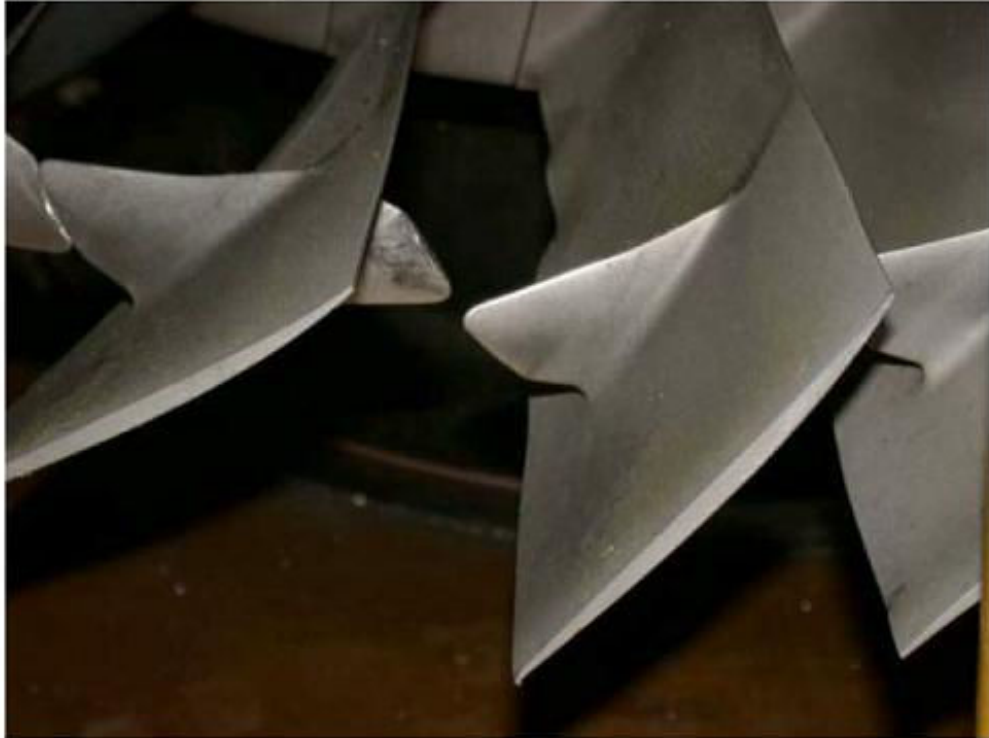
Clappers Totally Mis-Aligned and Blade Bent
Result of Bird Strike

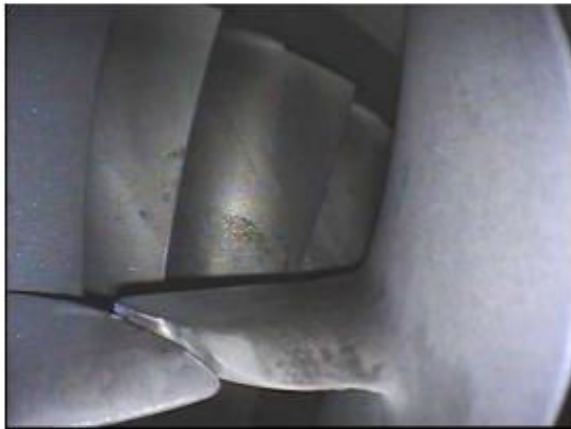
Irregular

ACCEPT, RE-INSPECT WITHIN 100 CYCLES

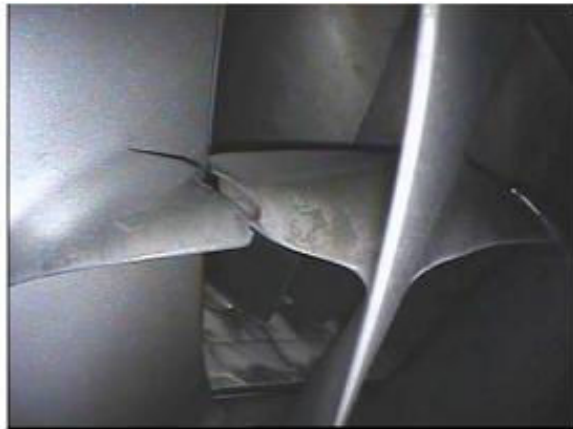
Irregular

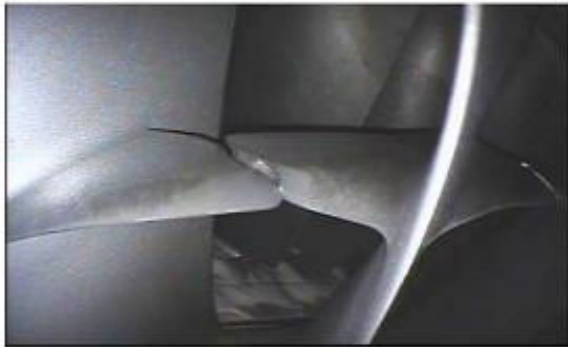
Irregular

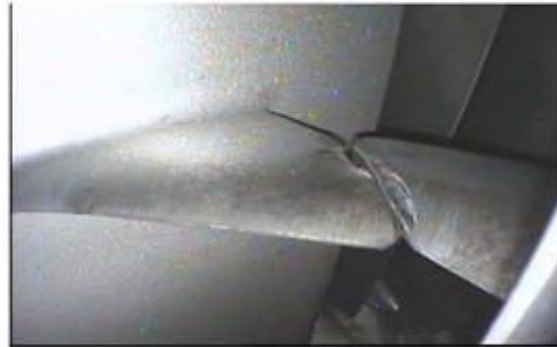
Irregular and stepped

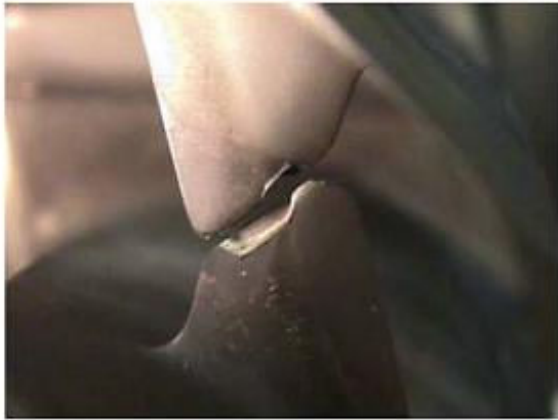
Irregular and Stepped

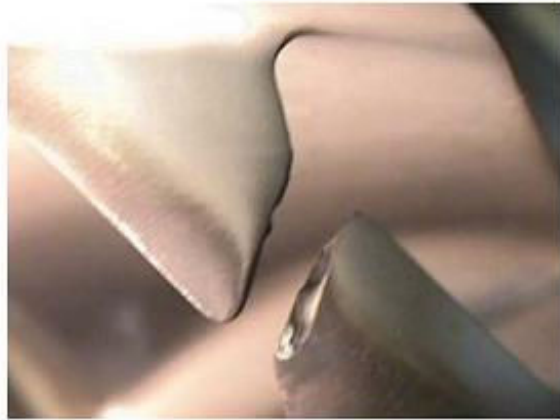
Irregular Hollowing

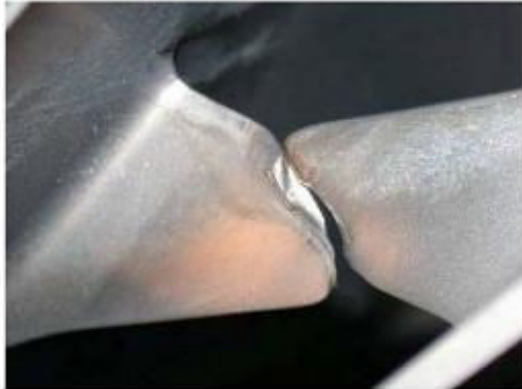
Irregular and Stepped

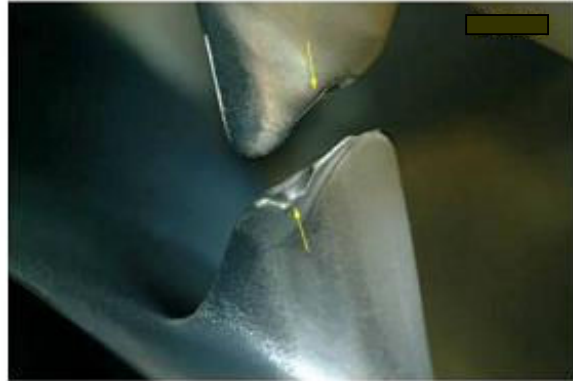
Irregular and Stepped

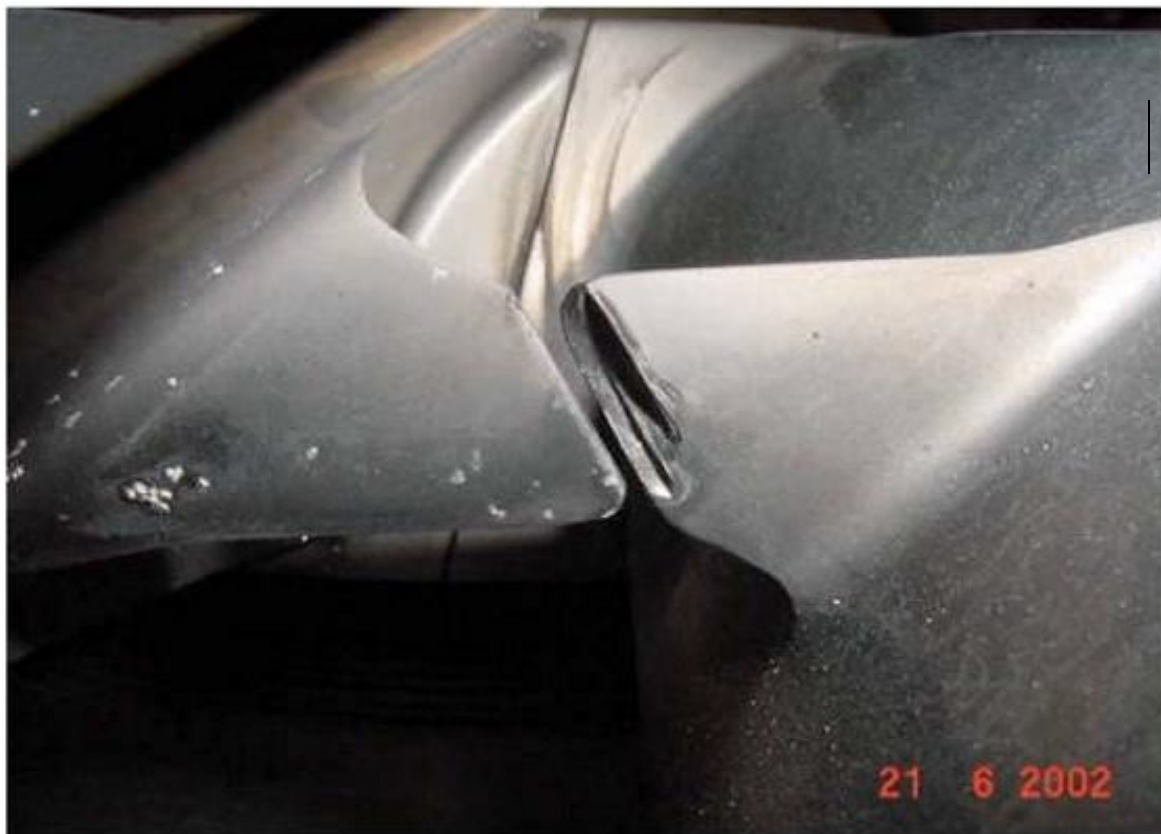
Aligned Stepped Wear

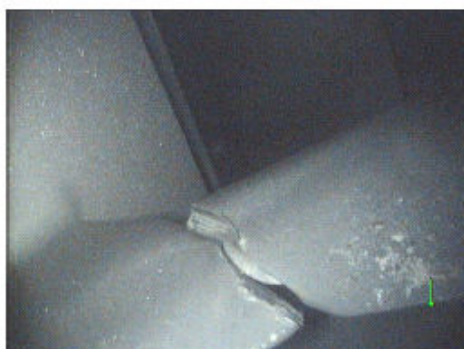
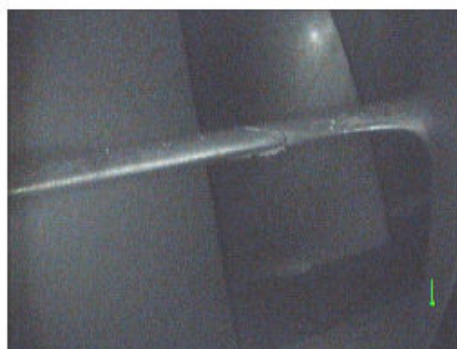
Advanced Aligned Irregular Wear to same pair of blades

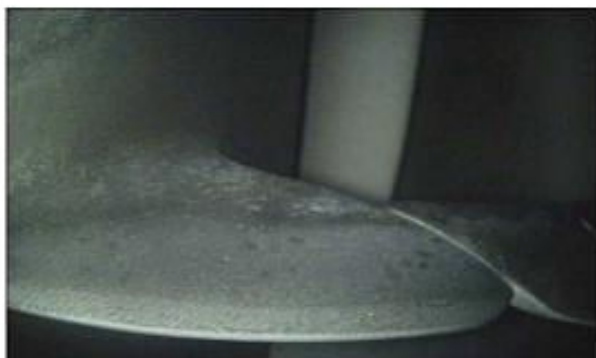
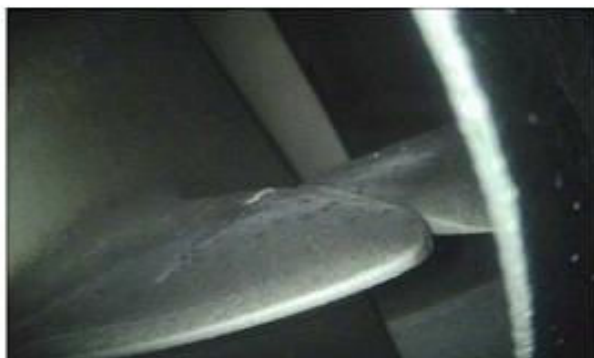
CLAPPERS WITH GOOD ALIGNMENT NO OBVIOUS WEAR

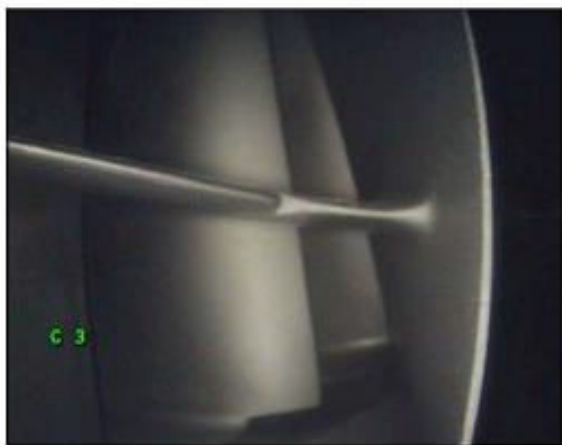
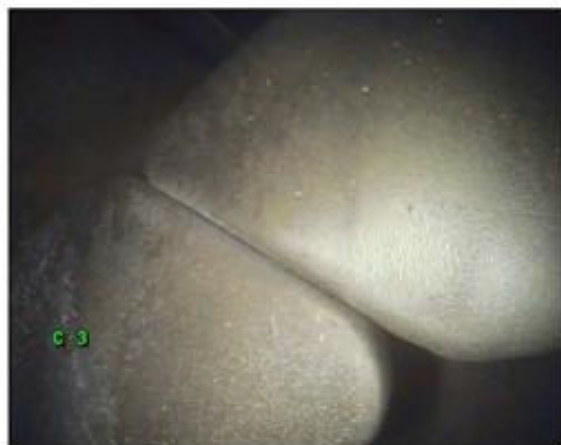
CLAPPERS WITH GOOD ALIGNMENT NO OBVIOUS WEAR

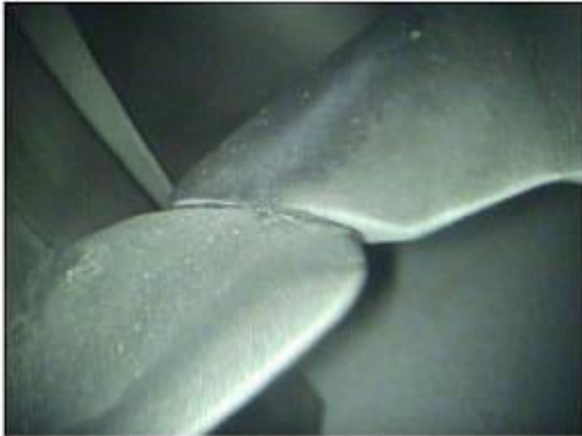
COULD BE HIDING
SOME WEAR REVIEW

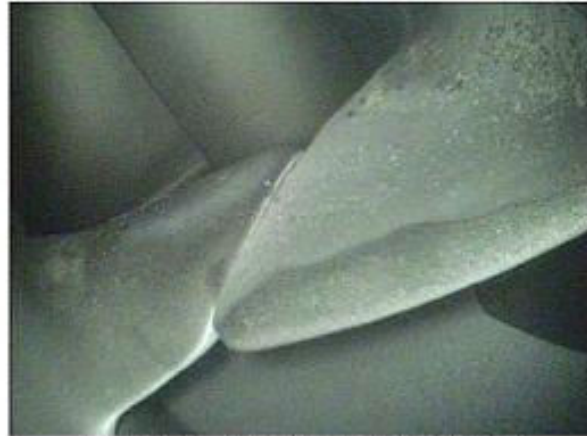
GOOD ALIGNMENT NO
OBVIOUS WEAR

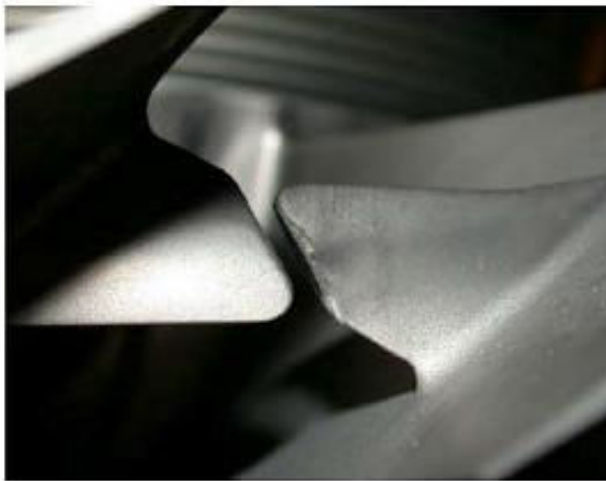
Normal

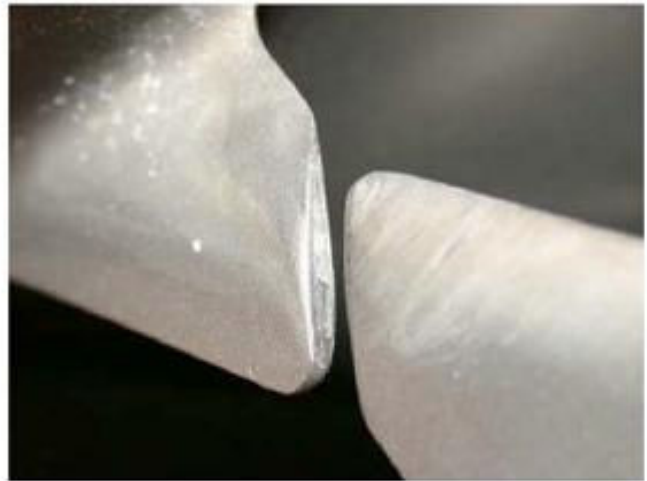
Normal

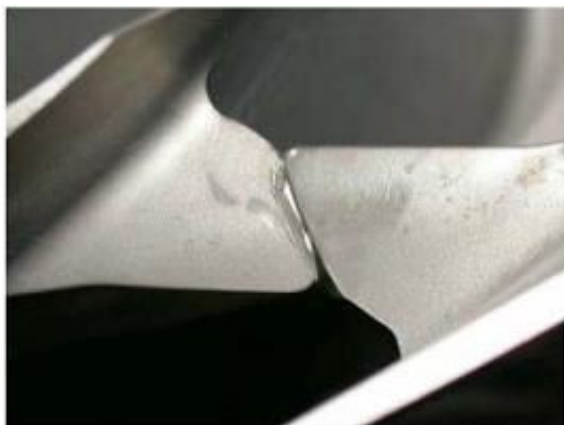
Aligned Wear

Wear evident on the clapper faces is vertical (no step evident)

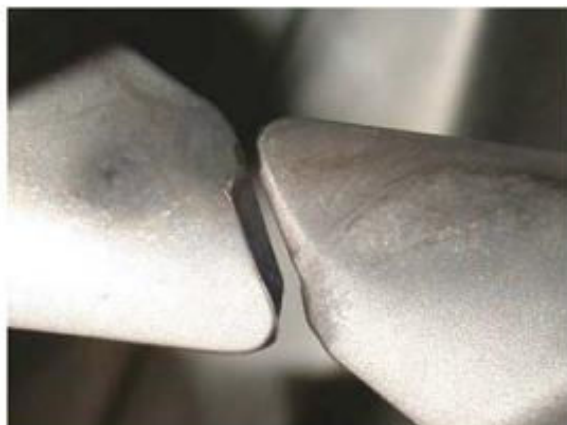
Aligned Wear

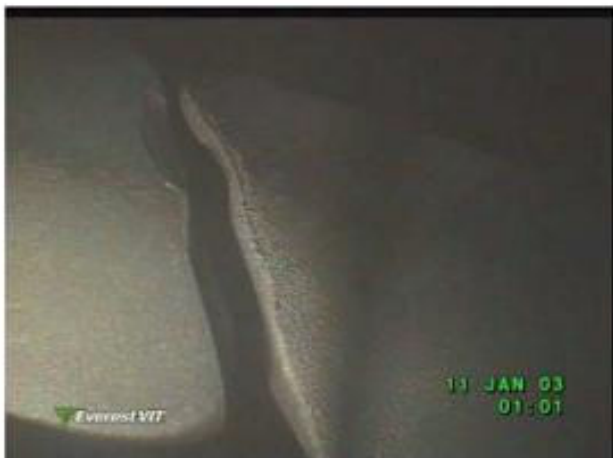
Irregular

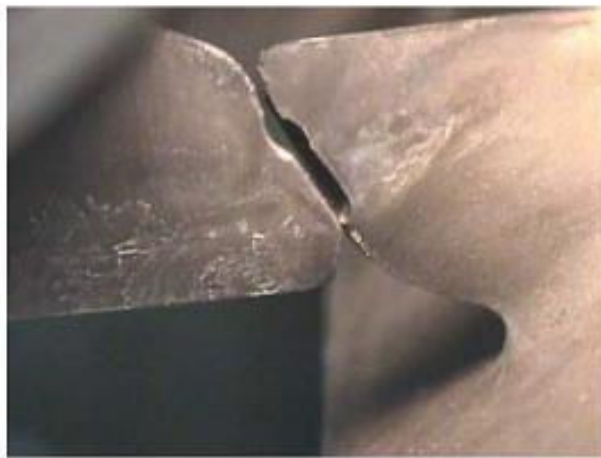
Irregular With Material Missing

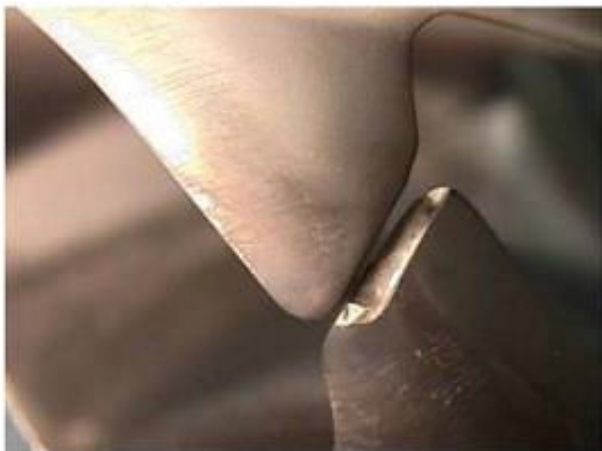
Aligned Wear

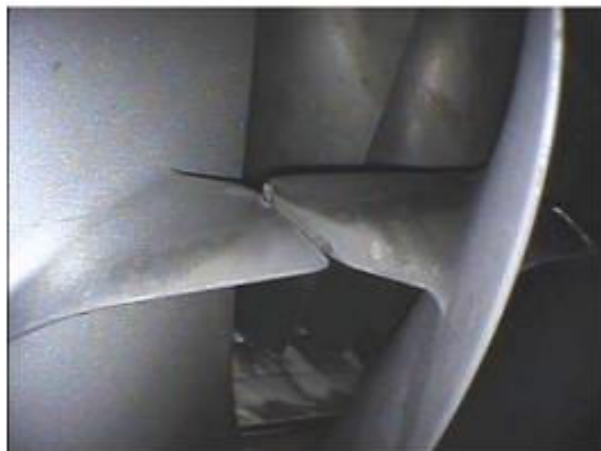
Aligned, some irregular wear

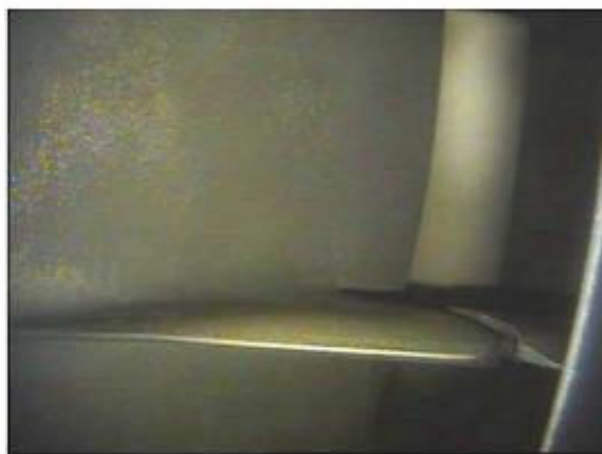
Aligned Vertical wear

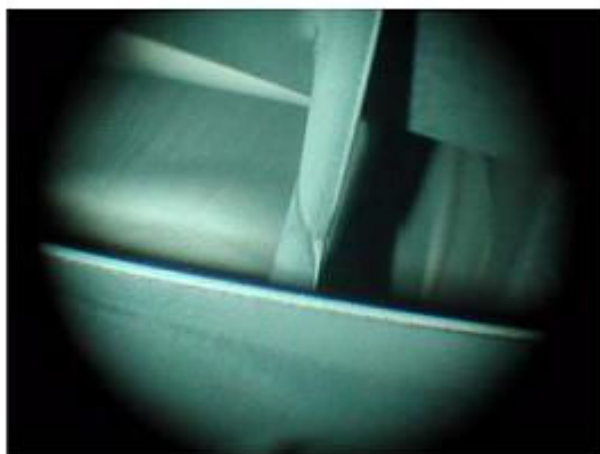
Aligned

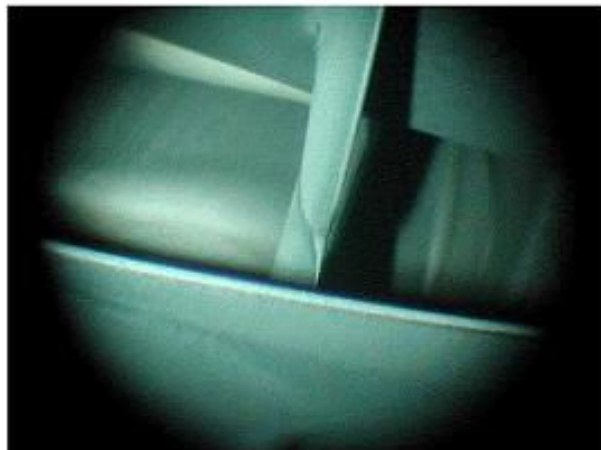
Aligned

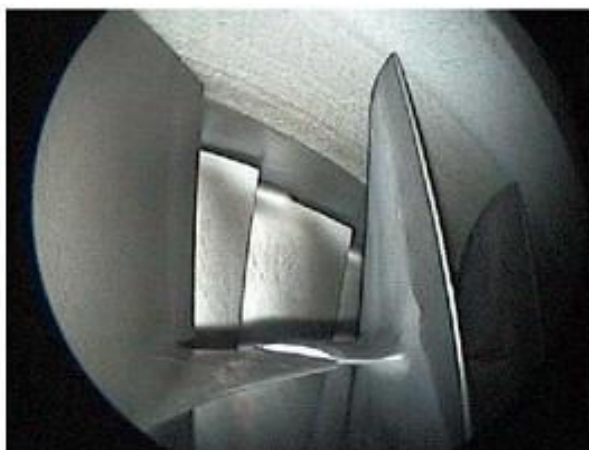
50% Aligned

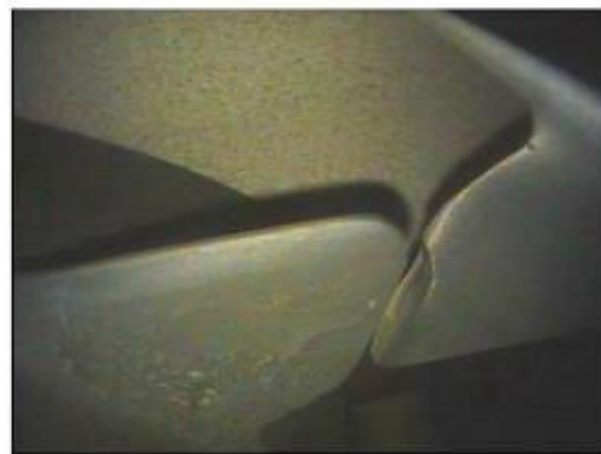
Aligned 100% face Wear

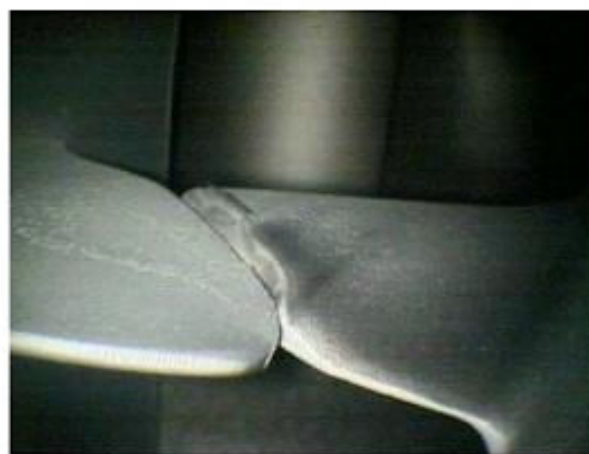
Aligned irregular Wear

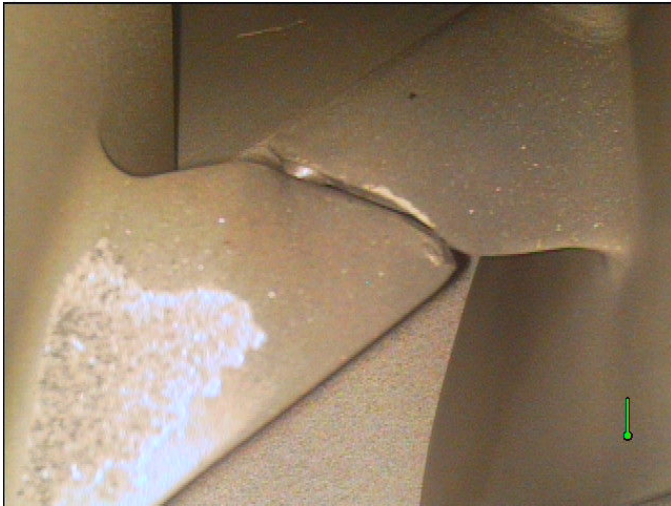
Aligned Irregular Wear

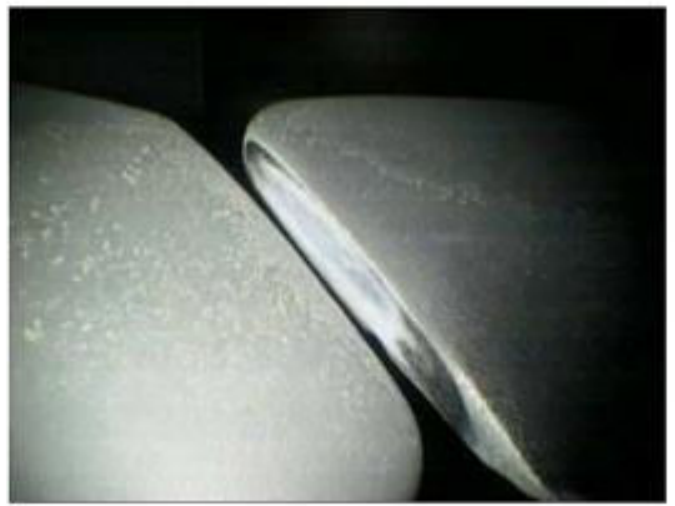
Aligned Hollowing of Face
