V2500-A1 SERIES PROPULSION SYSTEMS SERVICE BULLETIN

V2500-ENG-72-0548
Transmittal - Page 1 of 2

ENGINE - PROVIDE NEW SECOND STAGE TURBINE AIR SEAL

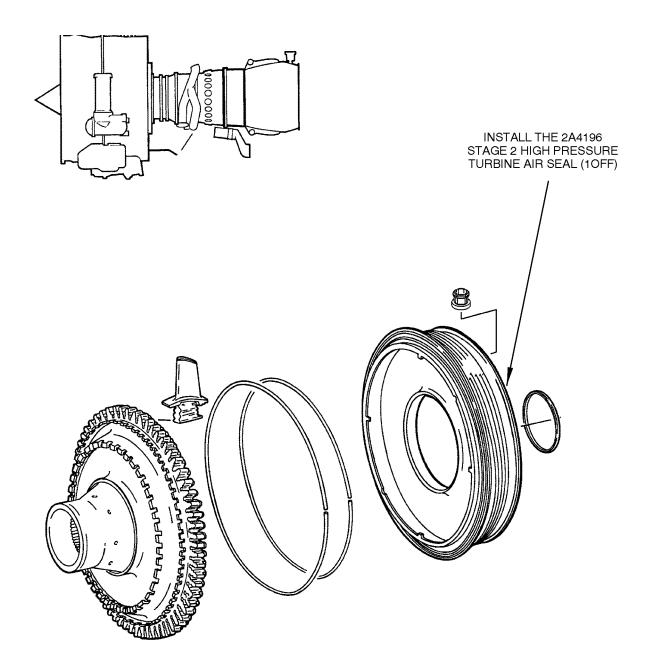
LOCATION OF THE STAGE 2 HIGH PRESSURE TURBINE AIR SEALS FIGURE 1

V2500-A1 Second Stage High Turbine Air Seal is experiencing cracking in the field. The fleet is being managed by a fleet management plan which includes vibration monitoring and replacing the seal per Reference (17) Service Bulletin No. V2500-ENG-72-0500, Reference (18) Service Bulletin No. V2500-ENG-72-0501 and Reference (19) Service Bulletin No. V2500-ENG-72-0502.

Root cause investigation has indicated hot gas path air is ingested into the Second Stage High Turbine Seal cavity, which increases stress in the region of the fillet where the cracking occurs. Decreasing the 2nd Vane Cluster Honey-comb Segment pretrench will reduce the amount of ingestion. This Service Bulletin redesigns the A1 2nd Stage High Turbine Seal by adding a compound radius in the fillet and increasing the forward flange thickness to reduce stress and redesign the 2nd Vane Cluster Segment to eliminate the honey-comb pretrench.

(1) Provide new Second Stage Turbine Air Seal. See Figure 1.

- (4) Disassemble per Reference (23) Engine Manual, Chapter/Section 72-45-00-030-001.
- (5) Discard Seal-Air Turbine Assy, 2 Stage PN 2A1160 or PN 2A3108 or PN 2A0487 or PN 2A3185 and replace with PN 2A4196.
