NON — MODIFICATION SERVICE BULLETIN — BORESCOPE INSPECTION OF HIGH PRESSURE TURBINE (HPT) STAGE 1 DUCT SEGMENTS

Turbojet Engine Service Bulletin No. V2500-ENG-72-0557 Revision No. 1 dated August 12, 2014.

V2500-ENG-72-0557

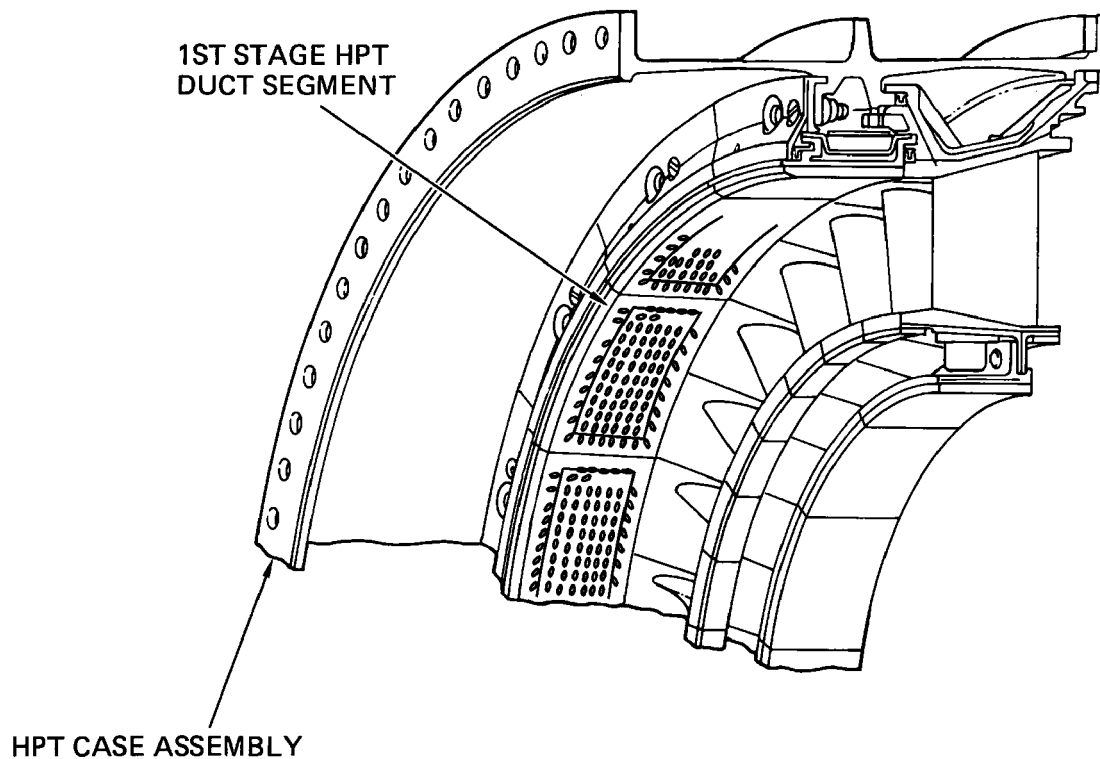
STAGE 1 HPT DUCT SEGMENT INSPECTION LOCATIONS
Appendix F

Condition	300-hr inspection	125-hr inspection	Pull in 10 cycles
Cracking Axial	< 0.5 in. (12,7 mm) (individual crack)	≥ 0.5 in. (12,7 mm) or < 1.20 in. (30,5 mm) (Area 1, Area 2 or Area 1 and 2 combined)	≥ 1.20 in. (30,5 mm) (Area 1, Area 2 or Area 1 and 2 combined)
Cracking Circumferential	< 0.5 in. (12,7 mm) (individual crack)	≥ 0.5 in. (12,7 mm) or < 1.50 in. (38,1 mm) (Area 1, Area 2 or Area 1 and 2 combined)	≥ 1.50 in. (38,1 mm) (Area 1, Area 2 or Area 1 and 2 combined)
Burning/Erosion of base metal Area 1 (No Burn Through)	Any Amount	Does Not Apply	Does Not Apply
Burning/Erosion of base metal Area 2 (No Burn Through)	Shiplap burning up to 2nd row of cooling holes	Shiplap burning beyond 2nd row of cooling holes	Does Not Apply
Burn Through Area 1 & 2	Does Not Apply	< 0.5 in. (12,7 mm) of continuous burn through (Area 1, Area 2 or Area 1 and 2 combined)	≥ 0.5 in. (12,7 mm) of continuous burn through (Area 1, Area 2 or Area 1 and 2 combined)

Burn Through Impingement Plate	Does Not Apply	Does Not Apply	Any Amount
Lifting of LE Material	Does Not Apply	Does Not Apply	Lifting of Seal Edge
Loss of LE Material	< 0.3 in. (7,6 mm)	≥ 0.3 in. (7,6 mm) or < 0.5 in. (12,7 mm)	≥ 0.5 in. (12,7 mm)

Any crack greater than 0.5 in. (12,7 mm) over the cooling pocket is considered a burn through.
