V2500-A1/A5/D5 SERIES PROPULSION SYSTEMS SERVICE BULLETIN

V2500-ENG-72-0568
Transmittal - Page 1 of 1

ENGINE – SEAL ASSEMBLY, NO. 3 BEARING – REPLACEMENT OF THE CARBON SEAL FOR IMPROVED
DURABILITY

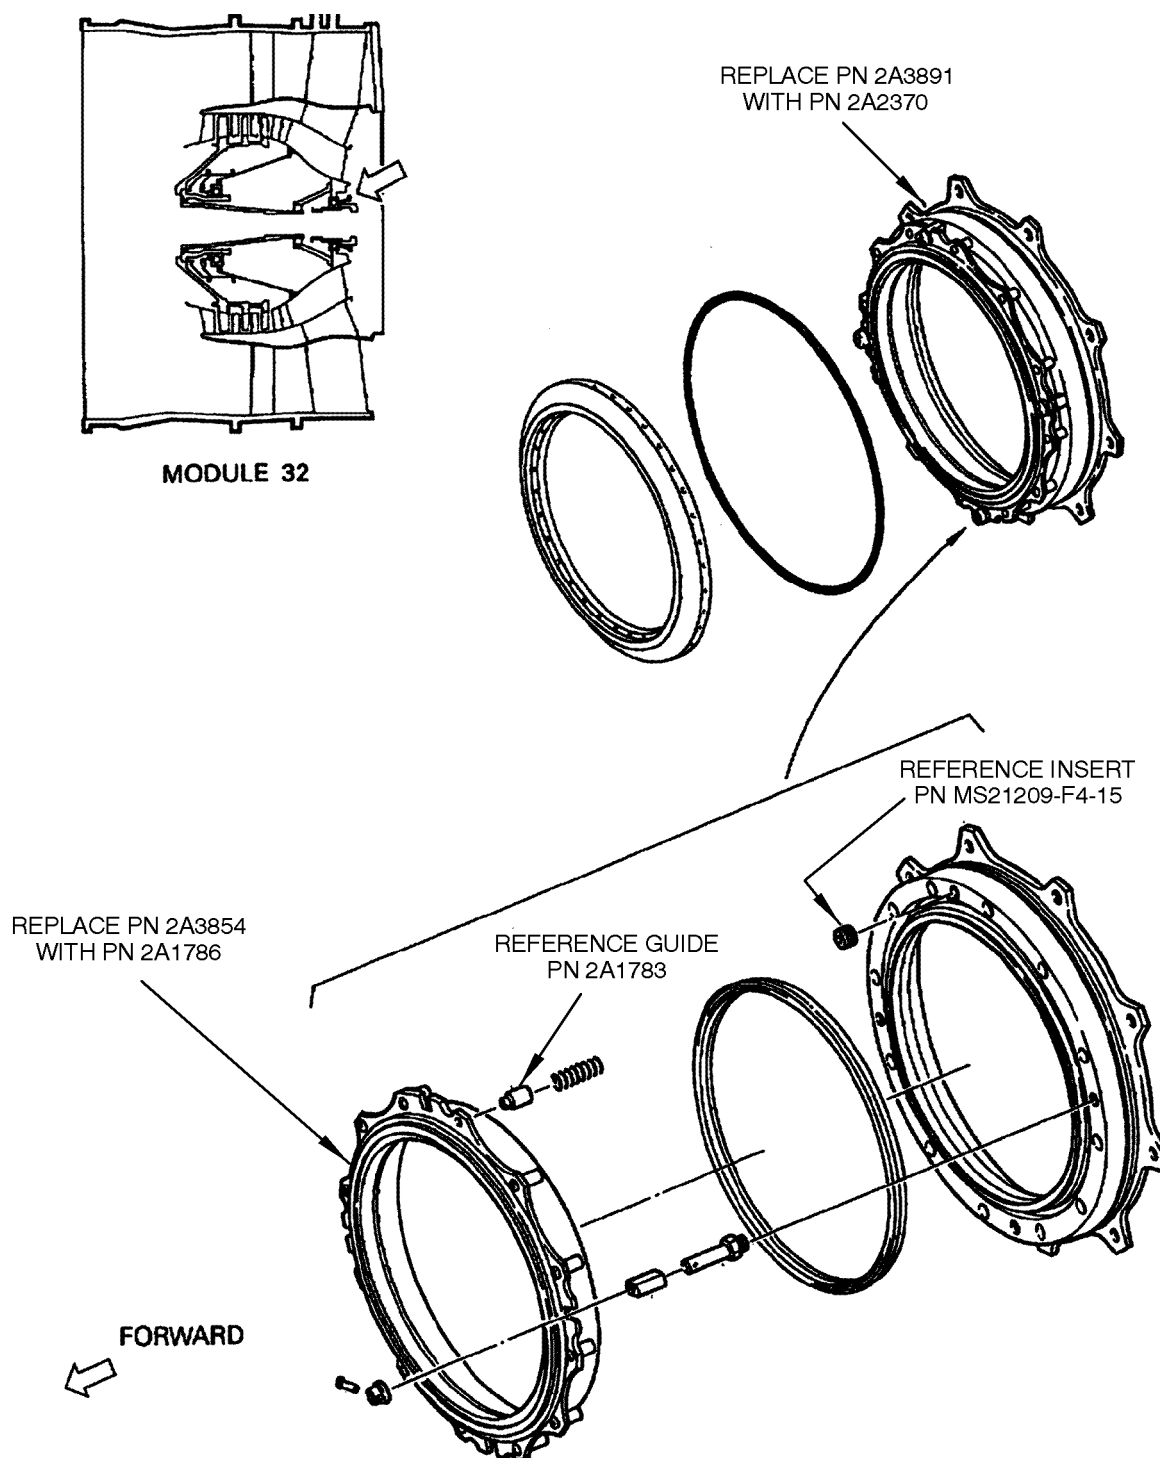
NO. 3 BEARING REAR OIL SEAL ASSEMBLY
FIGURE 1

Review of service experience of No. 3 carbon seal exhibits the potential to experience a higher wear rate of seal material than predicted.

To date there have been no service events associated with seal wear. However, higher wear rate has been observed on the current carbon seal than on prior configuration carbon seal.

Replace the current No. 3 Bearing Seal Assembly with the prior configuration.

- (1) Remove the No. 3 bearing seal assembly from the front bearing compartment per:
 - (a) V2500-A1 Pre Service Bulletin ENG-72-0132 Engine Manual Subtask 72-32-20-040-052-A00.
 - (b) V2500-A1 Post Service Bulletin ENG-72-0132 Engine Manual Subtask 72-32-20-040-052-B00.
 - (c) V2500-A5 Service Bulletin ENG-72-0132 Engine Manual Subtask 72-32-20-040-052-C00.
 - (d) V2500-D5 Engine Manual Task 72-32-20-040-001, Subtask 72-32-20-040-052.
- (2) Disassemble the No. 3 bearing seal assembly per Engine Manual Subtask 72-32-25-040-051.
- (3) Replace the No. 3 bearing seal carbon detail per Engine Manual Task 72-32-25-300-007.
