V2500-A5/D5 SERIES PROPULSION SYSTEM SERVICE BULLETIN

This document transmits the Initial Issue of Service Bulletin V2500-ENG-72-0569

INFORMATION – ENGINE – PROVIDE A NEW NO. 3 BEARING1. Planning InformationA. Effectivity

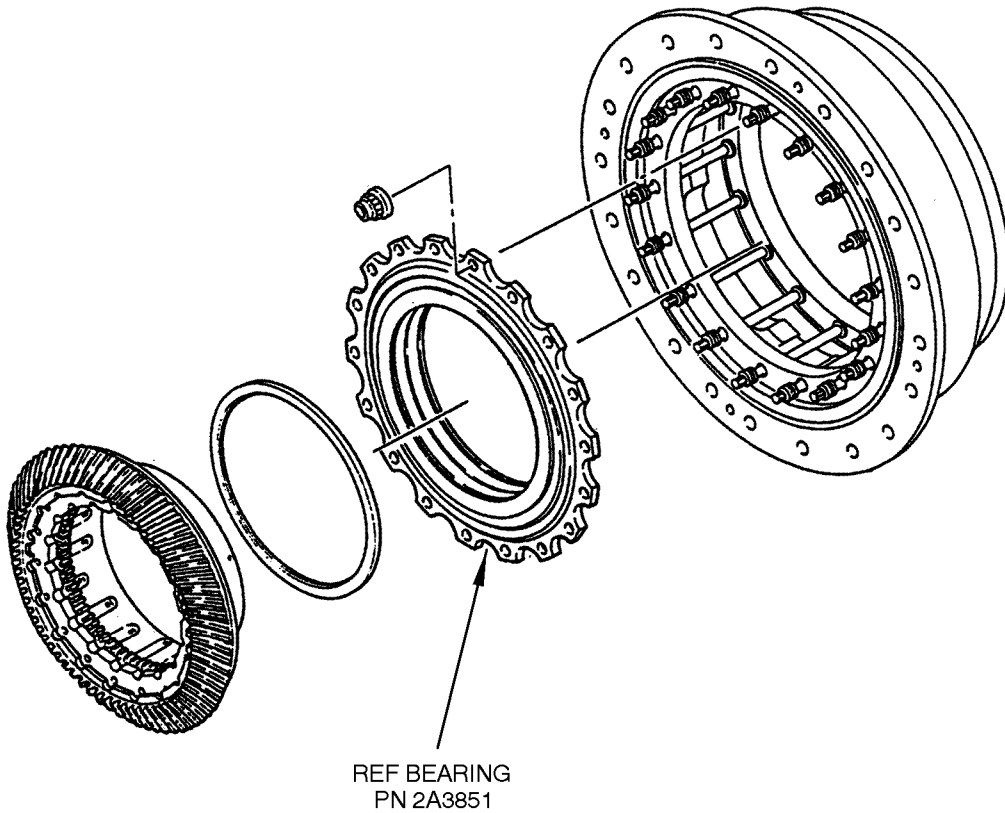
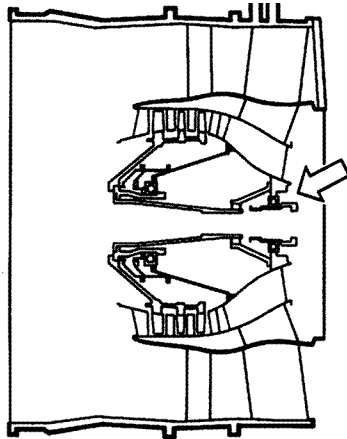
Engine - No. 3 Bearing
Figure 1

V2500-A5/D5 No. 3 bearing outer race distress. Opportunity exists to introduce a more fracture-resistant outer race material, resulting in improved detection of distress and a slower progression rate of fracture.

The V2500 No. 3 bearing has experienced occasional outer ring fracture events which results in increased engine repair costs.

Introduce new No. 3 bearing, P/N 2A3851, as an alternate bearing for current MRC No. 3 bearing P/N 2A1170 and FAG No.3 bearing P/N 2A4022. This bearing material change provides product improvement to decrease post-spall (distress) progression rate and improve resistance to crack propagation of outer ring in the event of distress.

Provide a new No. 3 bearing as an alternate to P/N 2A1170 and P/N 2A4022.
