V2500-A5 SERIES PROPULSION SYSTEM SERVICE BULLETIN

V2500-ENG-72-0576

ENGINE – TURBINE NOZZLE – PROVIDE A SELECTONE NEW HIGH PRESSURE TURBINE (HPT) 1ST
STAGE VANE ASSEMBLY –

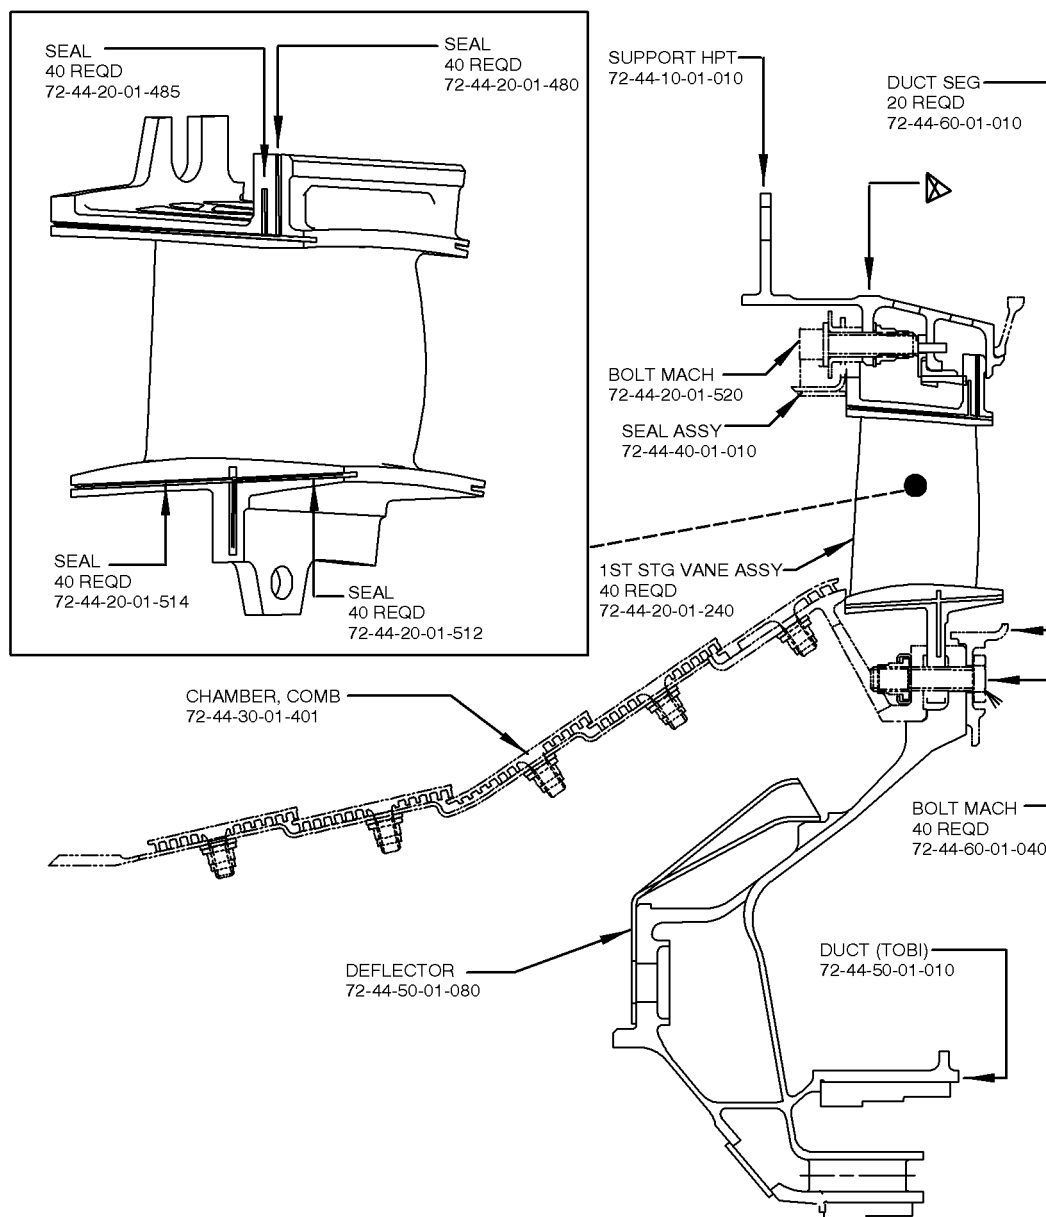
LOCATION OF STAGE 1 HIGH PRESSURE TURBINE VANE ASSEMBLY
FIGURE 1

HPT 1st Vane outer platform cracking adjacent to the feather seal slots.

The SelectOne endurance engine V12723 experienced some HPT 1st Vane outer platform cracking adjacent to the feather seal slots.

Provide a new HPT 1st Vane to minimize outer platform cracks adjacent to the feather seal.
