V2500-A1/A5/D5 SERIES PROPULSION SYSTEM NON-MODIFICATION SERVICE BULLETIN

V2500-ENG-72-0580

NON-MODIFICATION SERVICE BULLETIN – BORESCOPE INSPECTION OF HIGH PRESSURE TURBINE
(HPT) STAGE 1 DUCT SEGMENTS

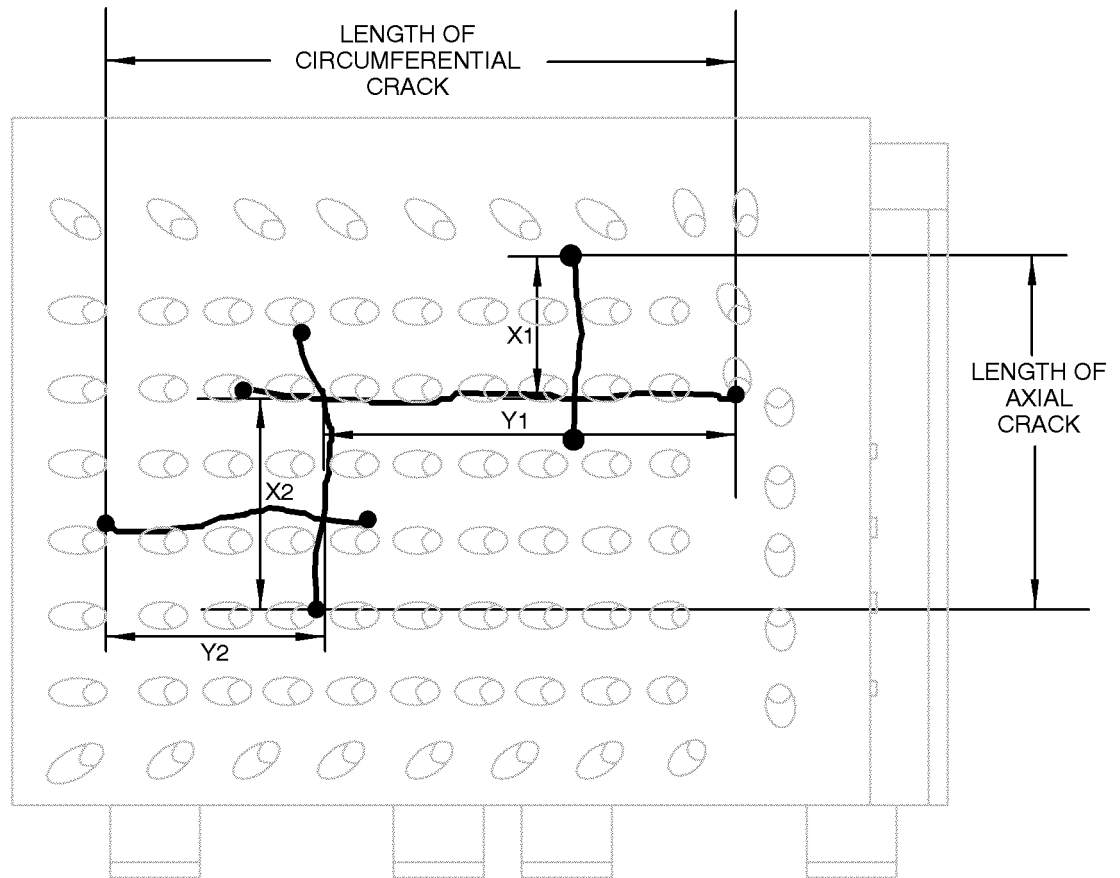
STAGE 1 BOAS PLATFORM – INTERSECTING CRACKS
Appendix D (Sheet 4 of 9)

One or more axial or circumferential cracks that intersect each other. See Sheets 4, 5 and 6.

LENGTH OF AXIAL CRACK = $X1 + X2$

LENGTH OF CIRCUMFERENTIAL CRACK = $Y1 + Y2$

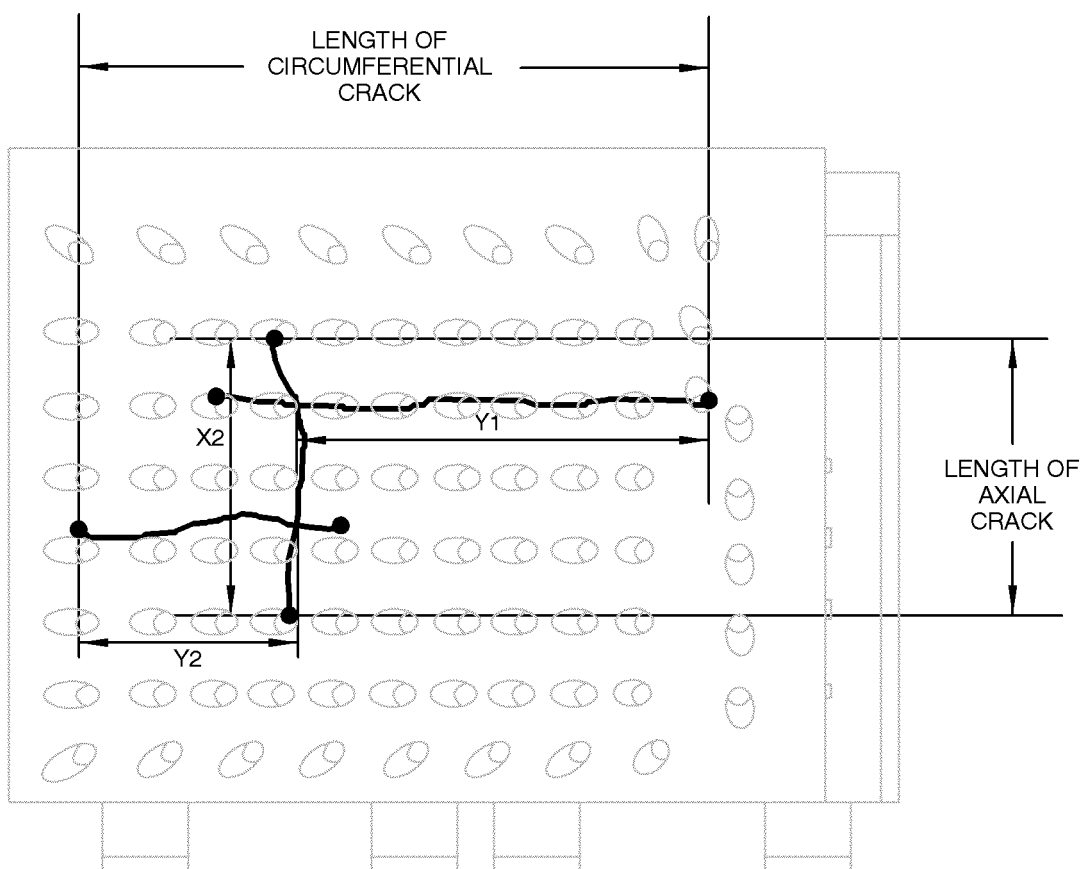
STAGE 1 BOAS PLATFORM – INTERSECTING CRACKS
Appendix D (Sheet 5 of 9)

LENGTH OF AXIAL CRACK = X2

LENGTH OF CIRCUMFERENTIAL CRACK = Y1 + Y2

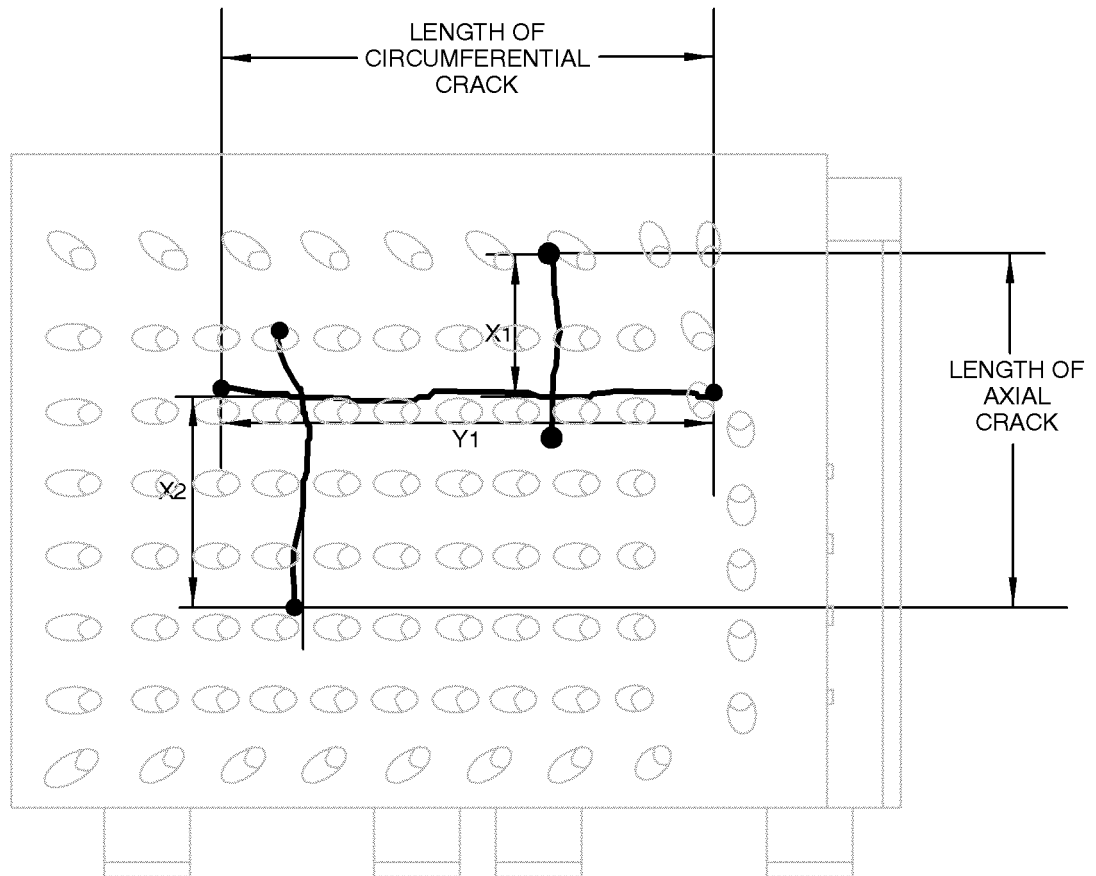
STAGE 1 BOAS PLATFORM – INTERSECTING CRACKS
Appendix D (Sheet 6 of 9)

LENGTH OF AXIAL CRACK = $X1 + X2$

LENGTH OF CIRCUMFERENTIAL CRACK = $Y1$

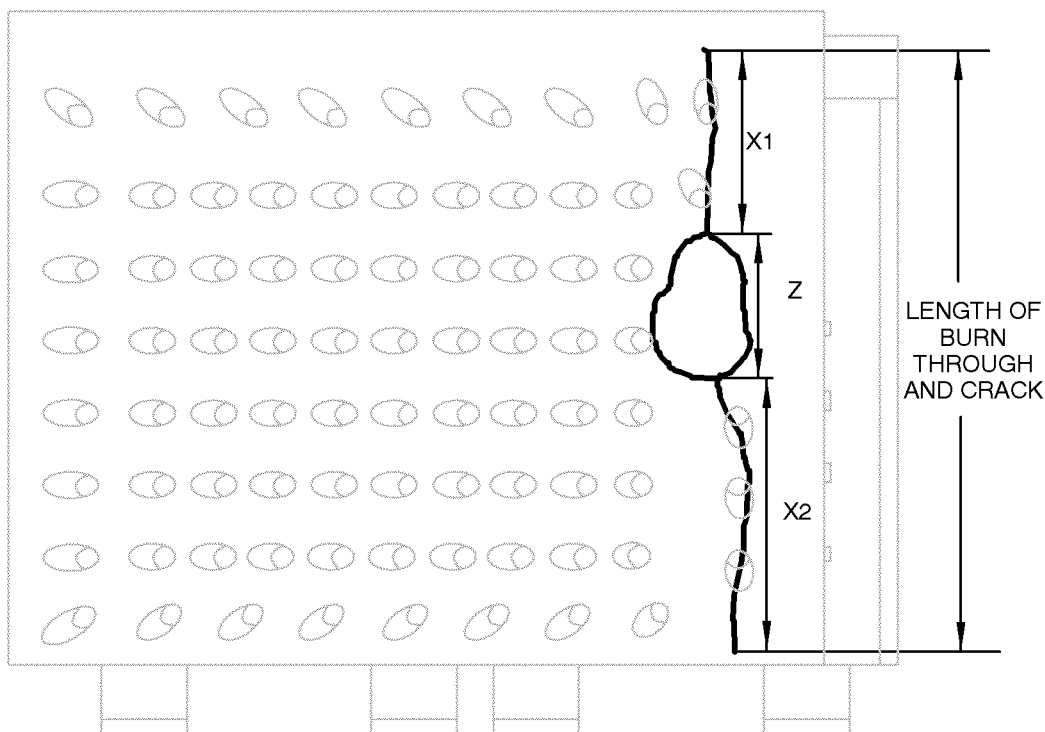
STAGE 1 BOAS PLATFORM – BURN THROUGH WITH ADJOINING CRACKS IN AXIAL DIRECTION
Appendix D (Sheet 7 of 9)

TOTAL LENGTH = $X1 + X2 + Z$

LENGTH OF BURN THROUGH = Z

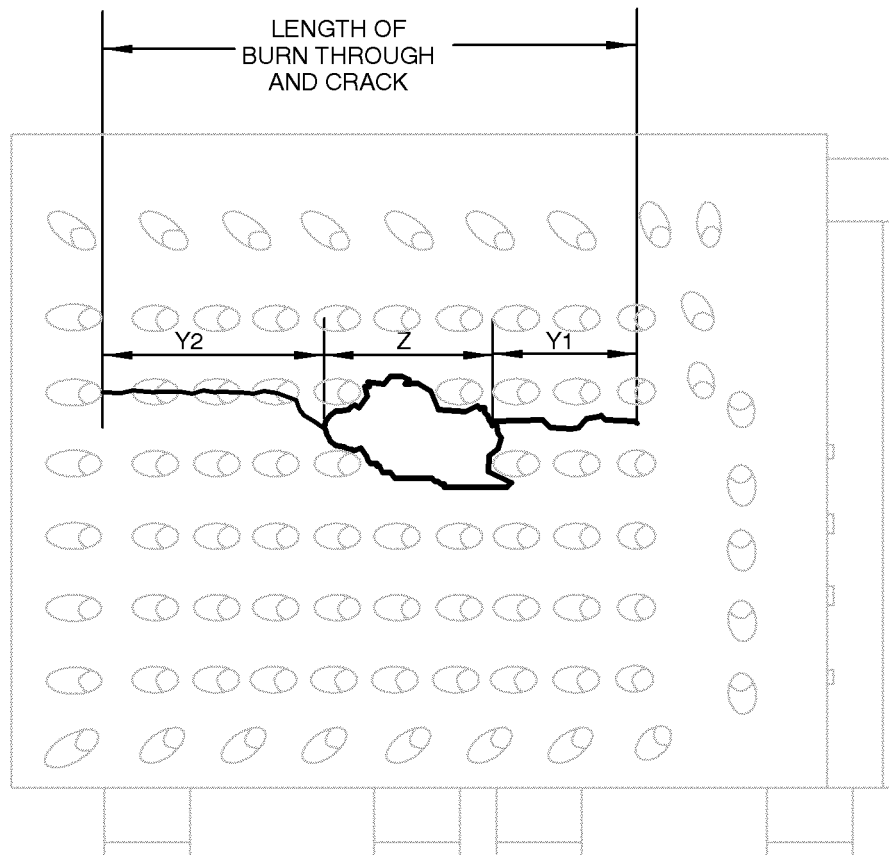
STAGE 1 BOAS PLATFORM – BURN THROUGH WITH ADJOINING CRACKS IN CIRCUMFERENTIAL DIRECTION

Burn through with adjoining cracks in the circumferential direction *See Sheet 8	Does Not Apply	Combined length of Y1+Y2+Z less than 1.500 in. (38,10 mm) and Z less than 0.500 in. (12,70 mm) in Area 1, Area 2 or Areas 1 and 2 together	Combined length of Y1+Y2+Z more than or equal to 1.500 in. (38,10 mm) or Z more than or equal to 0.500 in. (12,70 mm) in Area 1, Area 2 or Areas 1 and 2 together
Burn Through Impingement Plate	Does Not Apply	Does Not Apply	Any Amount
Lifting of LE Material	Does Not Apply	Does Not Apply	Lifting of Seal Edge
Loss of LE Material	Less than 0.300 in. (7,62 mm)	0.300 in. (7,62 mm) or more, but less than 0.500 in. (12,70 mm)	0.500 in. (12,70 mm) or more

TOTAL LENGTH = $Y1 + Y2 + Z$

LENGTH OF BURN THROUGH = Z

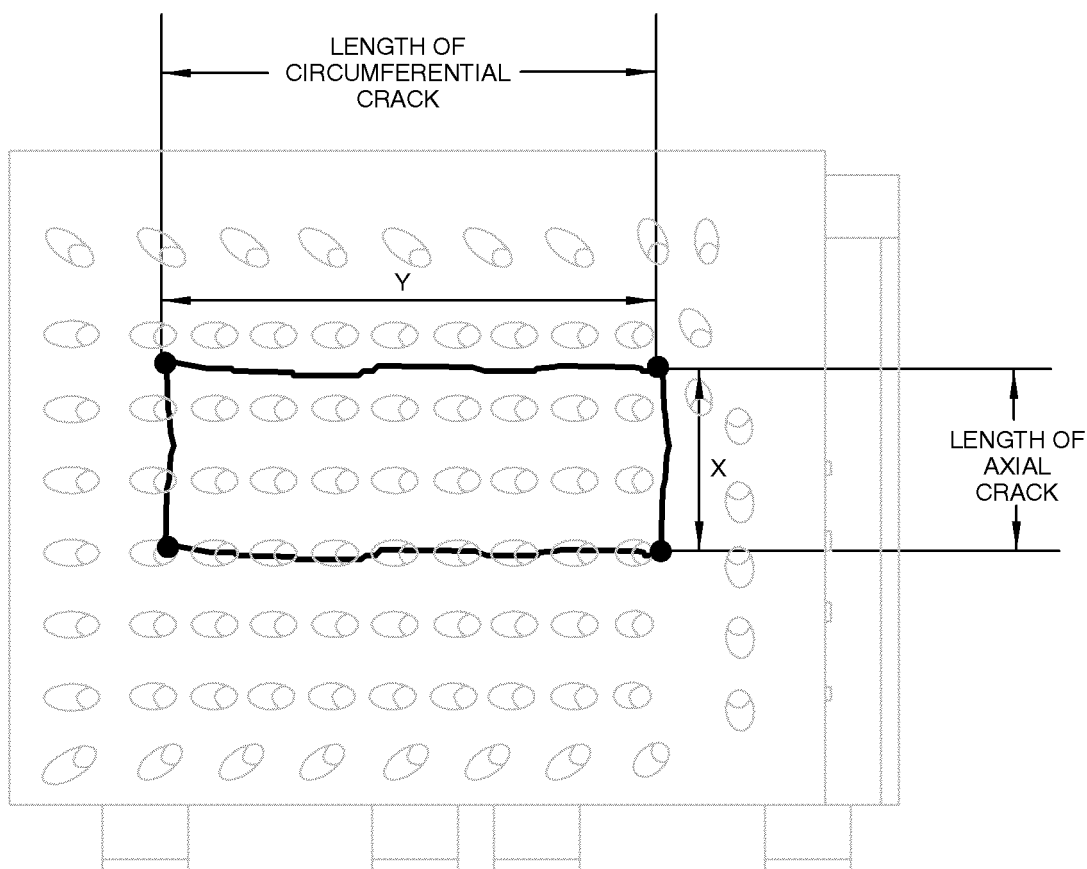
STAGE 1 BOAS PLATFORM – CLOSED LOOP OF CRACKS
Appendix D (Sheet 9 of 9)

Closed loop of cracks * See Sheet 9	Does Not Apply	Maximum length in X or Y direction less than 0.500 in. (12,70 mm)	Maximum length in X or Y direction more than or equal to 0.500 in. (12,70 mm)
Burning/ Erosion of base metal Area 1 (No Burn Through)	Any amount greater than two connecting cooling holes	Does Not Apply	Does Not Apply
Burning/ Erosion of base metal Area 2 (No Burn Through)	Shiplap burning greater than the 1st row of cooling holes and up to 2nd row of cooling holes	Shiplap burning beyond 2nd row of cooling holes	Does Not Apply
Burn Through Area 1 and 2	Does Not Apply	Less than 0.500 in. (12,70 mm) of continuous burn-through in Area 1, Area 2 or Areas 1 and 2 together	0.500 in. (12,70 mm) or more of continuous burn-through in Area 1, Area 2, or Areas 1 and 2 together
Burn through with adjoining cracks in the axial direction * See Sheet 7	Does Not Apply	Combined length of X1+X2+Z less than 1.200 in. (30,48 mm) and Z less than 0.500 in. (12,70 mm) in Area 1, Area 2 or Areas 1 and 2 together	Combined length of X1+X2+Z more than or equal to 1.200 in. (30,48 mm) or Z more than or equal to 0.500 in. (12,70 mm) in Area 1, Area 2 or Areas 1 and 2 together

Adjoining cracks that close in on themselves. See Sheet 9.

NOTE: Individual crack limits still apply to a closed loop of cracks.

LENGTH OF AXIAL CRACK = X

LENGTH OF CIRCUMFERENTIAL CRACK = Y

NOTE: IN THIS EXAMPLE, MAXIMUM LENGTH IS Y, BECAUSE THE CIRCUMFERENTIAL CRACK IS LONGER THAN THE AXIAL CRACK.
