## V2500-A5/D5 SERIES PROPULSION SYSTEM NON-MODIFICATION SERVICE BULLETIN

# V2500-ENG-72-0585

NON-MODIFICATION SERVICE BULLETIN – ENGINE – HP COMPRESSOR BLADES - INSPECTION  
OF THE HPC STAGE 5 ROTOR BLADE RETAINING PLATE SLOT

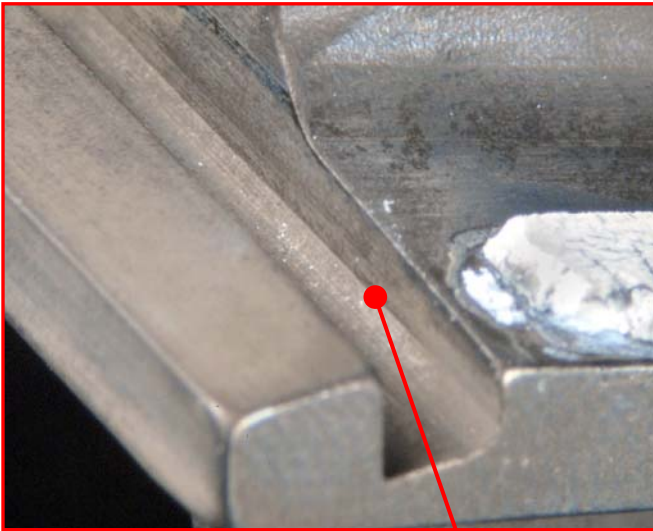
Two (2) HPC Stage 5 Rotor blade fractures have occurred in service. Investigation has revealed the blade fracture initiated from an abrupt transition in the retaining plate slot. A non-conforming tool induced the abrupt transition during blade manufacture. The investigation has shown that a number of blades manufactured using this tool were fitted during new production V2500-A5 HPC module build and also during V2500-A5 and V2500-D5 shop visits after 1<sup>st</sup> March 1997.

Figure 1 – Appearance of Abrupt Transition

- (a) Visually examine the retaining plate slot of the HPC stage 5 rotor blade with minimum 10x magnification.
- (b) Examine the Stage 5 Rotor Blade retaining plate slots for cracks.
- (c) Compare each blade to Figure 1 and Figure 2.
- (d) Reject any HP compressor stage 5 rotor blade with a crack or an abrupt transition in accordance with Figure 1.
- (e) If any blade is found cracked in the retaining plate slot, reject the whole set of HPC stage 5 rotor blades.
- (f) Quarantine the whole set of rejected HPC stage 5 blades and inform your local IAE office.

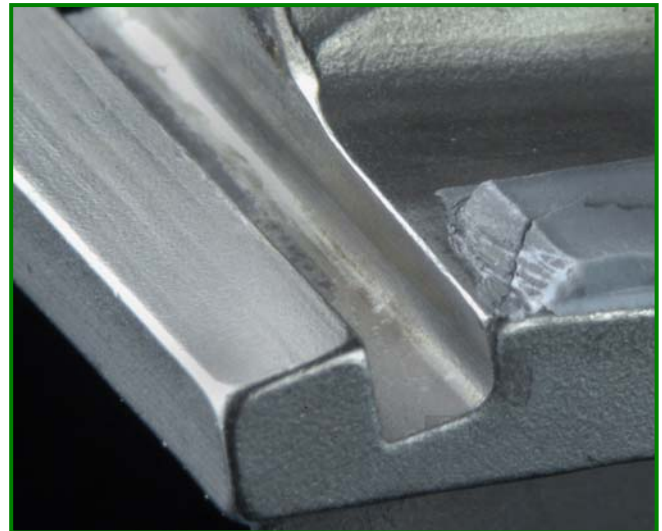
Figure 2 – Appearance of Nominal Slot

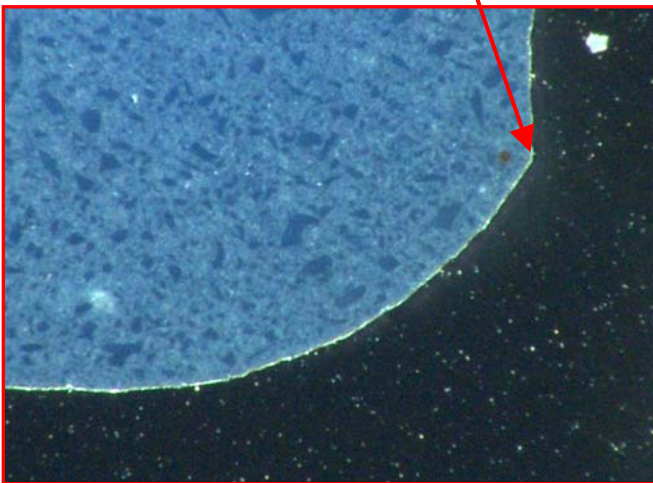
Figure 3 – Sectioned Replica of Abrupt Transition

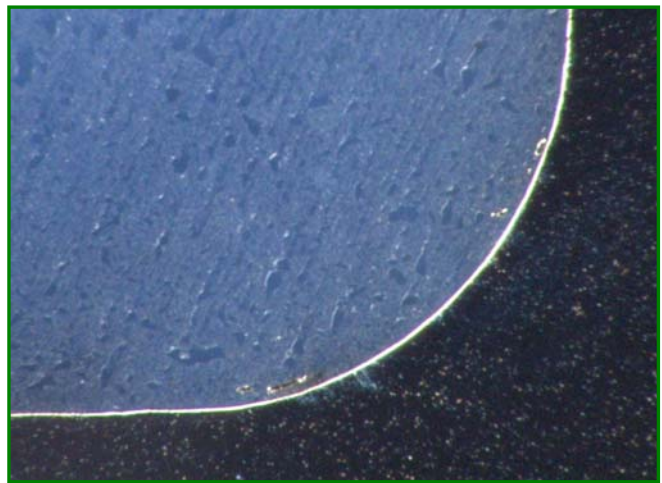
Figure 4 - Sectioned Replica of Nominal Slot

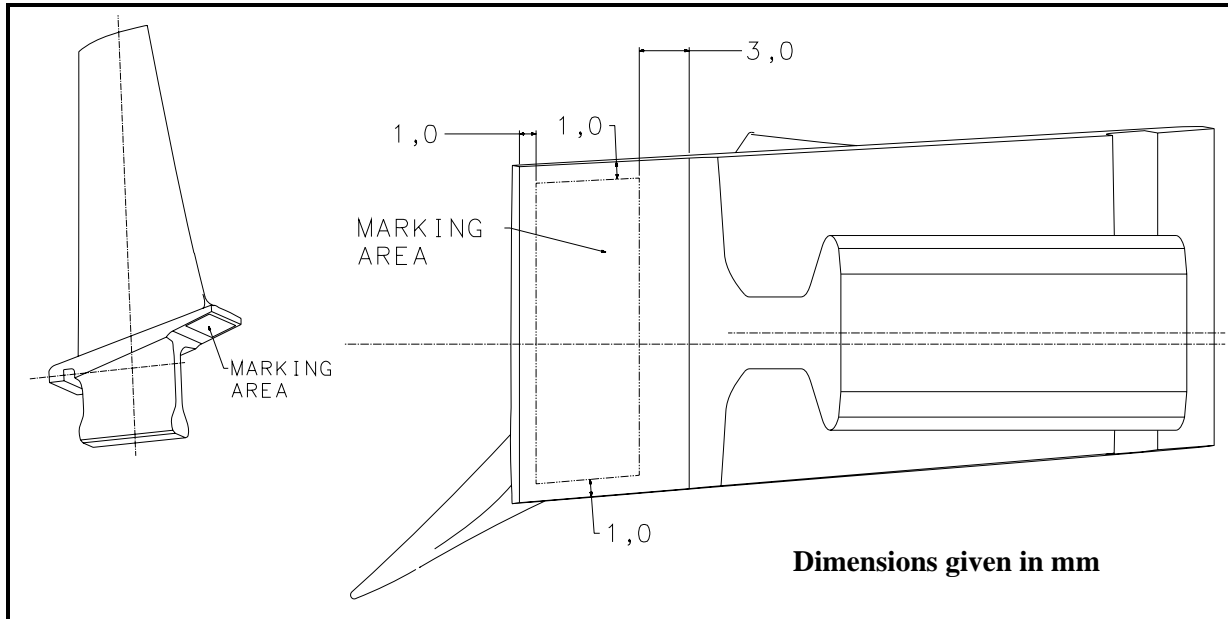
Figure 5 – Area Allocated for Part Marking (N 585)

- (b) Identify the inspected HP compressor stage 5 blades (Refer to the Standard Practices/Processes Manual, Chapter 70-09-00).
- (c) Vibro peen 'N 585' on each HPC stage 5 rotor blade that passed inspection in 3.E(1), 3.E.(2) and 3.E.(3) in allocated area (Fig.5).

Note: Do not vibro peen outside the marking area.

Note: Any blade marked outside the marking area must be scrapped.
