V2500-A5/D5 SERIES PROPULSION SYSTEM NON-MODIFICATION SERVICE BULLETIN

V2500-ENG-72-0586

## NON-MODIFICATION SERVICE BULLETIN - ENGINE - HIGH PRESSURE (HP) COMPRESSOR BLADES - SAMPLING OF THE HP COMPRESSOR STAGE 5 ROTOR BLADE RETAINING PLATE SLOT

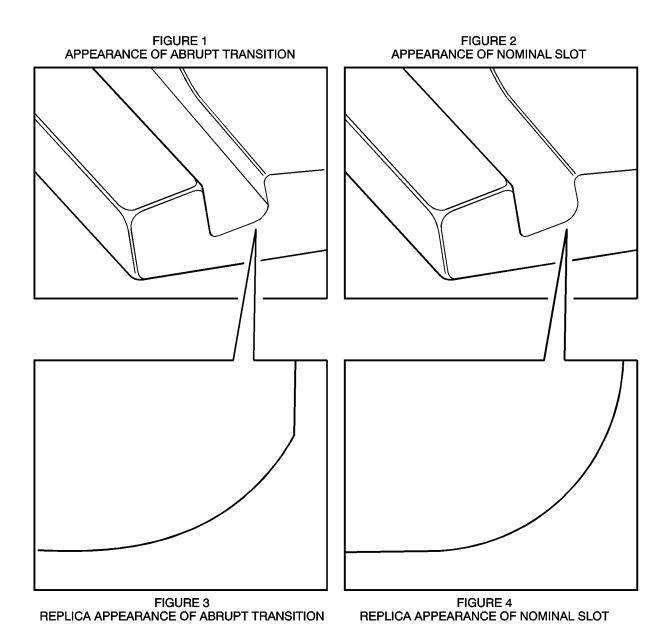
Figures 1, 2, 3 and 4

Two (2) HPC Stage 5 Rotor blade fractures have occurred in service. Investigation has revealed the blade fracture initiated from an abrupt transition in the retaining plate slot. A non-conforming tool induced the abrupt transition during blade manufacture. The investigation has shown that a number of blades manufactured using this tool were fitted during new production of V2500-A5 HPC module build and also during V2500-A5 and V2500-D5 shop visits after 1st March 1997.

- (b) Examine the Stage 5 Rotor Blade retaining plate slots for cracks.
  - (c) Compare each blade to Figure 1 and Figure 2.
  - (d) Reject any HP compressor stage 5 rotor blade with a crack or an abrupt transition in accordance with Figure 1.

- (e) If any blade is found cracked in the retaining plate slot, reject the whole set of HPC stage 5 rotor blades.
  - (f) If rejected, quarantine the whole set of rejected HPC stage 5 blades and inform your local IAE office.
