V2500-A1/A5/D5 SERIES PROPULSION SYSTEM SERVICE BULLETIN

This document transmits the Revision 1 of Service Bulletin V2500-ENG-72-0592.

ENGINE – TUBE, NO.4 BEARING ASSEMBLY PRESSURE – MODIFICATION TO PREVENT CRACKING OF
WELD REPAIRED PARTS

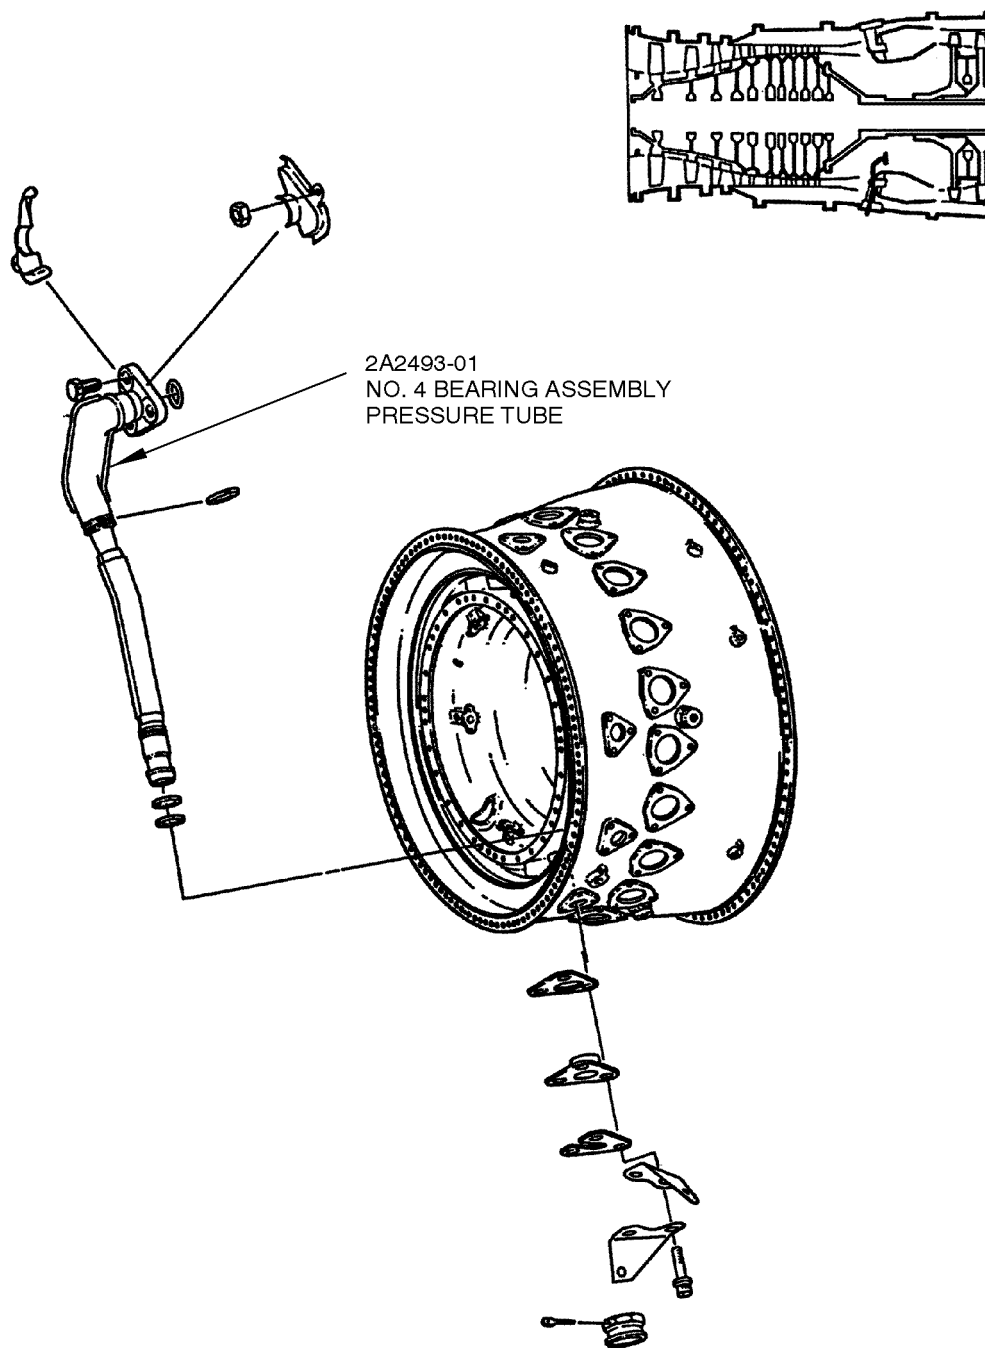
LOCATION OF THE NO.4 BEARING ASSEMBLY PRESSURE TUBE
72-42-20
FIGURE 1

(a) A V2500 engine experienced oil loss outside of the No.4 bearing compartment due to a crack in the No.4 oil pressure tube, resulting in oil ignition outside of the No.4 bearing compartment.

(a) Investigation determined the crack is attributed to the weld repair per VRS3642 of the upper seal land area performed during a previous shop visit. The subject repair, VRS3642, has been removed from the Engine Manual by a temporary revision. An existing alternate repair for the No.4 bearing pressure tube seal land area will still be available, VRS3728, which will replace the tube section. All tubes will either be repaired, if required, to VRS3728 or replaced new.

- (1) If you have a No.4 Bearing Assembly Pressure Tube, P/N 2A2493-01 that was previously repaired by Reference 3 or 4, Component Maintenance Manual, VRS3642 or if you have a No.4 Bearing Assembly Pressure Tube, P/N 2A2493-01 and it cannot be determined whether it has been repaired by Reference 3 or 4, Component Maintenance Manual, VRS3642, then do one of the procedures that follow. See Figure 1 for the location of the part.

- (a) Replace No.4 Bearing Assembly Pressure Tube, P/N 2A2493-01 with P/N 2A4256-01. Refer to the list that follows for old and new part numbers.

NOTE: The approved source will remove and replace two tube details, reidentify the No.4 bearing assembly pressure tube as P/N 2A4256-01 and return the No.4 bearing assembly pressure tube to you.
