V2500-A1 SERIES PROPULSION SYSTEMS SERVICE BULLETIN

This document transmits the Initial Issue of Service Bulletin V2500-ENG-72-0595.

ENGINE - LP COMPRESSOR - DELETION OF SCREENS OF THE LPC BLEED DUCT ASSEMBLY

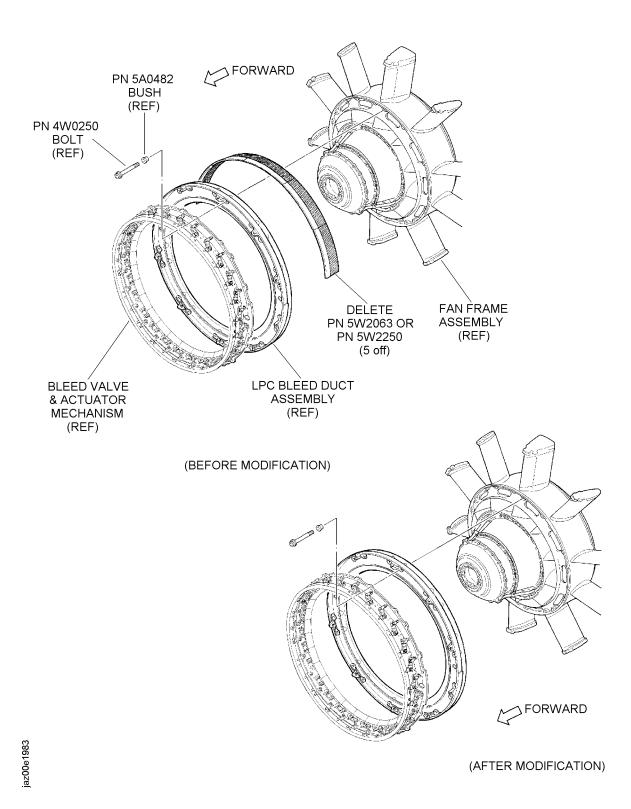
Screen Assembly of LPC Bleed Duct Assembly - Before and After Modification Figure 1

Material for the frame and mesh in the screen assembly on the V2500-A1 engine will not be available in the future. The original material is no longer available and while researching and testing alternatives, IAE found the screen was not necessary so IAE are deleting the part.

The screen assembly has been deleted.

Accomplish when supply of superseded parts has been depleted.
