**International Aero Engines
NON-MODIFICATION
SERVICE BULLETIN**

**NON-MODIFICATION SERVICE BULLETIN – ENGINE – HP COMPRESSOR BLADES -
INSPECTION OF THE HPC STAGE 8 LOCKING BLADE CORNER RADIUS**

V2500-ENG-72-0599

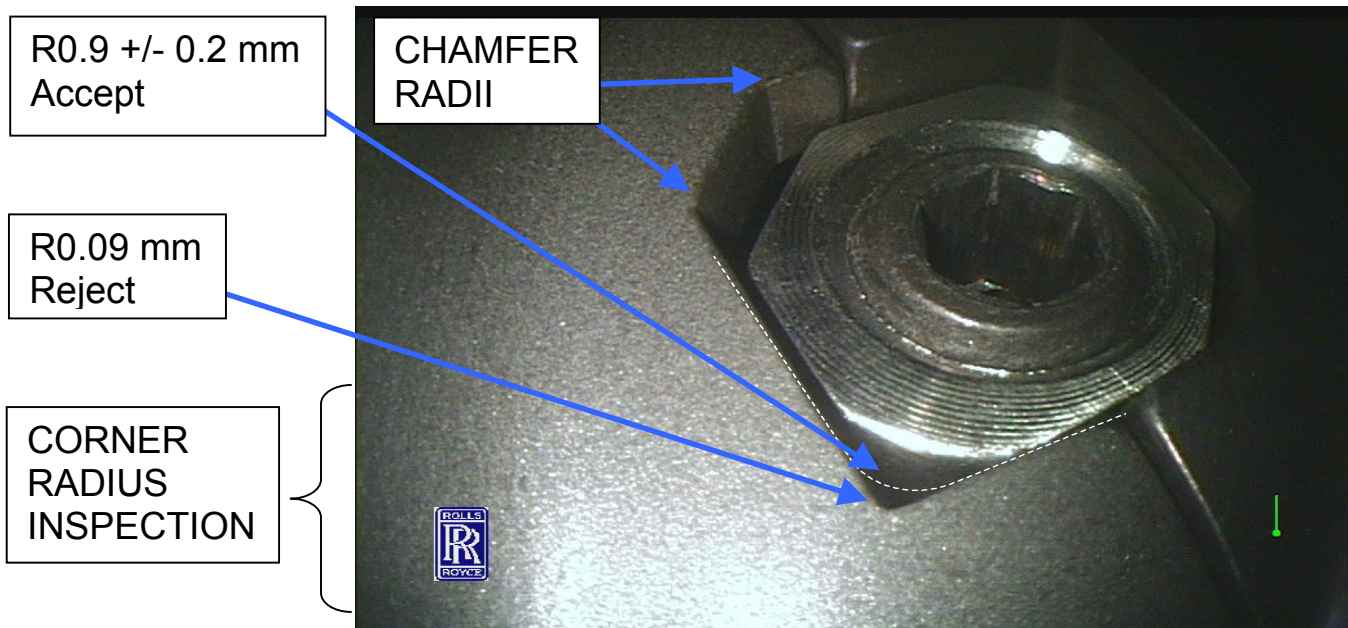
During manufacture, the corner radii in some of the right and left hand stage 8 rotor locking blades were machined to tighter radii than required (0.09 mm instead of 0.9 mm). The tight radii could initiate cracks resulting in the release of a small portion of the platform into the gas path.

Figure 1: Appearance of the blade locking slot corner radius
Example of blade that fails inspection and is unserviceable

- (1) Examine the HP Compressor stage 8 rotor locking blade slots at inspection location 10 in accordance with SUBTASK 72-41-15-222-095
 - (a) Visually examine the locking slot corner radius as shown in figure 1 and 2.
 - (b) Measure the corner radius with a radius gauge
 - (c) Radius 0.9 ± 0.2 mm Accept
 - (d) Other than A. (1) (c) Reject the locking blade.

Visually examine the blade corner radius for cracks. If cracked, measure the crack length and take a photo.
 - (e) Mark all HPC stage 8 rotor locking blades that failed inspection as unserviceable and scrap.
 - (f) Complete the Accomplishment Proforma to record the number of HPC stage 8 rotor locking blades that have been rejected due to a non-conforming corner radius at location 10.
