V2500-A5 SERIES PROPULSION SYSTEMS NON-MODIFICATION SERVICE BULLETIN

NON-MODIFICATION SERVICE BULLETIN – INSPECTION OF THE INNER AND OUTER COMBUSTION CHAMBER LINER ASSEMBLIES FOR DEFECTS

V2500-ENG-72-0604

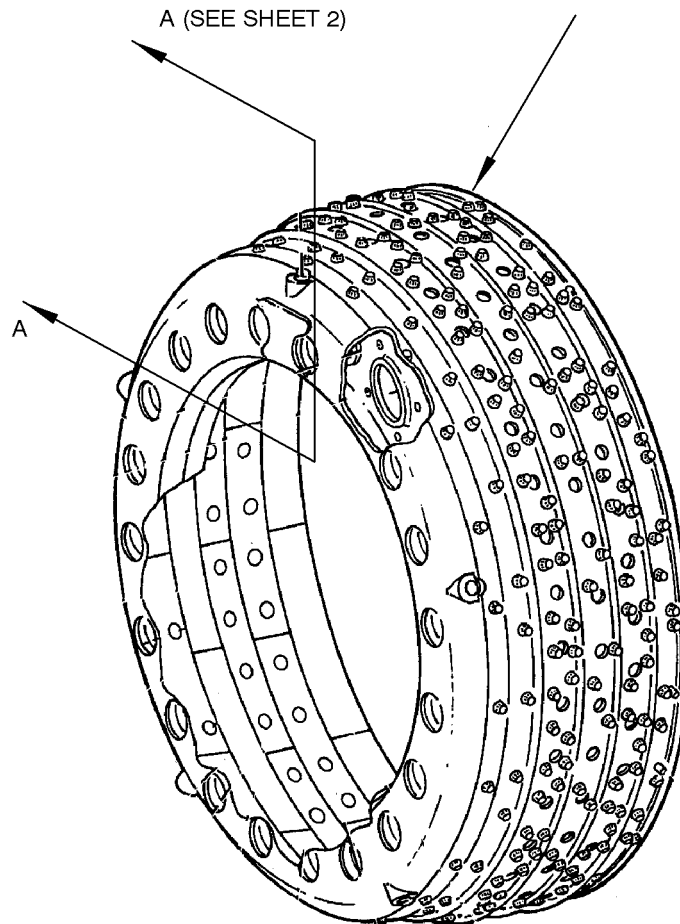
FIGURE 1, SHEET 1

2A3442-01
OUTER COMBUSTION
CHAMBER ASSEMBLY
INSPECT AND
REPLACE OR REPAIR
AS SPECIFIED IN TEXT

LOCATION AND INSPECTION OF THE OUTER COMBUSTION CHAMBER ASSEMBLY
72-42-61

If there is a machining defect like missing cooling holes or double-drilled cooling holes, then the outer combustion chamber liner assembly is not acceptable and you must do one of the following steps:
 - (1) Disassemble the outer combustion chamber assembly by the procedure in Reference 2, Engine Manual, Task 72-42-60-040-001, Disassembly.

- (2) Repair the defective Outer Combustion Chamber Liner Assembly, PN 2A2711-01 by the procedure in Reference 2, Engine manual, Task 72-42-61-300-003, Repair 003, VRS3091.

OR
- (3) Replace the defective Outer Combustion Chamber Liner Assembly, PN 2A2711-01 with a new Outer Combustion Chamber Liner Assembly, PN 2A2711-01.
- (4) Assemble the outer combustion chamber assembly by the procedure in Reference 2, Engine Manual, Task 72-42-60-440-001, Assembly.
- (f) Install the outer combustion chamber assembly by the procedure in Reference 2, Engine Manual, Task 72-40-00-430-004, Assembly-04.
- (g) Install the stage 1 turbine nozzle assembly by the procedure in Reference 2, Engine Manual, Task 72-40-00-430-005, Assembly-05.
- (h) Install the HP turbine assembly by one of the procedures that follow:
 - (i) Install the HP turbine assembly by the procedure in Reference 2, Engine Manual, Task 72-40-00-430-006-A00, Assembly-06.

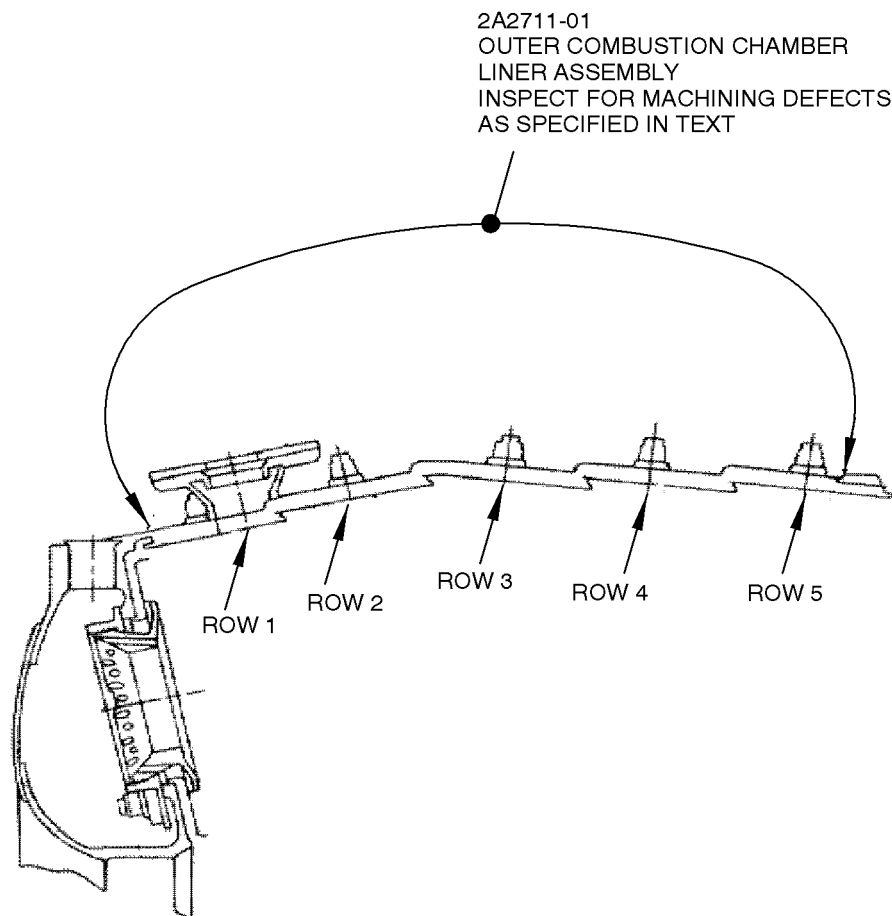
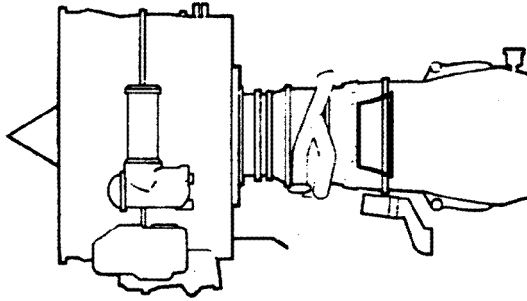
LOCATION AND INSPECTION OF THE OUTER COMBUSTION CHAMBER ASSEMBLY
72-42-61
FIGURE 1, SHEET 2

If there is no machining defect like missing cooling holes or double-drilled cooling holes, then the outer combustion chamber liner assembly is acceptable. See Figure 1, Sheet 2 and Figure 3.

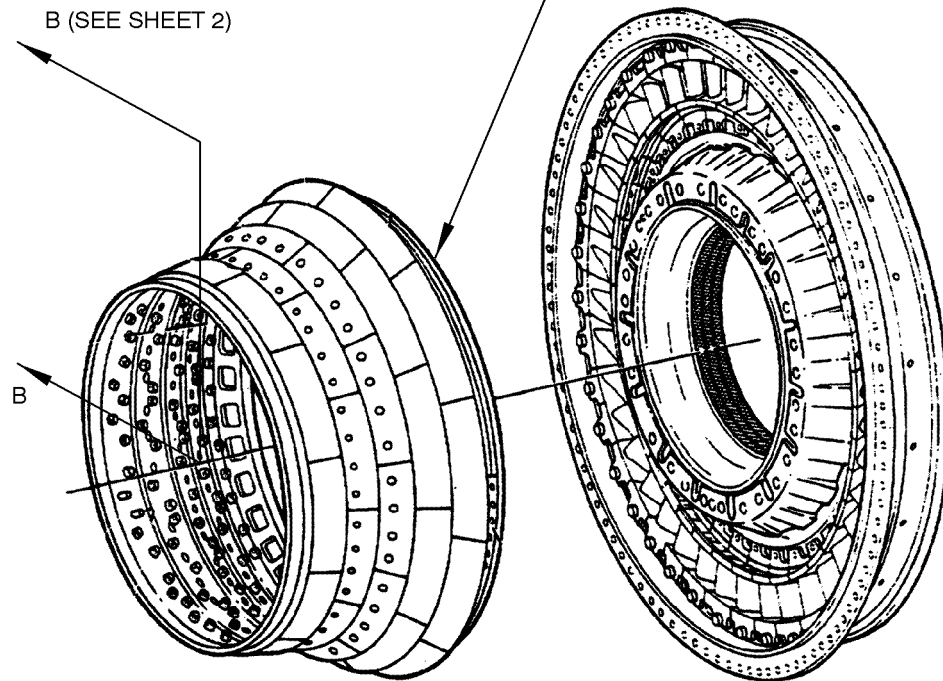
FIGURE 2, SHEET 1

If there is a machining defect like missing cooling holes or double-drilled cooling holes, then the inner combustion chamber liner assembly is not acceptable and you must do the following steps:
 - (1) Disassemble the stage 1 turbine nozzle assembly by the procedure in Reference 2, Engine Manual, Task 72-44-00-040-001, Disassembly.
 - (2) Disassemble the Inner Combustion Chamber Assembly, PN 2A3344-01 by the procedure in Reference 2, Engine Manual, Task 72-44-30-040-001, Disassembly. See Figure 2, Sheet 1 for the location of the assembly.

2A3344-01
INNER COMBUSTION
CHAMBER ASSEMBLY
INSPECT AND
REPLACE OR REPAIR
AS SPECIFIED IN TEXT

LOCATION AND INSPECTION OF THE INNER COMBUSTION CHAMBER ASSEMBLY
72-44-30

- (3) Repair the defective Inner Combustion Chamber Liner Assembly, PN 2A2718-01 by the procedure in Reference 2, Engine Manual, Task 72-44-30-300-005, Repair 005, VRS3174

OR
 - (4) Replace the defective Inner Combustion Chamber Liner Assembly, PN 2A2718-01 with a new Inner Combustion Chamber Liner Assembly, PN 2A2718-01.
 - (5) Assemble the inner combustion chamber assembly by the procedure in Reference 2, Engine Manual, Task 72-44-30-440-001, Assembly.
 - (6) Assemble the stage 1 turbine nozzle assembly by the applicable procedure that follows:
 - A Reference 2, Engine Manual, TASK 72-44-00-440-001-A01, Assembly (for pre SB 72-0339 and SB 72-0341 engines).

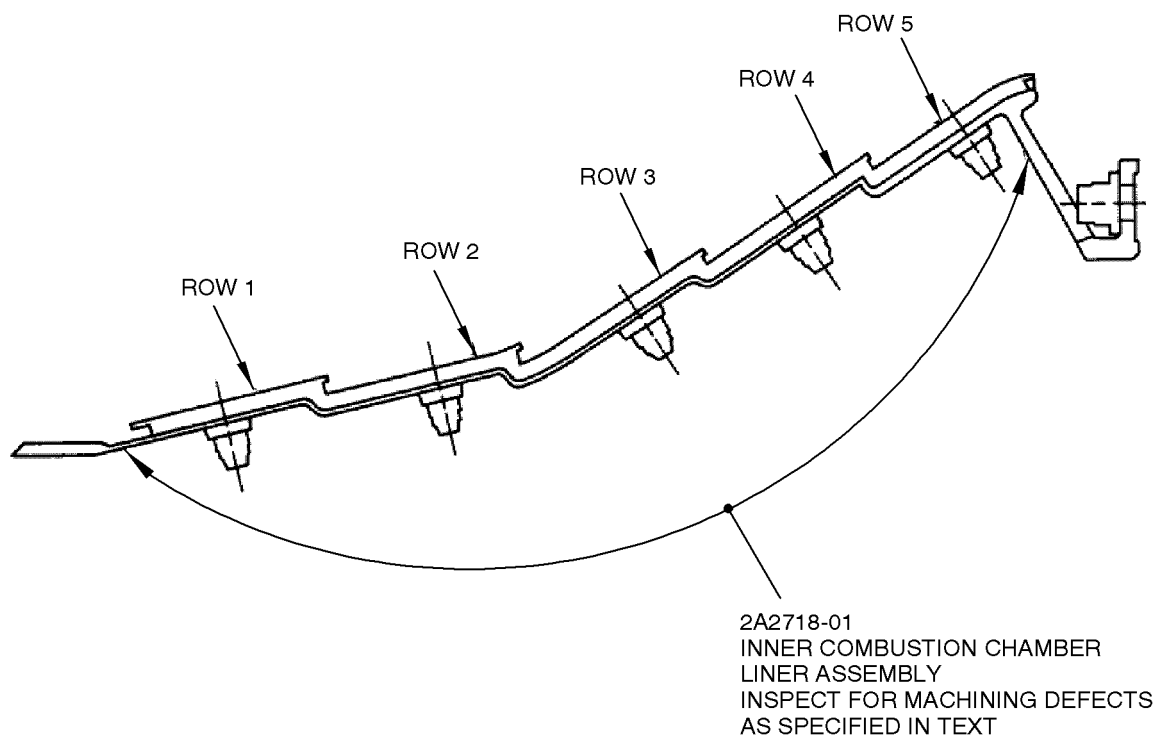
LOCATION AND INSPECTION OF THE INNER COMBUSTION CHAMBER ASSEMBLY
72-44-30
FIGURE 2, SHEET 2

If there is no machining defect like missing cooling holes or double-drilled cooling holes, then the inner combustion chamber liner assembly is acceptable. See Figure 2, Sheet 2 and Figure 3.

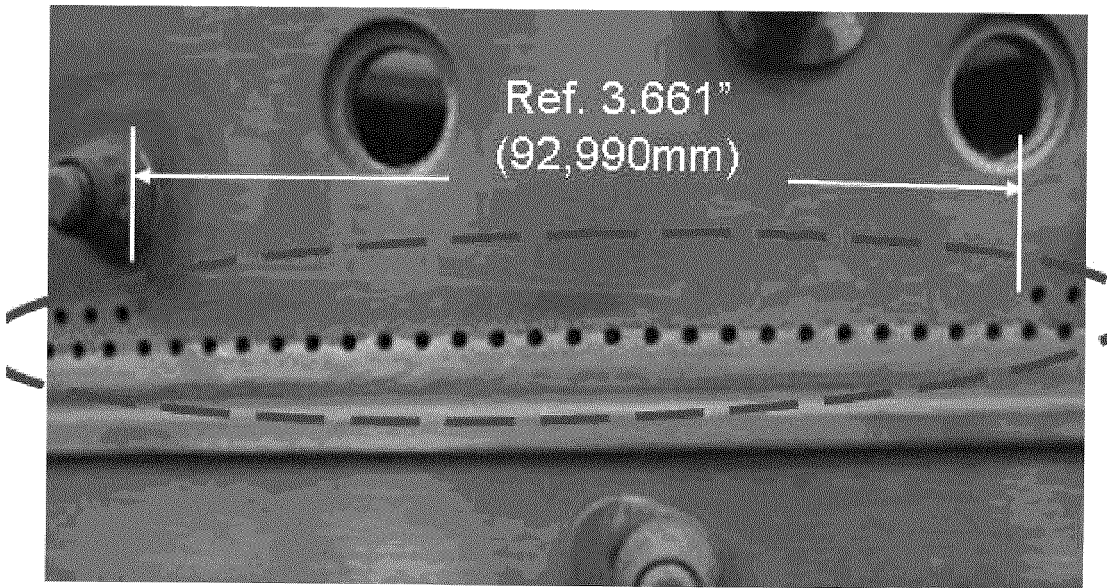
FIGURE 3

An overhaul shop reported machining defects on two areas of a first-run outer combustion chamber liner assembly. One area, approximately 3.66 in. (92,99 mm) long, was missing 24 cooling holes in one of two rows of cooling holes. The second area, approximately 3.03 in. (77,01 mm) long, had 24 double-drilled cooling holes in one of the two rows. Upon further investigation, it is suspected that similar machining defects could have occurred on other inner and outer combustion chamber liner assemblies.

The condition was caused during initial manufacturing. The suspect quantity has been identified as one outer combustion chamber liner assembly and either six outer or six inner combustion chamber liner assemblies produced between 2006 and 2007. The six additional liner assemblies were available for installation in a range of 84 engines. Inspection per this Non-Modification Service Bulletin is necessary to determine exactly which of the 84 engines are affected.

AREA MISSING 24 COOLING HOLES

EXAMPLE OF MACHINING DEFECT (MISSING COOLING HOLES AND/OR DOUBLE-DRILLED COOLING HOLES)

It is recommended that the maintenance shops do a visual inspection of the suspect inner and outer combustion chamber liner assemblies identified in Table 1 for machining defects. All holes on all five rows of the suspect outer and inner combustor liner shells must be inspected under white light at the detail level to make sure that there are no machining defects such as missing cooling holes or double-drilled cooling holes. For all effected engines, complete the attached Inspection Feedback Forms and send them to your local IAE representative. Defective inner and outer combustion chamber liner assemblies must be repaired or replaced. Contact IAE Technical Services for further disposition instructions.

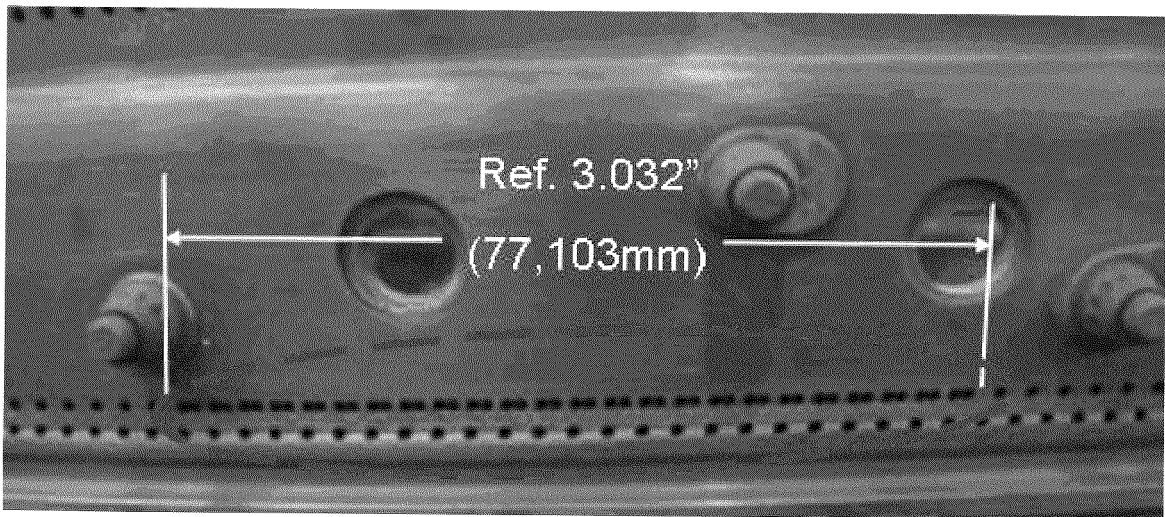
AREA WITH 24 DOUBLE-DRILLED COOLING HOLES
