V2500-A5 SERIES PROPULSION SYSTEM NON-MODIFICATION SERVICE BULLETIN

This document transmits the Initial Issue of Non-Modification Service Bulletin V2500-ENG-72-0610.

NON-MODIFICATION SERVICE BULLETIN – REPLACEMENT OF PRESSURE KIEL TAPS IN THE TURBINE EXHAUST CASE (TEC) TO IMPROVE THRUST AND ENGINE PRESSURE RATIO (EPR) PERFORMANCE CHARACTERISTICS

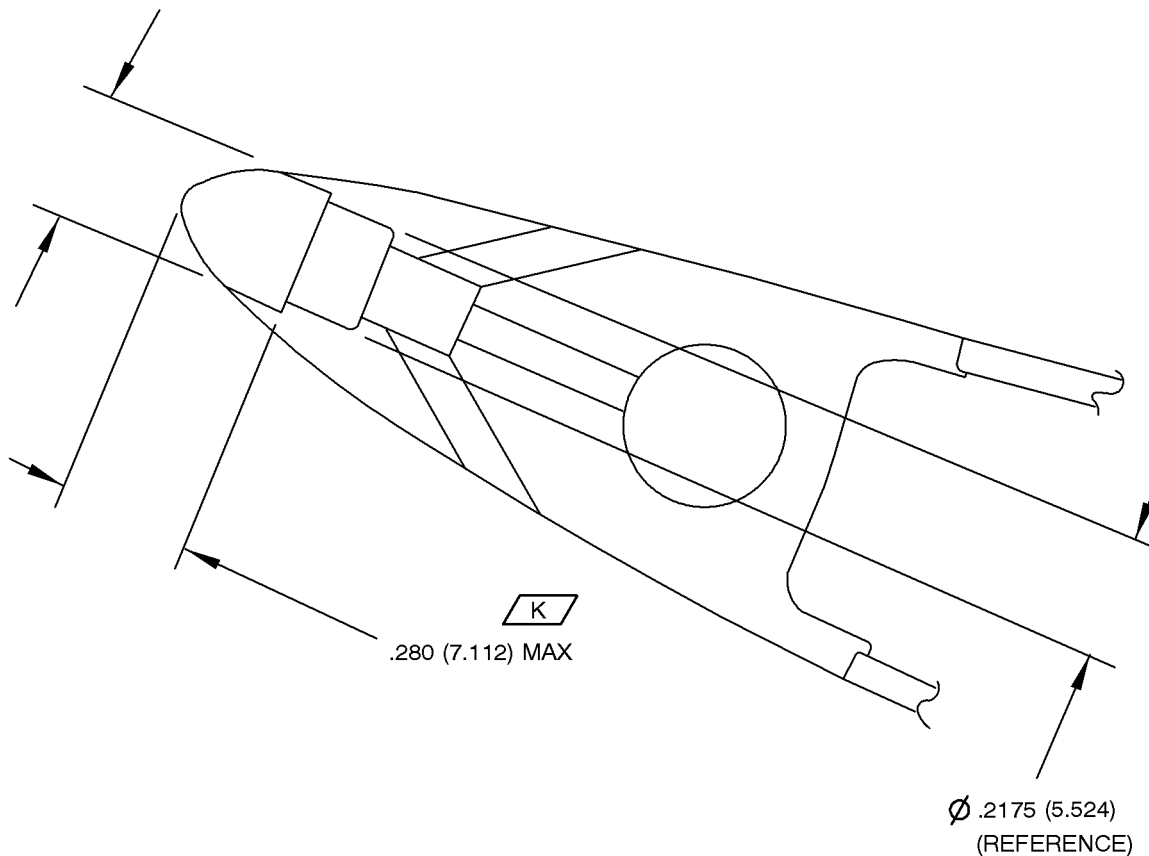
LOCATION OF THE TURBINE EXHAUST CASE ASSEMBLY AND REPLACEMENT
OF THE PRESSURE KIEL TAPS
FIGURE 1, SHEET 5

DIAMETER .238 (6.045) MAXIMUM PERMISSIBLE FOR DISTANCE K
BREAK-EDGE REQUIREMENT WAIVED ON EDGE SURFACE,
CONSUMED DURING WELD.

- (8) Partially remove the 24 pressure kiel taps by machining a 0.238 in. (6,045 mm) diameter hole to 0.280 in. (7,112 mm) maximum depth at each pressure kiel tap location. Locate the center of the 0.238 in. (6,045 mm) diameter hole using the center line of the existing 0.2175 in. (5,524 mm) diameter hole. See Figure 1, Sheet 5.

- (13) Break all edges/corners 0.003 - 0.015 in. (0,08 - 0,38 mm), except as shown in Figure 1, Sheet 5.
- (14) Locally clean affected areas. See Reference 3, Standard Practices Manual, Task 70-11-26-300-503, Solvent Cleaning 03.
