V2500-A1/A5/D5 SERIES PROPULSION SYSTEMS SERVICE BULLETIN

V2500-ENG-72-0613

ENGINE - HIGH PRESSURE (HP) COMPRESSOR - INTRODUCTION OF A NEW HP COMPRESSOR REAR SHAFT ASSEMBLY WITH A RING NUT THAT IS SILVER PLATED ON THE THREAD AND ABUTMENT FACE TO THE CUP WASHER ONLY AND NUTS WHICH ARE SILVER PLATED ON THE THREADS ONLY

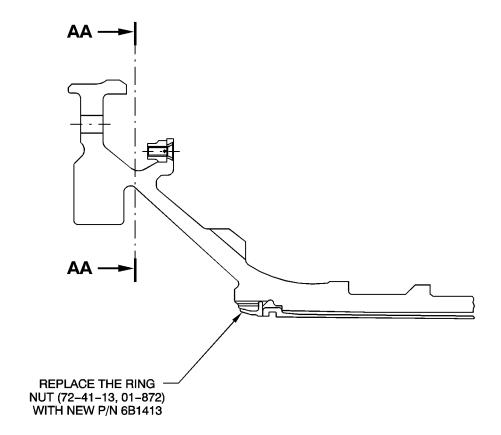
Rework details and dimensions Figure 1

GENERAL VIEW OF THE REAR H.P.C. SHAFT ASSEMBLY

- (9) Remove All Shank Nuts
 - (a) Refer to Figure 1, Figure 2 and Figure 3.

(b) Drill the flare section AB, until the nut is released. Refer to SPP TASK 70-35-11-300-501. Use a drilling machine with a 0.220 in (5.60 mm) diameter drill.

(c) Drill the flare section AC, until the nut is released. Refer to SPP TASK 70-35-11-300-501. Use a drilling machine with a 0.315 in (8,00 mm) diameter drill.

(b) Visually examine and check the dimensions of the nut location holes.

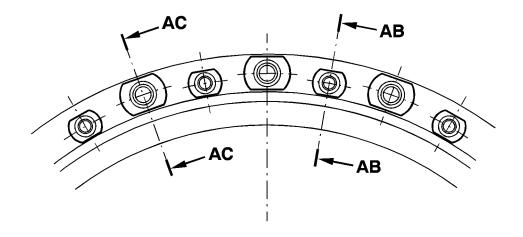
Rework details and dimensions Figure 2

PART SECTION AA-AA
