V2500-A1/A5 SERIES PROPULSION SYSTEM NON-MODIFICATION SERVICE BULLETIN

V2500-ENG-72-0617

NON-MODIFICATION SERVICE BULLETIN – X-RAY INSPECTION OF THE NO. 4 BEARING SCAVENGE
TUBE ASSEMBLY

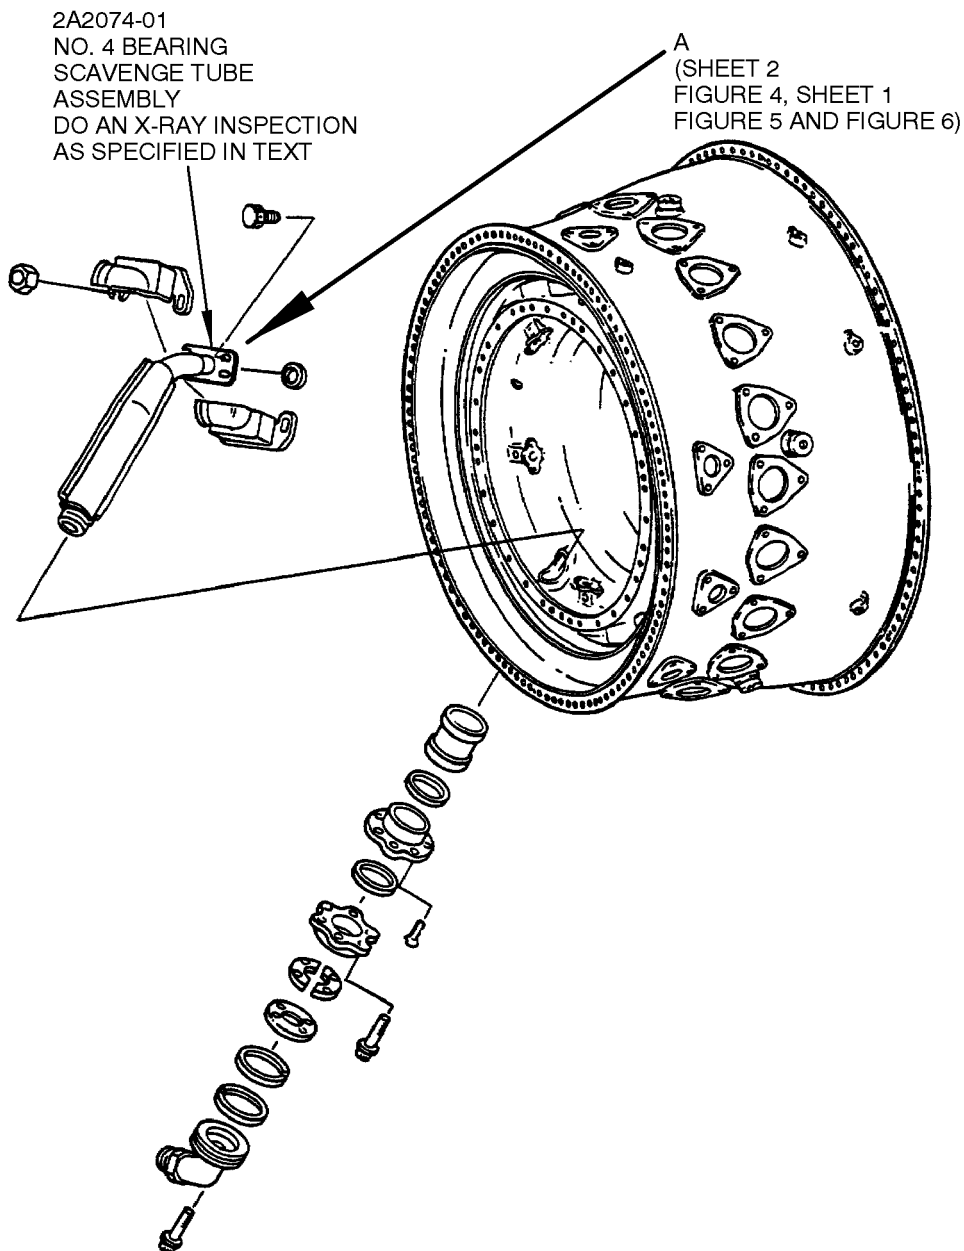
LOCATION, INSPECTION AND IDENTIFICATION OF THE NO.4 BEARING SCAVENGE TUBE ASSEMBLY
72-42-20
FIGURE 1, SHEET 1

- (1) Perform a one-time X-ray inspection of the No.4 Bearing Scavenge Tube Assembly, PN 2A2074-01, as follows. See Figure 1, Sheet 1 for the location of the assembly.

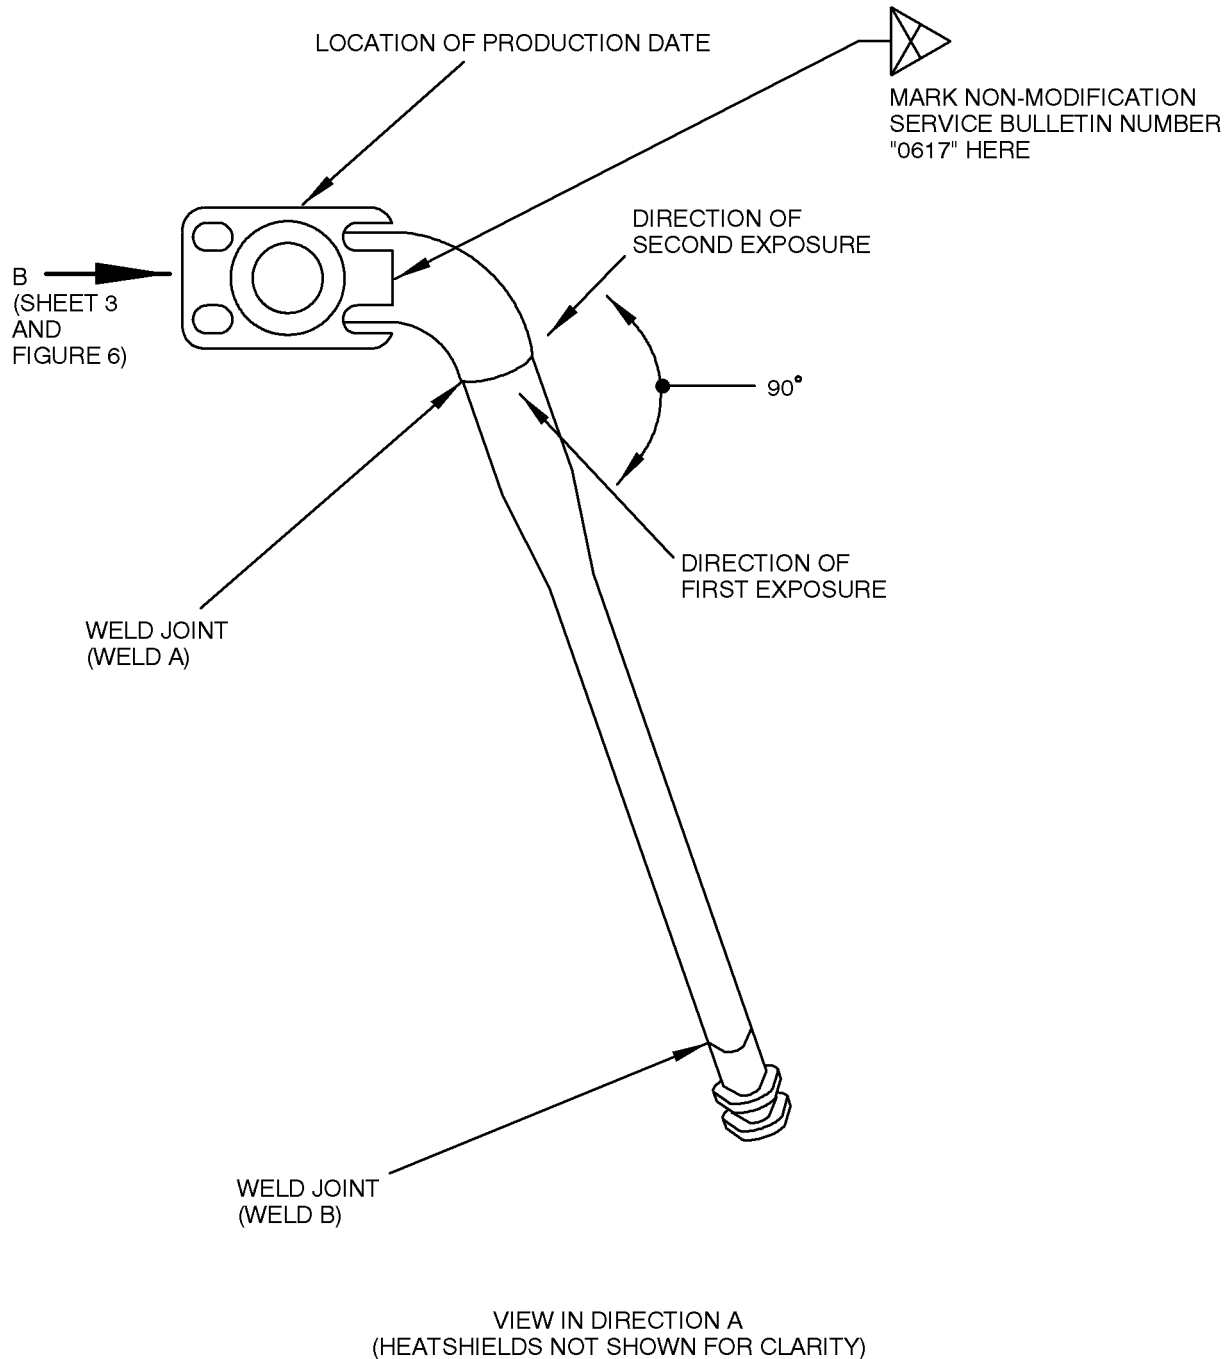
LOCATION, INSPECTION AND IDENTIFICATION OF THE NO.4 BEARING SCAVENGE TUBE ASSEMBLY
FIGURE 1, SHEET 2

- (a) Do an inspection of the tube flange and find the production date. See Figure 1, Sheet 2 for the location of the production date.

- (b) Take two exposures of the weld joints. The first exposure should be at 0 (zero) degrees and the second exposure should be taken at 90 degrees from the first. See Figure 1, Sheet 2 for the location of the weld joints and an example of the direction of the first and second exposures. Each exposure is to be taken with the following recommended settings:

(c) X-ray requirements. See Figure 1, Sheet 2 for the location of the weld joints: Weld A and Weld B.

(i) Requirements for Weld A and Weld B:

(1) No cracks, incomplete (lack of) penetration or incomplete (lack of) fusion allowed.

(2) Porosity, low density inclusions, or high density inclusions are acceptable provided:

A The maximum discontinuity size does not exceed 0.015 in. (0,381 mm).

B The total allowable number of discontinuities, regardless of type, must not exceed 4 per weld.

C The separation between discontinuities in linear alignment must be more than 0.050 in. (1,27 mm).

- (i) Mark the tube flange at the location shown in Figure 1, Sheet 2 with this Non-Modification Service Bulletin number as "0617". See Reference 4, Standard Practices Manual, Chapter/Section 70-09-00, Marking of Parts. Approved marking methods are deep electrolytic etch, metal stamp (press or roll), or drag impression.
- (ii) Return the tube assembly to service.
- (iii) Make a copy of Figure 2, No.4 Bearing Scavenge Tube Inspection Results, record the results for each inspection, and send it to the IAE (Hot Section) representative via PSCOMM.

- (2) Mark the tube flange at the location shown in Figure 1, Sheet 2 with this Non-Modification Service Bulletin number as "0617". See Reference 4, Standard Practices Manual, Chapter/Section 70-09-00, Marking of Parts. Approved marking methods are deep electrolytic etch, metal stamp (press or roll), or drag impression.

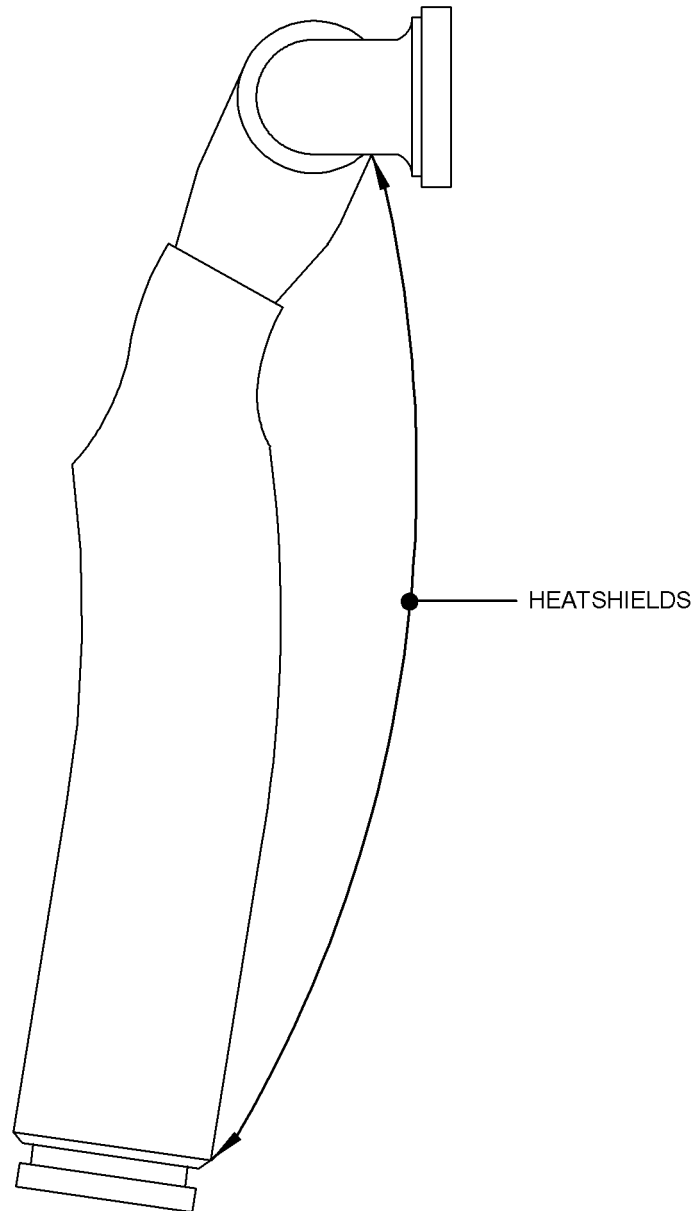
LOCATION, INSPECTION AND IDENTIFICATION OF THE NO.4 BEARING SCAVENGE TUBE ASSEMBLY
FIGURE 1, SHEET 3

VIEW IN DIRECTION B
(WITH HEATSHIELDS INSTALLED)

- (i) Remove the heatshields and insulation from the tube assembly by the applicable steps in the procedure provided in Reference 3, Component Maintenance Manual – Tubes, Hoses and Ducts, Chapter/Section 72-42-20, Repair 027, VRS3775. See Figure 1, Sheet 3 for the location of heatshields.

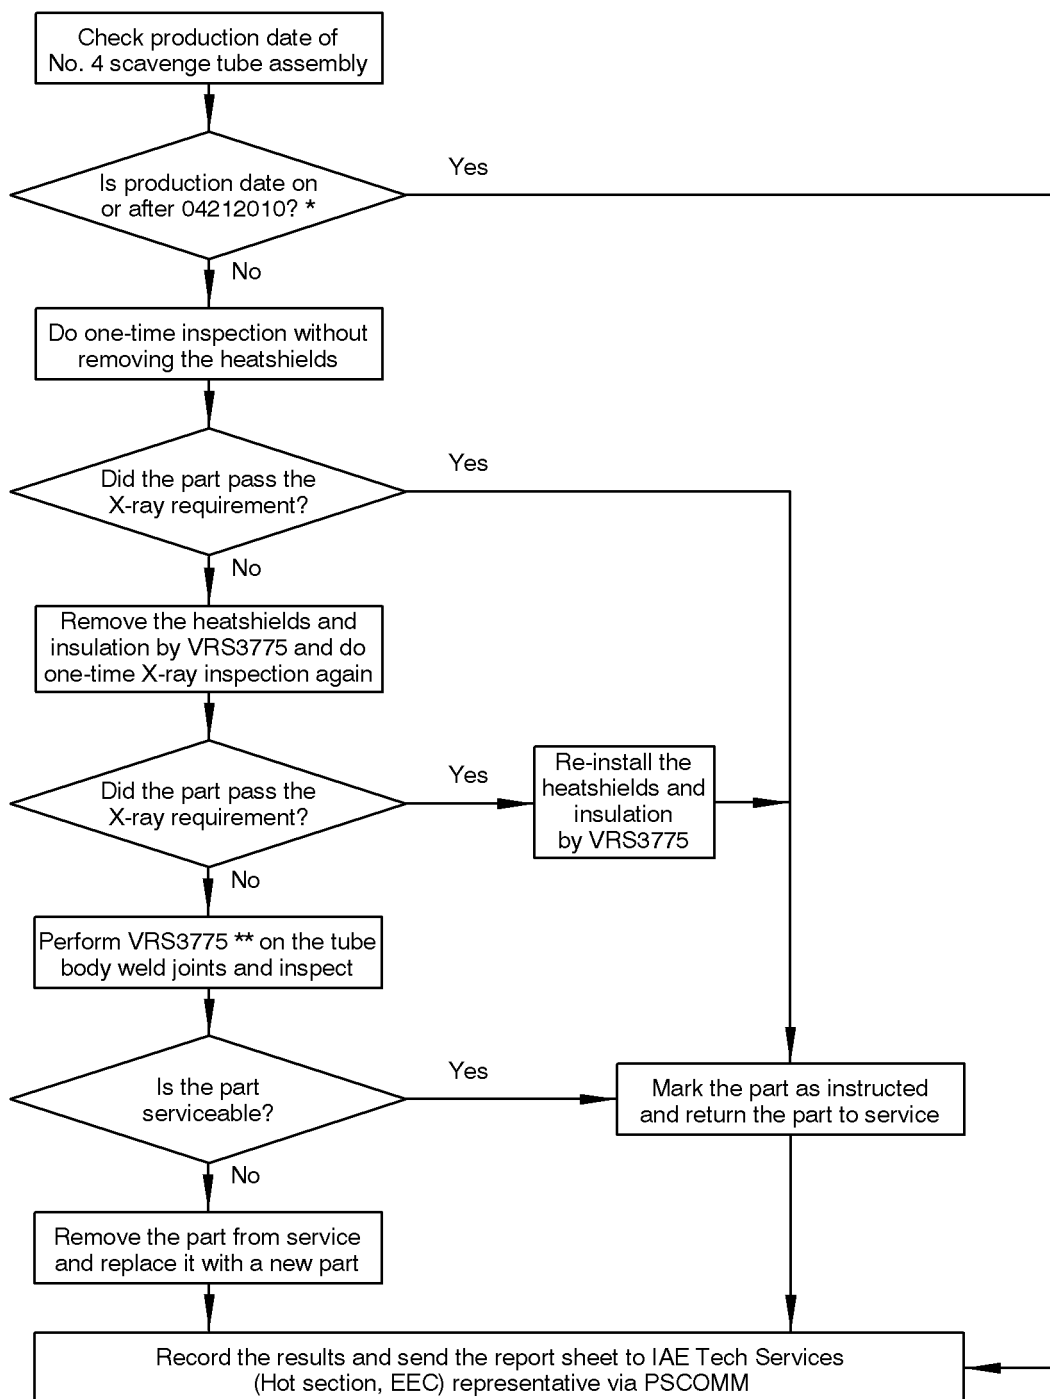
DECISION TREE
FIGURE 3

NOTE: See Figure 3 for a decision tree that highlights the steps that follow.
