V2500-A5/D5 SERIES PROPULSION SYSTEM NON-MODIFICATION SERVICE BULLETIN

This document transmits the Revision 1 of Non-Modification Service Bulletin V2500-ENG-72-0618.

# NON-MODIFICATION SERVICE BULLETIN - ENGINE - HIGH PRESSURE (HP) COMPRESSOR - ONE TIME INSPECTION OF STAGE 3 ROTOR BLADE CLAPPERS

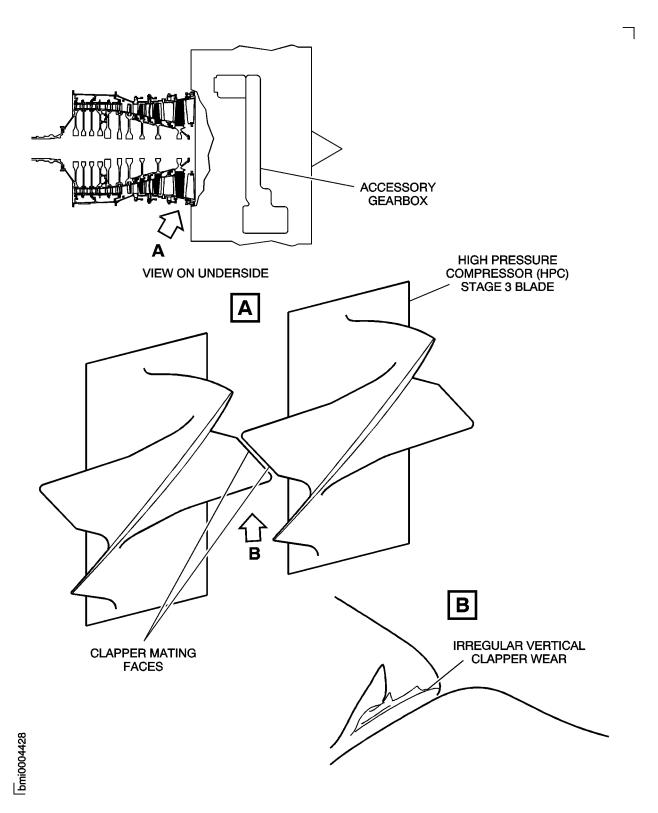
High Pressure Compressor (HPC) Stage 3 rotor Blades Figure 1

HP compressor stage 3 rotor blades with no hard coating on the clappers have been discovered during "In Service" and at "Overhaul/Shop Visit" borescope inspection. The uncoated clappers showed wear pattern outside acceptable limits. Irregular wear of the clappers may lead to shingling of the clappers and cause the blade airfoil to vibrate with possible blade fracture, if continued in service.

- (2) Compare the results with Figure 1.
- (3) Accept and reject criteria:
  - (a) No evidence of wear Accept.
  - (b) Irregular vertical wear as shown in Figure 1 Reject within 100 cycles.

- (2) Compare the results with Figure 1.
- (3) Accept and reject criteria:
  - (a) No evidence of wear Accept.
  - (b) Irregular vertical wear as shown in Figure 1 Reject.

NOTE: Make pictures of the clapper wear and send them to IAE Tech Services, referenced to Non-Modification Service Bulletin 72-0618 and together with the Engine Serial Number and blade Cycles since new of the affected blade recorded.
