V2500-A1/A5/D5 SERIES PROPULSION SYSTEMS SERVICE BULLETIN

This document transmits the Initial Issue of Non-Modification Service Bulletin V2500-ENG-72-0621.

NON-MODIFICATION SERVICE BULLETIN – INSPECTION OF THE NO.4 BEARING ASSEMBLY PRESSURE TUBE PROFILE

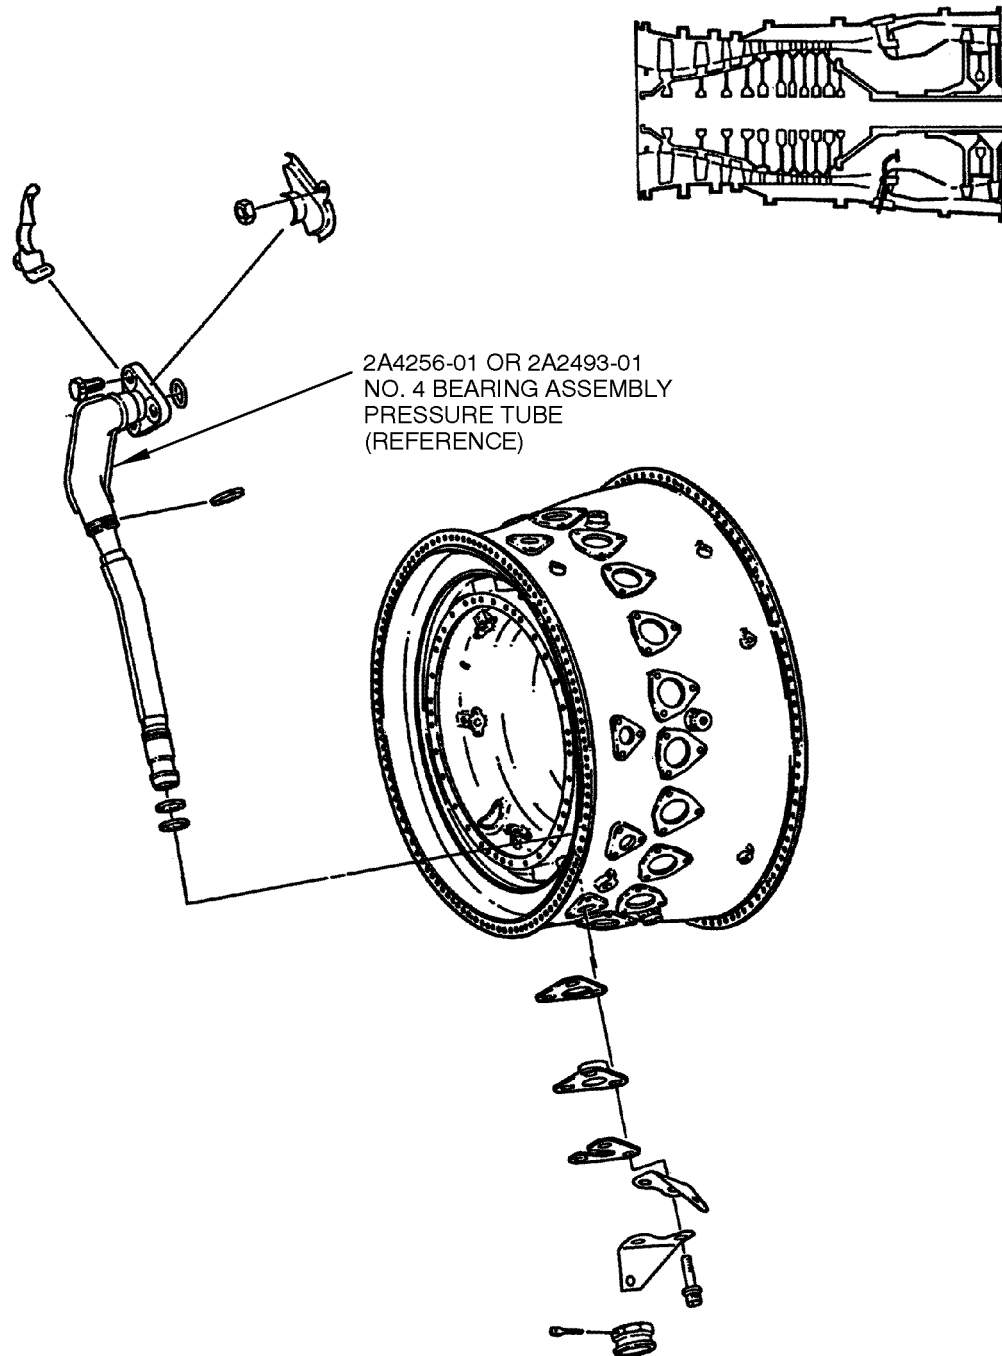
Location of the N0.4 Bearing Assembly Pressure Tube  
72-42-20  
Figure 1

There is a suspect population of 102 No.4 bearing assembly pressure tubes that can have discrepant profiles which hinder form, fit and function. The form, fit and function non-conformances do not satisfy the established Final Acceptance Inspection (FAI) criteria.

- (1) Send your No.4 Bearing Assembly Pressure Tube, PN 2A4256-01 or PN 2A2493-01 to the following vendor for inspection. See Figure 1 for the location of the tube.
