V2500-A1/A5/D5 PROPULSION SYSTEMS SERVICE BULLETIN

This document transmits the Initial Issue of Service Bulletin V2500-ENG-72-0622.

ENGINE – SEAL ASSEMBLY, NO. 3 BEARING – REPLACE OR MODIFY TO IMPROVE DURABILITY**1. Planning Information****A. Effectivity****(1) Airbus A319**

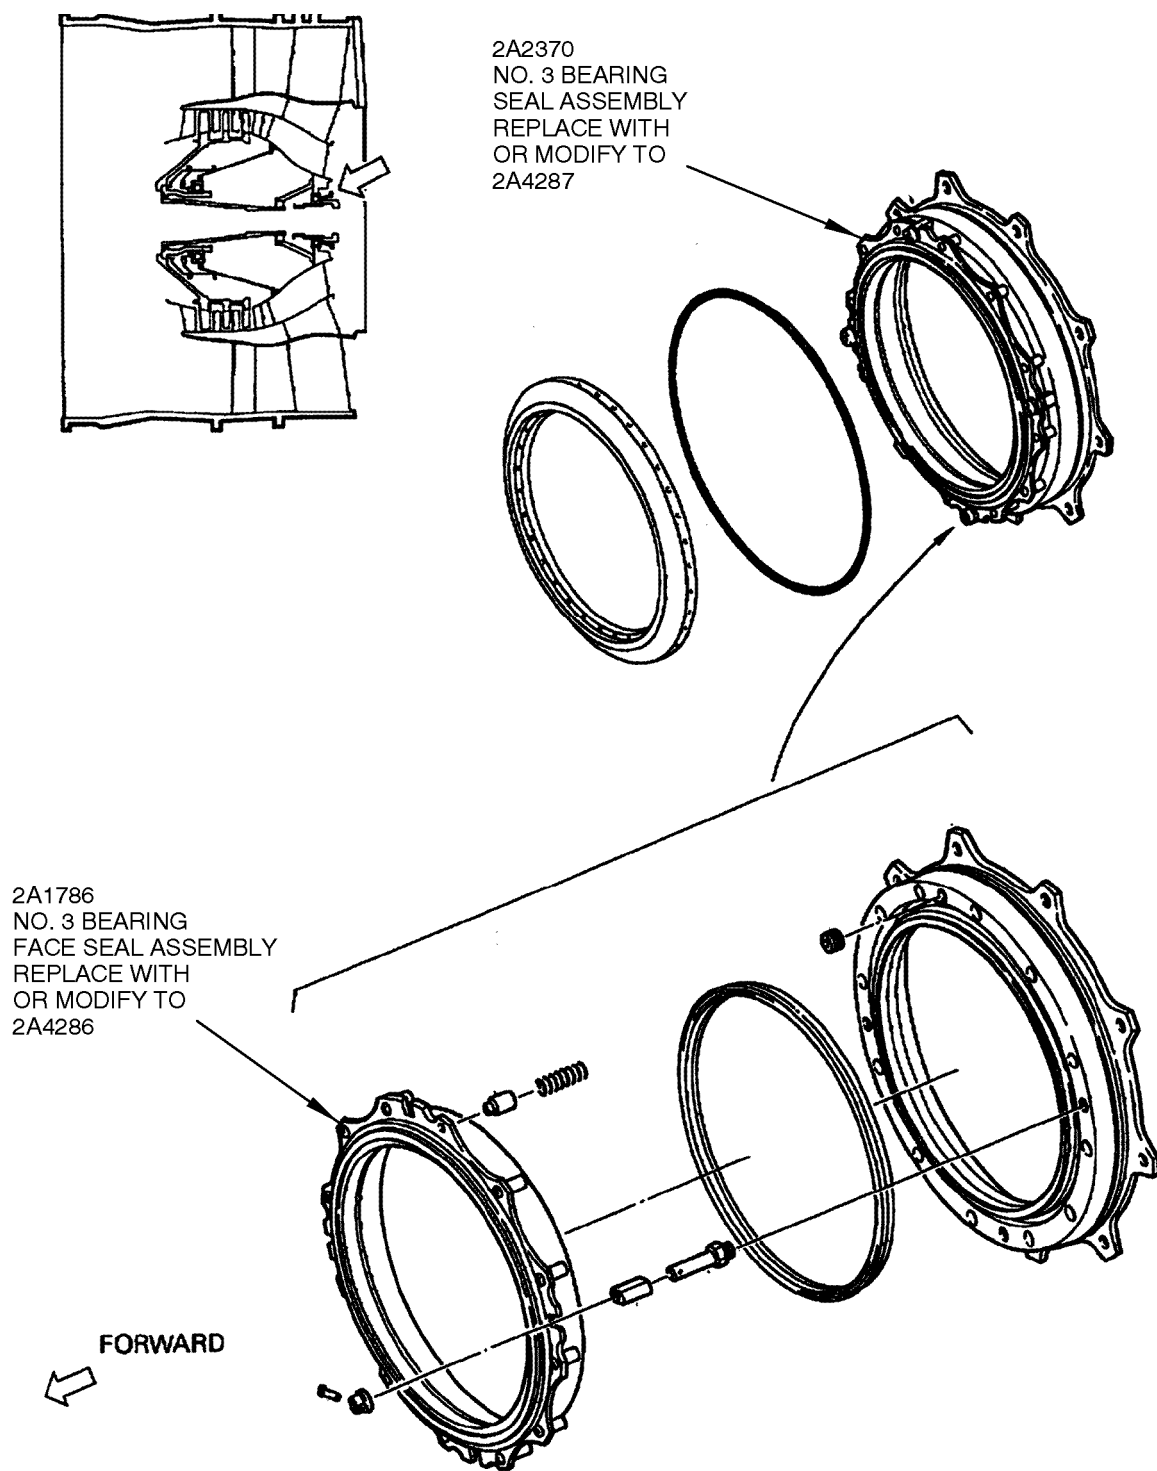
Location of the No. 3 Bearing Seal Assembly 72-32-25
Figure 1

The No. 3 bearing rear carbon seal assembly wear durability has been lower than expected.

The current contact pressure limits the carbon seal performance.

- (1) Replace No. 3 Bearing Seal Assembly, PN 2A2370 with PN 2A4287, refer to Figure 1 for the location of the assembly.

- (i) Replace No. 3 Bearing Face Seal Assembly, PN 2A1786 with PN 2A4286. See Figure 1 for the location of the assembly.
- (ii) Assemble the No. 3 bearing seal assembly by the procedure in Reference 7 or 8, Engine Manual, Task 72-32-25-440-001.
- (iii) Identify the modified No. 3 bearing seal assembly as specified in the list that follows. Use the procedure in Reference 9 or 10, Standard Practices Manual, Task 70-09-00-400-501. Use the vibration peen method. Mark the new part number near the old part number.
