V2500-D5 PROPULSION SYSTEMS NON-MODIFICATION SERVICE BULLETIN

V2500-ENG-72-0630
Transmittal - Page 1 of 1

NON-MODIFICATION SERVICE BULLETIN – NO.4 BEARING SCAVENGE TUBE ASSEMBLY REPLACEMENT
PROCEDURE

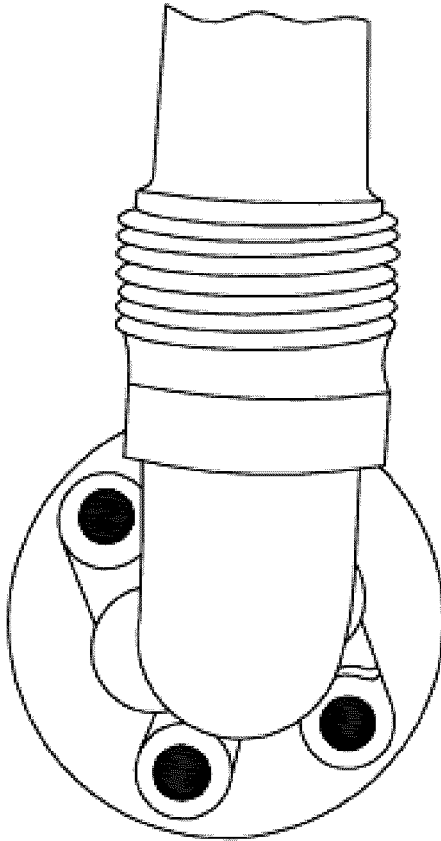
EXAMPLES OF ALIGNED AND MIS-ALIGNED NO.4 BEARING EXTERNAL SCAVENGE TUBE
FIGURE 2

R B Make sure that the tube is still aligned and in free condition. The end of the conical fitting of the tube 55 must be inside the top conical seat of the elbow, PN 2A2514 or PN 2A3951-01 as illustrated in Figure 2 of this Service Bulletin.

CORRECTLY ALIGNED
--- ACCEPT ---

R C If the tube is still aligned and in free condition, torque the nut to 566.0 to 611.0 lbfin (63,949 to 69,034 Nm). Use the IAE 1R18003 wrench.

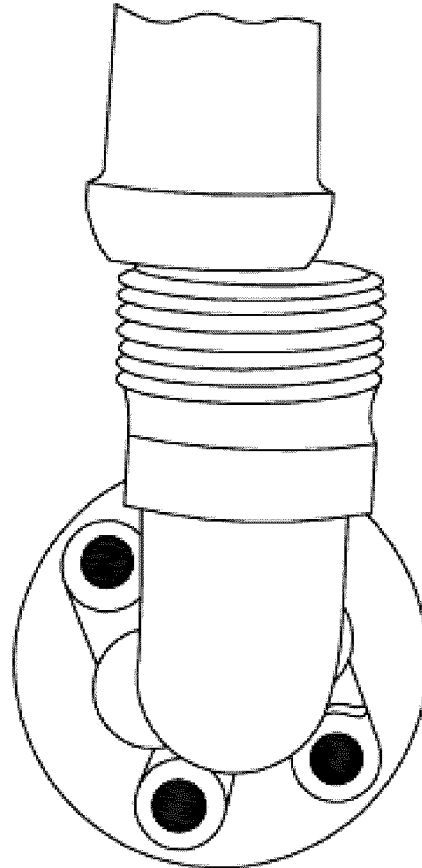
(2) Background: A higher than desired stress is being experienced by No.4 Bearing Internal Scavenge Tubes, PN 2A2074-01 fleet-wide on the V2500-D5 Engine Model. In addition, previously repaired No.4 Bearing External Scavenge Tubes, PN 6A5254, were causing misalignment during assembly, and resulted in higher stresses to the internal tubes.

MIS-ALIGNED
--- REJECT ---

- D If the tube is mis-aligned, reject the tube 55 and replace with the new tube. Repeat steps (i) to (v). Discard the old tube and make it unserviceable in an acceptable manner which is described in FAA - Order: 8120.11 "Disposition of scrap or salvageable aircraft parts and materials", dated 2/12/96.
- E Safety wire the tube nut and tube connector with CoMat 02-126 lockwire.
