V2500-A1/A5/D5 SERIES PROPULSION SYSTEM SERVICE BULLETIN

This document transmits the Initial Issue of Service Bulletin V2500-ENG-72-0633.

ENGINE – ACTUATING MECHANISM HIGH PRESSURE (HP) COMPRESSOR VARIABLE VANES – CONTROL
ROD LOCK NUT TORQUE INCREASE

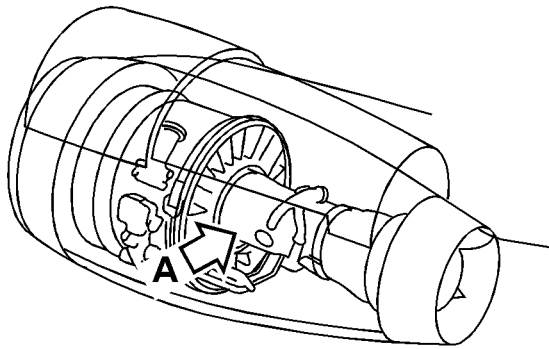
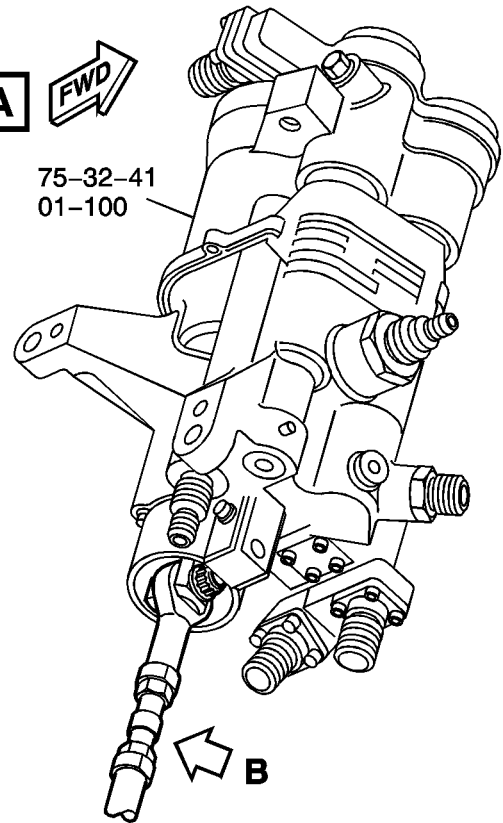
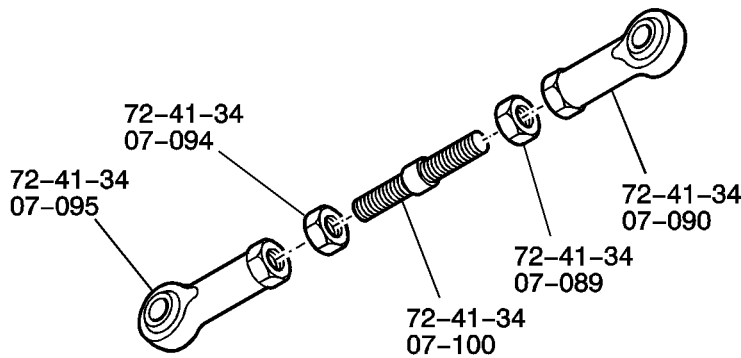
Variable Stator Vane (VSV) Actuator Control Rod
Figure 1

The Locking torque for the Lock nuts on the Variable Stator Vane (VSV) control rod between the VSV actuator and the VSV crankshaft is too low.

Service experience has shown that the instructed locking torque is too low and in several cases has allowed the control rod end connected to the VSV actuator to loosen and rotate.

The attaching bolt on the rotated rod end can cause chafing on the VSV actuator High Pressure (HP) servo fuel supply tube.

- (i) Tighten and torque the locknuts (72-41-34, 07-089) and (72-41-34, 07-094) on the VSV actuator control rod to 205 to 220 lbf in. (23 to 25 Nm).
- (ii) Safety the locknuts (72-41-34, 07-089) and (72-41-34, 07-094) to the control rod bearings (72-41-34, 07-090) and (72-41-34, 07-095) with corrosion resistant steel lockwire (Material No. V02-126) (Ref TASK 70-40-11-911-014).

- (i) Tighten and torque the locknuts (72-41-34, 07-089) and (72-41-34, 07-094) on the VSV actuator control rod to 205 to 220 lbf in. (23 to 25 Nm).
- (ii) Safety the locknuts (72-41-34, 07-089) and (72-41-34, 07-094) to the control rod bearings (72-41-34, 07-090) and (72-41-34, 07-095) with corrosion resistant steel lockwire (Material No. V02-126) (Ref TASK 70-40-11-911-803).
