SERVICE BULLETIN

NON MODIFICATION SERVICE BULLETIN — ENGINE — NO. 4 BEARING, COOLING AIR DUCT, REAR — INSPECT AND REPLACE IF SUSPECT DUCTS ARE FOUND

V2500 Series 72-0640

72-43-30

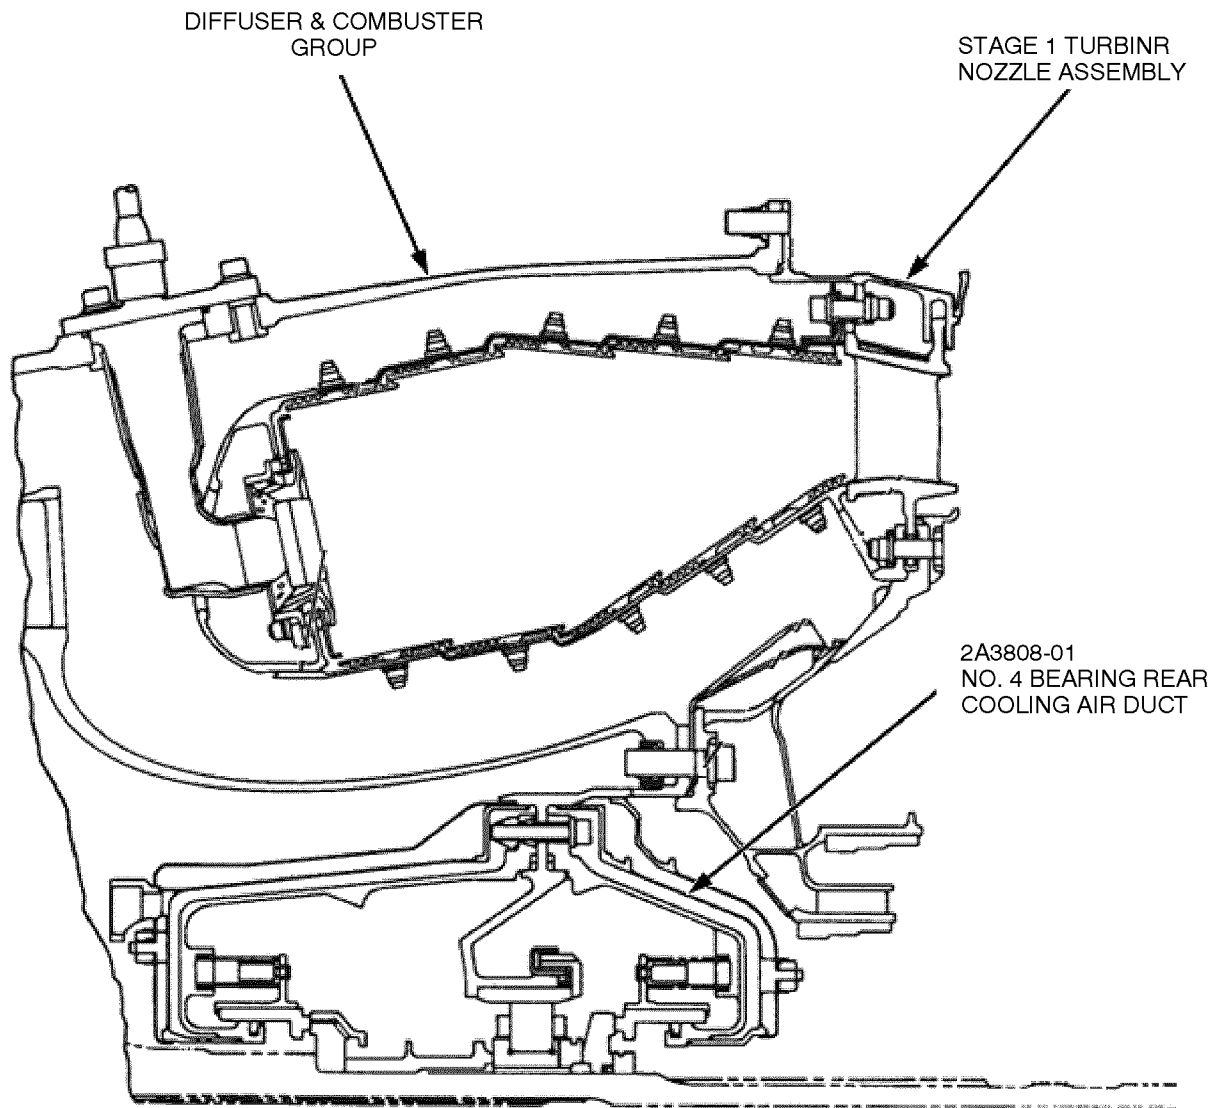
LOCATION OF NO. 4 BEARING COMPARTMENT AND MARKING LOCATION
FIGURE 1, SHEET 1

1. Remove the No. 4 Bearing Rear Cooling Air Duct, PN 2A3808-01 from the No. 4 Bearing and Rear Compartment. Refer to Reference 6, Engine Manual Task 72-00-43-020-001. See Figure 1 (Sheets 1 and 2).

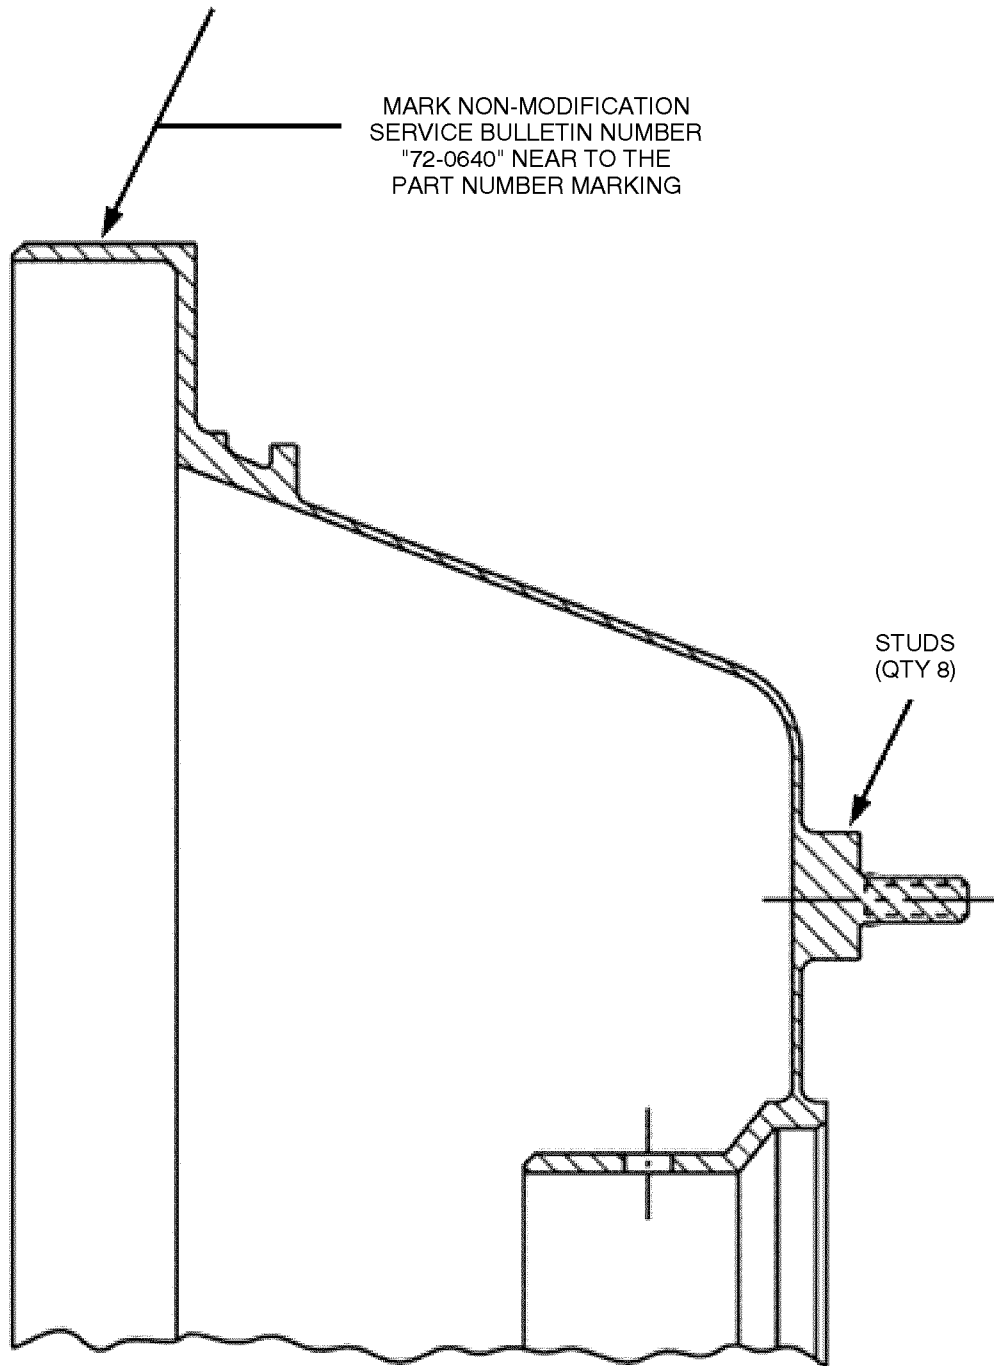
LOCATION OF NO. 4 BEARING COMPARTMENT AND MARKING LOCATION
FIGURE 1, SHEET 2

- A. Locate the lot number on the No. 4 Bearing Rear Cooling Air Duct marked adjacent to the part number. See Figure 1 (Sheet 2) for location of the lot number.

LOT NUMBER MARKED HERE
(ADJACENT TO PART NUMBER MARKING)

- B. If the lot number marked is 405215-0, 405604-0 or 408310-0, remove the part from service and return to the Vendor listed in Vendor Services or Special Components/Materials Section. Obtain a conforming No. 4 Bearing Rear Cooling Air Duct, PN 2A3808-01.

- C. Mark the conforming part (or) re-installed part at the location shown in Figure 1, Sheet 2 with this Non-Modification Service Bulletin number as "72-0640". See Reference 3, Standard Practices Manual, Chapter/Section 70-09-00, Marking of Parts. Approved marking methods are deep electrolytic etch, vibropeen, engrave (manual or mechanical), drag impression or deep dot peen.

MARK NON-MODIFICATION
SERVICE BULLETIN NUMBER
"72-0640" NEAR TO THE
PART NUMBER MARKING
