SERVICE BULLETIN

NON-MODIFICATION SERVICE BULLETIN — ENGINE — OIL CONSUMPTION MONITORING
AND NO. 4 FRONT AND REAR SEAL SEAT REPLACEMENT

V2500-A1

V2500 Series 72-0670

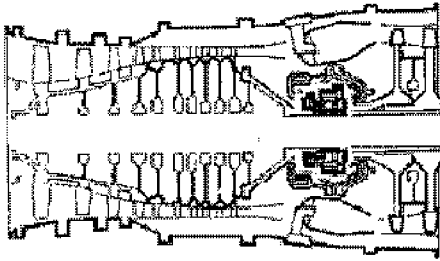
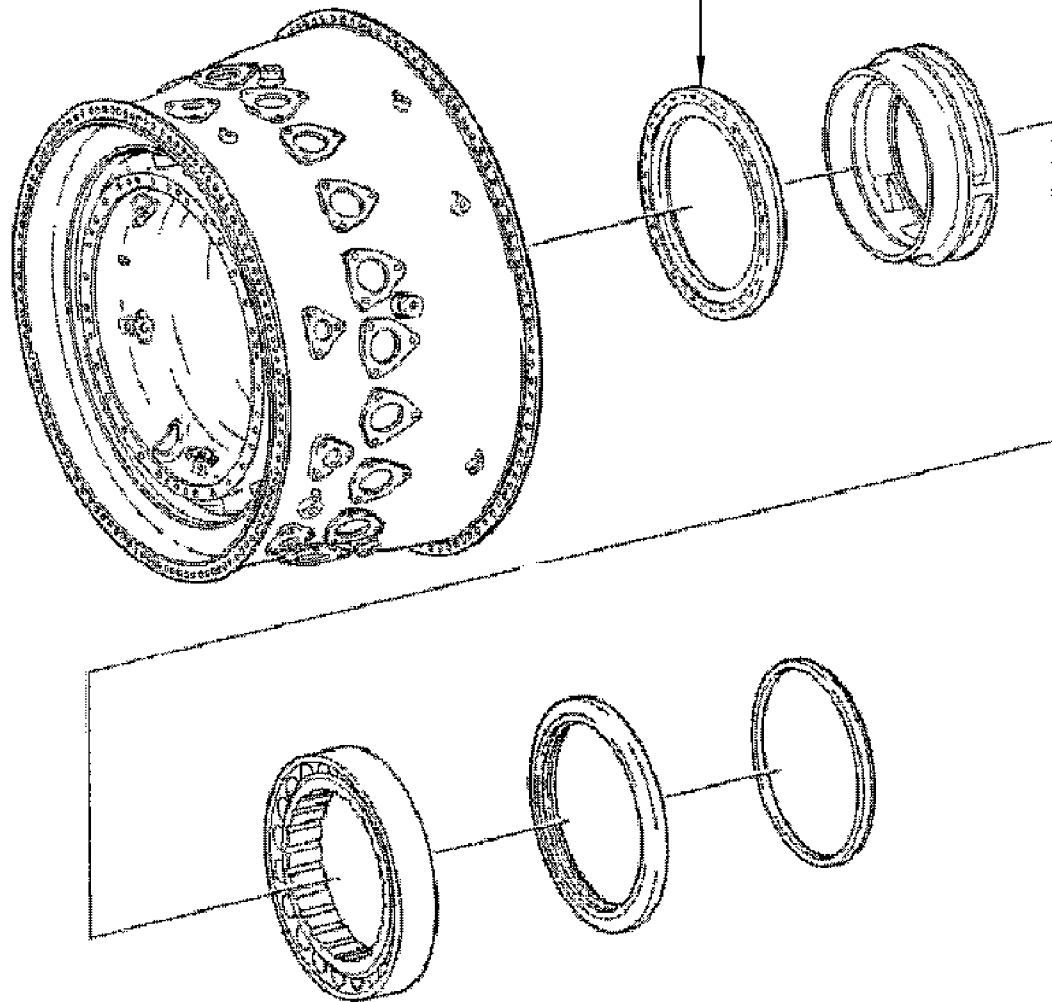
LOCATION OF THE NO. 4 BEARING FRONT SEAL SEAT
72-43-11
FIGURE 1

1. Condition: An uncontained event occurred on a V2500-A1 series engine, which was attributed to a fractured 2nd stage air-seal located in the High Pressure Turbine (HPT) module.

2. Background: Analysis of all the findings to date has shown that the preliminary cause of the event was blockage at the No. 4 bearing seal seat anti-weep grooves created during the overhaul process at an engine overhaul shop. Blockage of these anti-weep grooves could allow oil to escape the No. 4 compartment and migrate to the HPT. Oil migration to the HPT could result in the oil ignition in the HPT and may eventually result in a 2nd stage air-seal fracture.

2A3432
NO. 4 BEARING SEAL SEAT
INSPECT AS
SPECIFIED IN
THE ACCOMPLISHMENT
INSTRUCTIONS

1. Do the following procedures. See Figures 1 and 2.
 - A. Remove the No. 4 Bearing Front and Rear Seal Seats, per the Material Information section from the No. 4 bearing compartment. Refer to Reference 3, Engine Manual, Chapter/Section 72-00-43, Task 72-00-43-020-001.
 - (1) Do not perform any maintenance, including cleaning, on these parts. Return the removed parts to IAE for a detailed inspection. Parts will be returned after the inspection has been completed. Refer to IAE's shipping address. Contact your IAE Field Support Representative (FSR) for shipping instructions. Provide your IAE FSR with the quantity of parts being shipped with the following: Part Number (PN), Serial Number (SN) and Engine Serial Number (ESN) of the engine the parts were removed from.

- C. Install No. 4 Bearing Front and Rear Seal Seats, PN 2A3432 and PN 2A3433 from the No. 4 bearing and rear compartment. Refer to Reference 3, Engine Manual, Chapter/Section 72-00-43, Task 72-00-43-420-001.

- (1) Install a new or refurbished No. 4 bearing front and rear seal seat. A refurbished No. 4 bearing front and rear seal seat must be repaired as specified in Reference 3, Engine Manual, Chapter/Section 72-43-11, Repair Procedures 72-43-11-300-002, VRS3102, 72-43-14-300-002, VRS3108, 72-43-11-300-005, VRS3693 or 72-43-14-300-005, VRS3694, from an IAE source approved vendor listed within Material Information section.

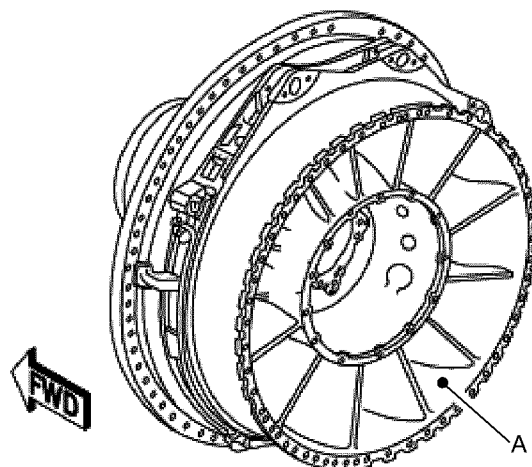
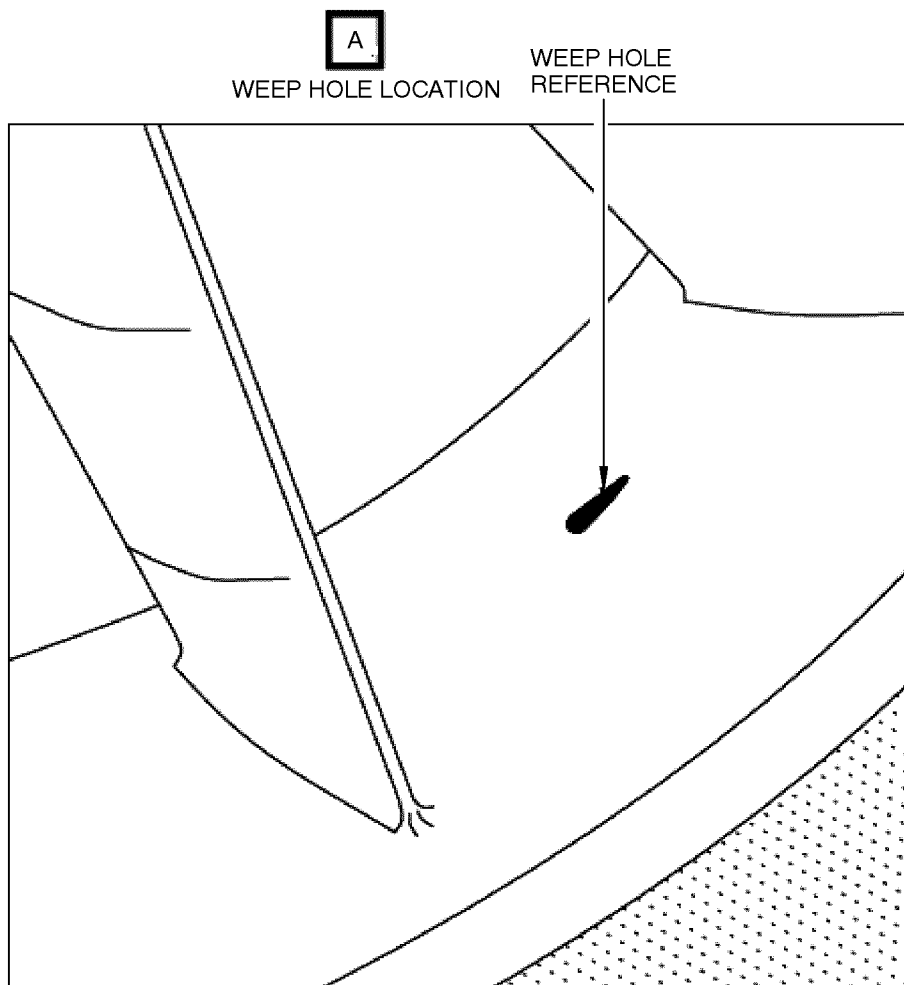
LOCATION OF THE WEEP-HOLE
FIGURE 5

1. Do a visual inspection of the turbine exhaust case weep hole.
 - A. Do a visual inspection of the the turbine exhaust case weep hole for oil wetting. See Figures 5 and 6.
 - (1) If oil wetting is found, do the steps that follow.
 - (a) Calculate the oil consumption rate using the oil quantity added to the specified engine during the last 250 +/- 25 flight hour time period divided by the actual engine operating hours during the same 250 +/- 25 flight hour time period.

- 1 If oil consumption is greater than 0.15 quarts (0.3 US pints) per hour, remove the engine from service and proceed to Part C. Refer to Reference 5, Aircraft Maintenance Manual, Chapter/Section 71-00-20, Task 71-00-20-000-040 and Task 71-00-20-400-040. Record Accomplishment of the Service Bulletin as specified in Step 3 below.

- 2 If oil consumption is less than or equal to 0.15 quarts (0.3 US pints) per hour, do the procedure to dry out the high pressure turbine after oil contamination. Refer to Reference 5, Aircraft Maintenance Manual, Chapter/Section 71-00-00, Task 71-00-00-700-013.

- a If the dry out procedure is successful, the engine may continue service. Record Accomplishment of the Service Bulletin as specified in Step 3 below.

- b If the dry out procedure is not successful, remove the engine from service and proceed to Part C. Refer to Reference 5, Aircraft Maintenance Manual, Chapter/Section 71-00-20, Task 71-00-20-000-040 and Task 71-00-20-400-040. Record Accomplishment of the Service Bulletin as specified in Step 3 below.
