NON-MODIFICATION SERVICE BULLETIN — NO. 3 BEARING — REDUCED MASTER  
MAGNETIC CHIP DETECTOR INSPECTION INTERVAL FOR SUSPECT POPULATION (LOT A)

V2522-A5, V2524-A5, V2527-A5, V2527E-A5, V2527M-A5, V2530-A5, V2533-A5

V2500 Series 72-0671

**V2500-ENG-72-0671**

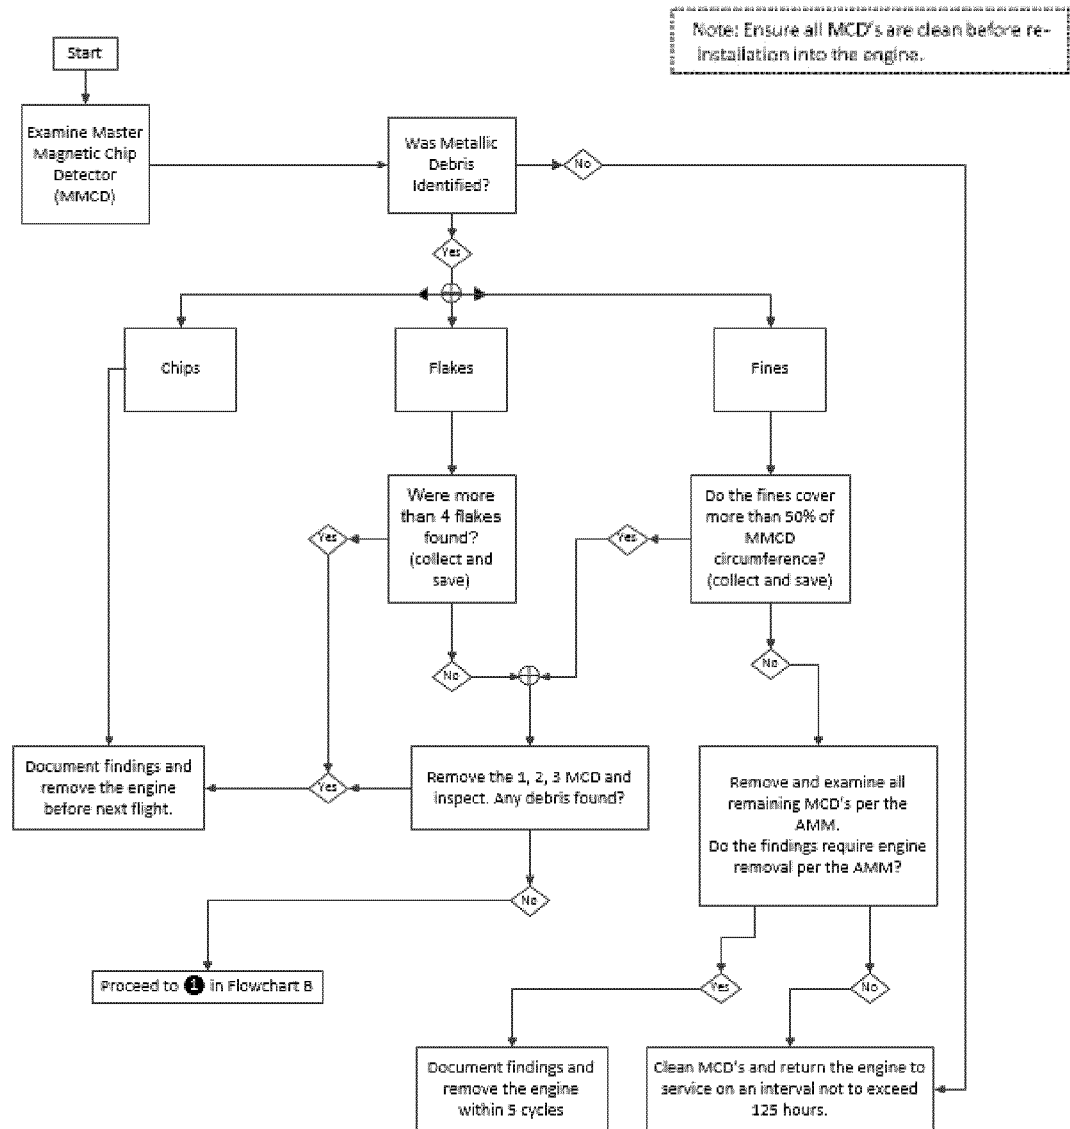
FLOW CHART A  
FIGURE 1

1. Remove and examine the Master MCD (Position 1) for metallic debris as specified in Reference 2, Aircraft Maintenance Manual (AMM), TASK 79-00-00-200-014-A. See Figure 1.

2. Was metallic debris found?
  - A. If metallic debris was not found, return engine to service on an inspection interval not to exceed 125 hours.
  - B. If findings were detected during the MMCD inspection, determine what type of metallic debris was found using the AMM definitions and figures as specified in Reference 2, AMM, TASK 79-00-00-200-011-A.

- A. No chips are allowed. If chips are identified, the findings should be documented and the engine should be removed from service before the next flight.

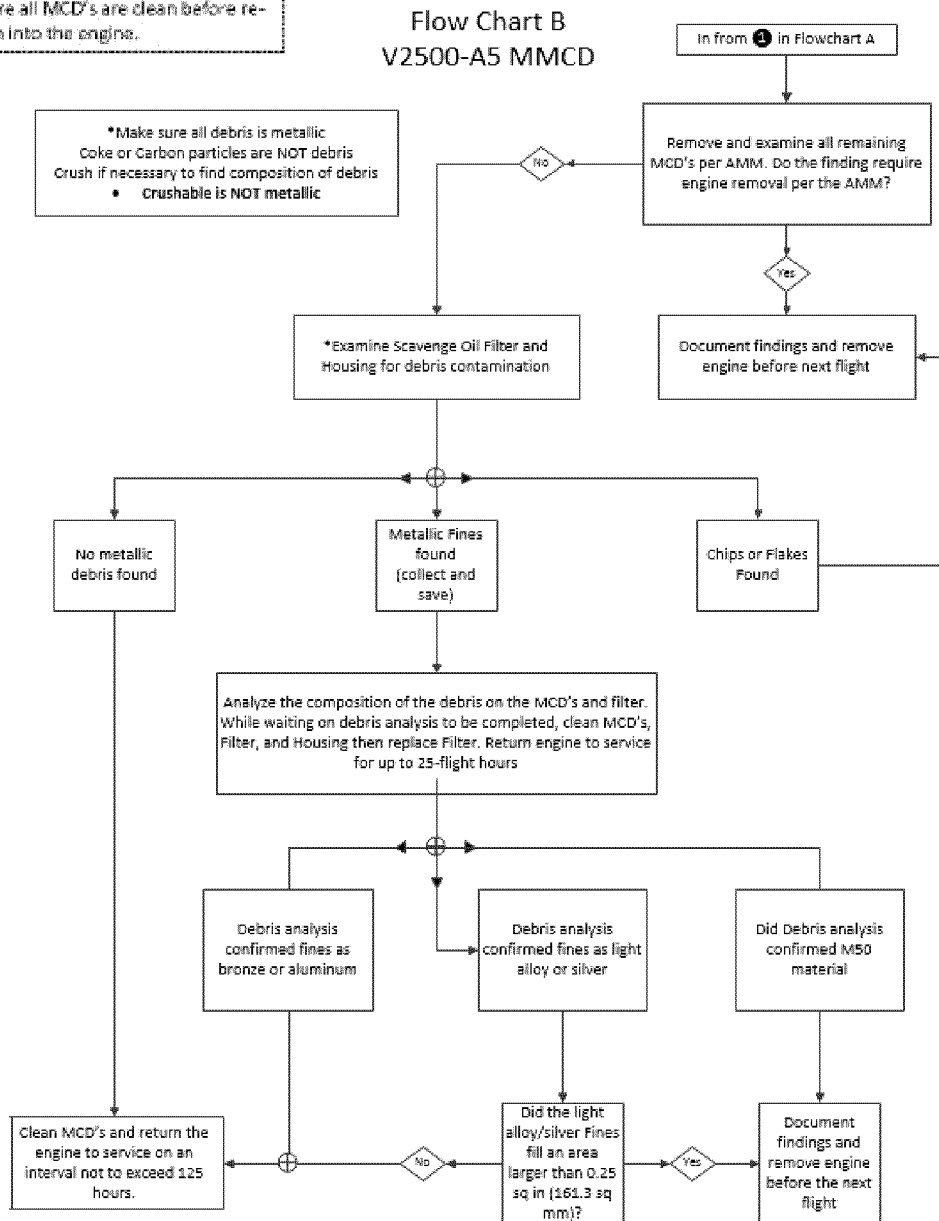
FLOW CHART B  
FIGURE 2

- 1 If yes, document the findings and remove the engine before the next flight.
- 2 If no, proceed to Step 4.C.
- C. Examine the scavenge oil filter and housing for debris contamination as specified in Reference 2, AMM, Chapter/Section 79-00-00. See Figure 2.

- (1) Was any debris found during examination of the Scavenge oil filter and housing?
- (a) If yes, determine what type of debris was found using AMM definitions and figures as specified in Reference 2, AMM, TASK 79-00-00-200-011-A. Proceed to Step 4.C.(2) for chips and/or flake findings and Step 4.C.(3) for metallic fines findings.

- (a) Document the findings and remove the engine before the next flight.
- (3) Metallic fines found during examination of the scavenge oil filter and housing:

- (a) Collect the debris, measure the amount of findings, then analyze the composition of the debris on the plugs and filters. While waiting on debris analysis to be completed, clean MCDs, filter and filter housing, re-install, then return the engine to service for up to 25 flight hours. Proceed to the following step in addition to putting the engine on a 25 flight hour interval.

Note: Ensure all MCD's are clean before re-installation into the engine.
