NON-MODIFICATION SERVICE BULLETIN — ENGINE — TURBINE EXHAUST CASE (TEC) — EDDY CURRENT INSPECTION (ECI)

Turbojet Engine Service Bulletin No. 72-0694 Revision No. 2 dated July 2, 2018.

V2500 Series 72-0694

ATA NUMBER 72-50-00

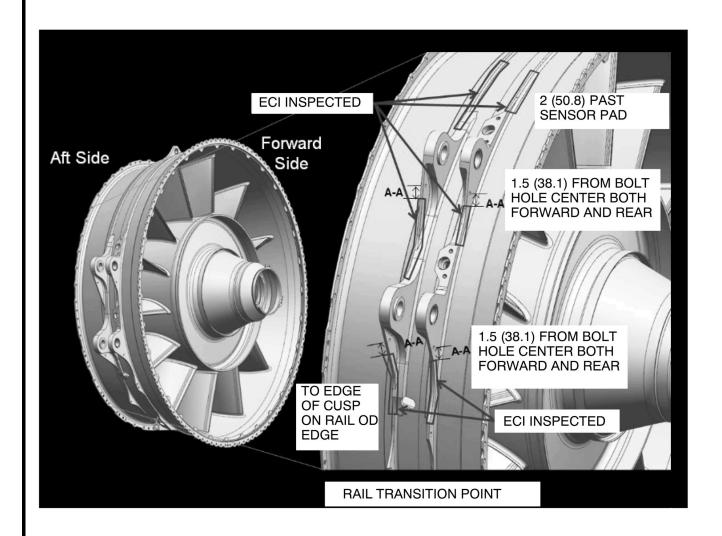
RIGHT ENGINE MOUNT LUG INSPECTION AREA FIGURE 8

- G. A non-inspect area has been defined approximately 1.5 ± 0.1 inches $(38.1 \pm 2.5 \text{ mm})$ around the four bolt holes noted as View A-A in Figures 8 and 9. There are four holes per side. Figure 10 shows the expanded View A-A of the non-inspect area around one of the four bolt holes.

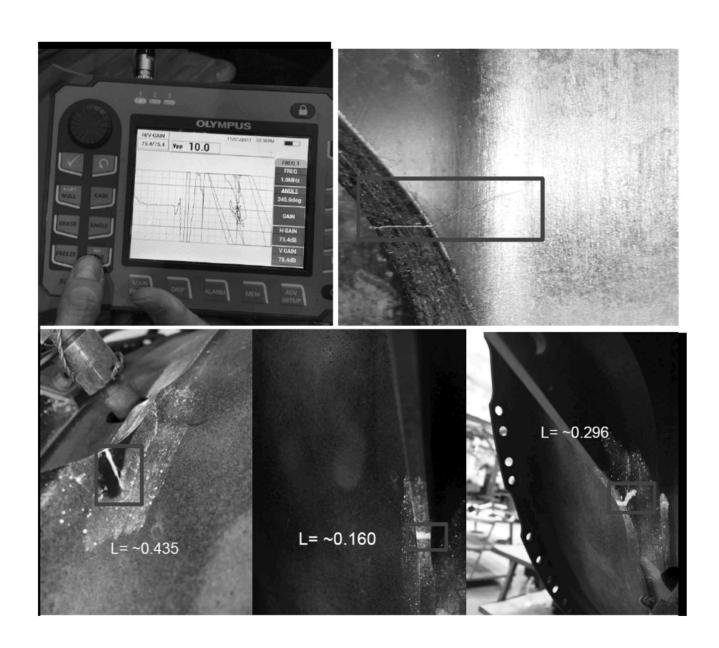
CRACK DETECTION EXAMPLE FIGURE 23

- D. Note that large cracks have been found through use of this eddy current inspection with results shown in Figure 23. The eddy current response (upper left) for this full-rail-width crack exceeded a 10 Vpp response. The crack extended across the rail face and down both sides (upper right). While this expanded image shows a clear crack indication, this crack was not easily visible. Through the FPI process (lower) shows a total crack of 0.89 inches (22.60 mm) was found.

- D. Note that large cracks have been found through use of this eddy current inspection with results shown in Figure 23. The eddy current response (upper left) for this full-rail-width crack exceeded a 10 Vpp response. The crack extended across the rail face and down both sides (upper right). While this expanded image shows a clear crack indication, this crack was not readily visually evident. Through the FPI process (lower) shows a total crack of 0.89 inches (22.60 mm) was found.
